Emergency Rehabilitation of the Zárate-Brazo Largo Bridges, Argentina

In November 1996 a cable ruptured on the Guazú Bridge across the Paraná River in Argentina, one of the two almost identical Zárate-Brazo Largo Bridges. COWI was immediately after retained as consultant by the bridge owner Direccíon Nacional de Vialidad in order to ensure and document the safety of the bridges and to investigate the causes of the cable failure.

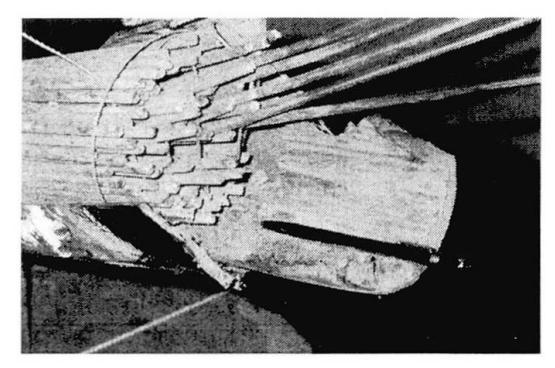
The evaluations revealed that a combination of corrosion and fatigue damage caused the failure of one cable, see Fig. 2, and large damages to a number of other cables. The corrosion was due to insufficient performance of the corrosion protection of the original cables. The cement grout, which was supposed to be the main active corrosion protection, was insufficient in the anchorage zone due to the presence of a nonprotecting epoxy tar.

The fatigue damage has been severe due to larger traffic loads than accounted for in the original design, but not least due to large amplitude cable vibrations.

Fig. 2 Ruptured cable

These amplitudes of the vibrations have been in the order of up to 1 m, which theoretically causes stress ranges well above the endurance limit of the wires. The corrosion has furthermore increased the fatigue stresses locally due to stress concentration.

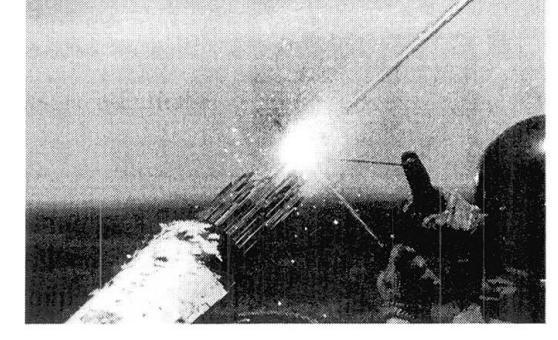
Fig. 4 Removal of existing cable by cutting of individual wires

A total of 13 cables were replaced during the emergency rehabilitation. The existing cables have been removed by cutting of the individual wires as seen in Fig. 4. It has been recommended to provide temporary wind ropes between the cables in order to limit the large amplitude cable vibrations. Furthermore, installation of guide deviators has been recommended in order to reduce the bending stresses in the anchorage zone.
