**Zeitschrift:** Schweizerische Bauzeitung  
**Herausgeber:** Verlags-AG der akademischen technischen Vereine  
**Band:** 83 (1965)  
**Heft:** 42: Prof. G. Schnitter zum 65. Geburtstag, 1. Heft

**Artikel:** Design and construction of Mänika Dam  
**Autor:** Bjerrum, Laurits / Kjaernsli, Björn  
**DOI:** <https://doi.org/10.5169/seals-68283>

# Design and Construction of Mänika Dam

By Laurits Bjerrum, Dr. sc. techn., Director, and Björn Kjaernsli, Chief Engineer, Norwegian Geotechnical Institute, Oslo - Blindern, Norway

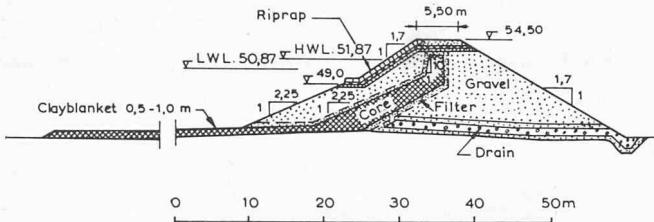
Fig. 3. Original Design of Mänika Dam, scale 1:1000

In Fig. 3 a cross section of the original design of the dam is shown. During construction, however, it became necessary to change the design.

According to the original design, if the dam was to have a sufficient factor of safety against sliding the shear strength of the core material had to be approximately  $4,0 \text{ t/m}^2$ . Since the clay was placed with a shear strength less than ten percent of this required value and because oedometer tests on the clay had shown that the coefficient of consolidation for this material was only  $5 \cdot 10^{-7} \text{ cm}^2/\text{s}$ , it was evident that the core material could not gain sufficient strength due to consolidation during the period of construction.

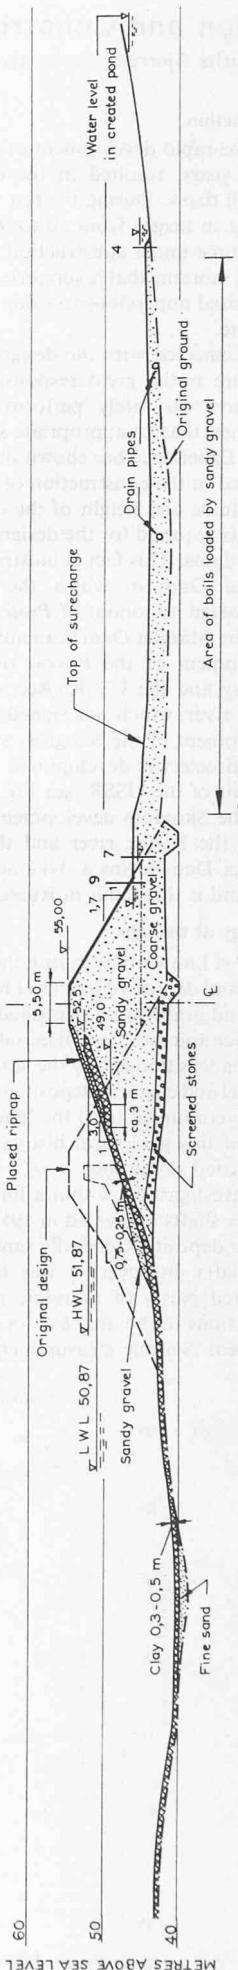
Fig. 4. Mänika Dam as constructed, scale 1:1000

After realizing the ineffectiveness of a flatter upstream slope and of a counterweight, consideration was given to the possibility of eliminating the internal clay core and instead placing the clay as an impervious facing on the upstream slope without any surcharge as an extension of the impervious blanket. It was felt that the clay would be stable on a slope of 1 vertical to 3 horizontal and the design which was agreed upon is shown in Fig. 4. At this stage, however, the loaded area downstream of the dam in figure 4 was not included in the design. To take advantage of the gravel fill that had already been constructed the dam was moved downstream so that the fill could be incorporated into the new structure simply by flattening the upstream slope of the fill to 1 on 3. To protect the clay facing from the deteriorating effect of ice and waves the clay from the top of the dam down to 1,0 m below the lowest regulated water level was protected by a riprap of stones with a minimum weight of 50 kg placed on a layer of sand and gravel; below this level, the facing and clay blanket were left unprotected.

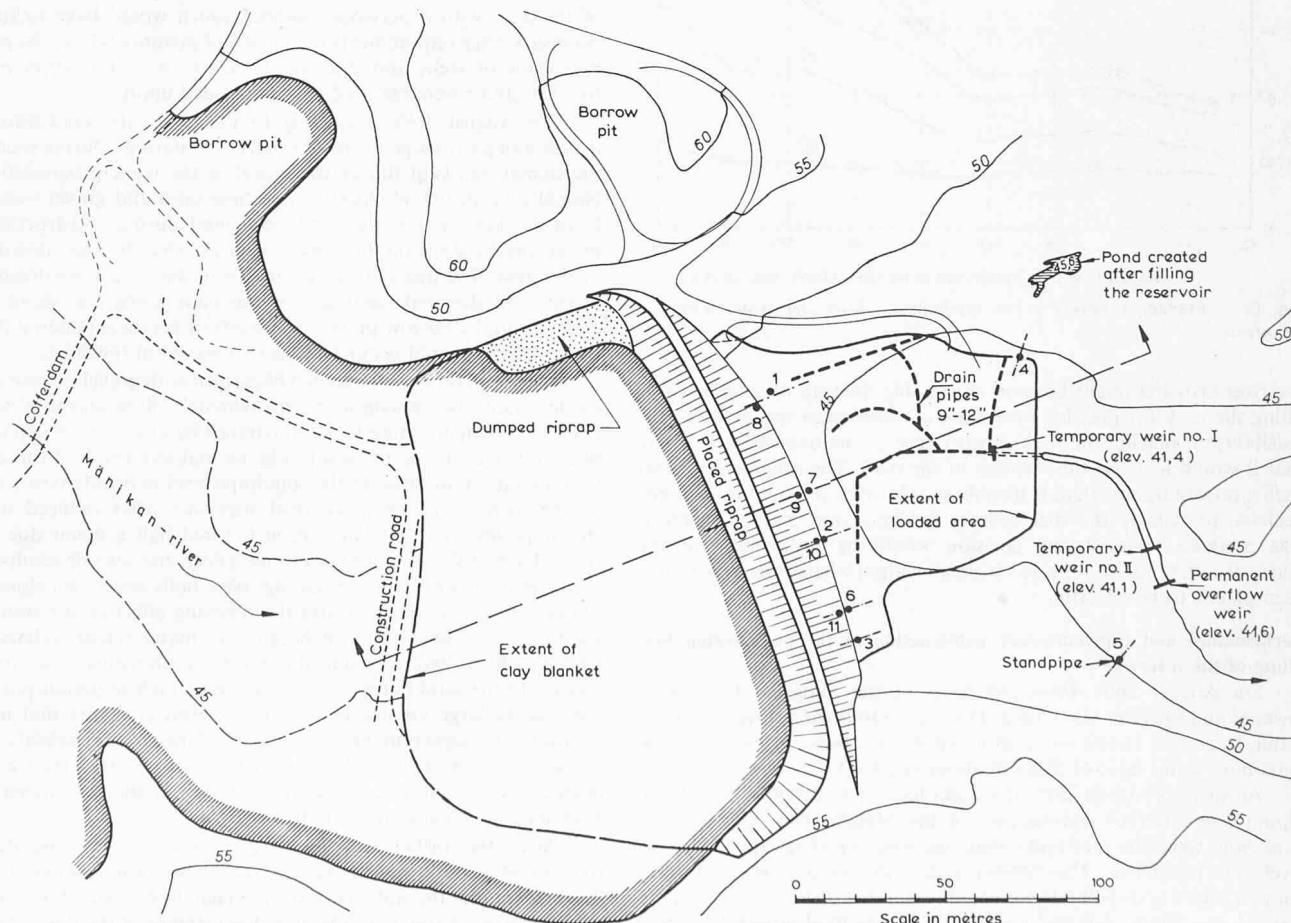
Fig. 5. Mänika Dam in Plan, scale 1:2500

Two overflow weirs were constructed downstream of the dam for seepage measurements and five standpipes, numbers 1 to 5 in Fig. 5, were installed for measuring the ground water level downstream of the dam.

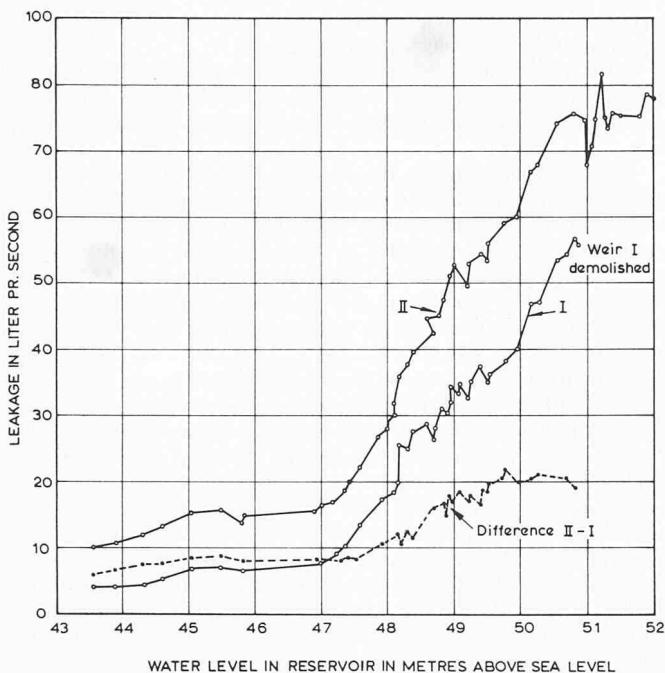
Fig. 6a. Leakage measured at temporary Weirs I and II versus Water Level in Reservoir

Before closing the main branch of the river at the Skogfoss Dam and raising the water level in the reservoir, the seepage and standpipe levels were measured for a water level upstream of the Mänika Dam which very nearly corresponded to the normal river level that existed prior to construction of the dam. For example, at the end of May 1964 the water level in the Pasvik river upstream of the cofferdam was 44,12 m above sea level and the water level in the pond between the cofferdam and the Mänika Dam was 43,55 m above sea level. Under these conditions, the seepage at the two overflow weirs was found to be 4,2 l/s and 10,3 l/s respectively, see Fig. 6a. The standpipe levels at the five measuring points for the same situation is shown in Fig. 6b.

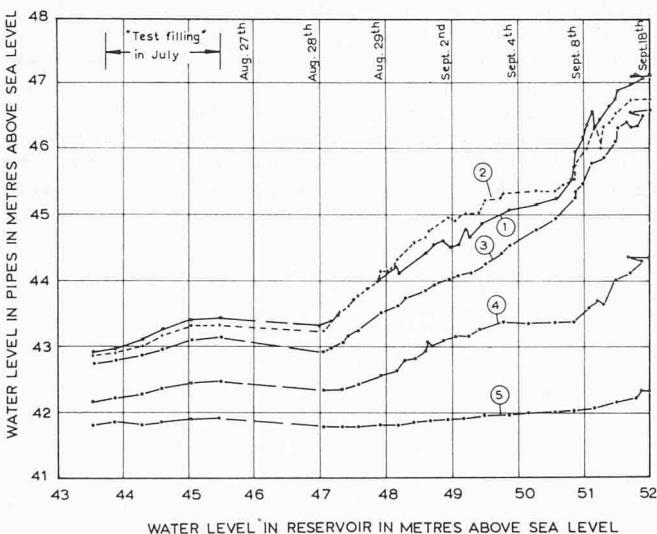
Fig. 6b. Standpipe Levels in Installations 1—5 versus Water Level in Reservoir

As early as August 28th, at a water level of 47,0 m above sea level, piping was observed downstream of the Mänika Dam. On the left bank boils were observed and a slight increase in leakage and standpipe level was registered. The following day the water level had risen another metre and the boils increased in number as well as in size; the leakage was almost doubled and the standpipe level in installations 1 and 2 had risen as much as the reservoir level, Fig. 6b. Downstream of

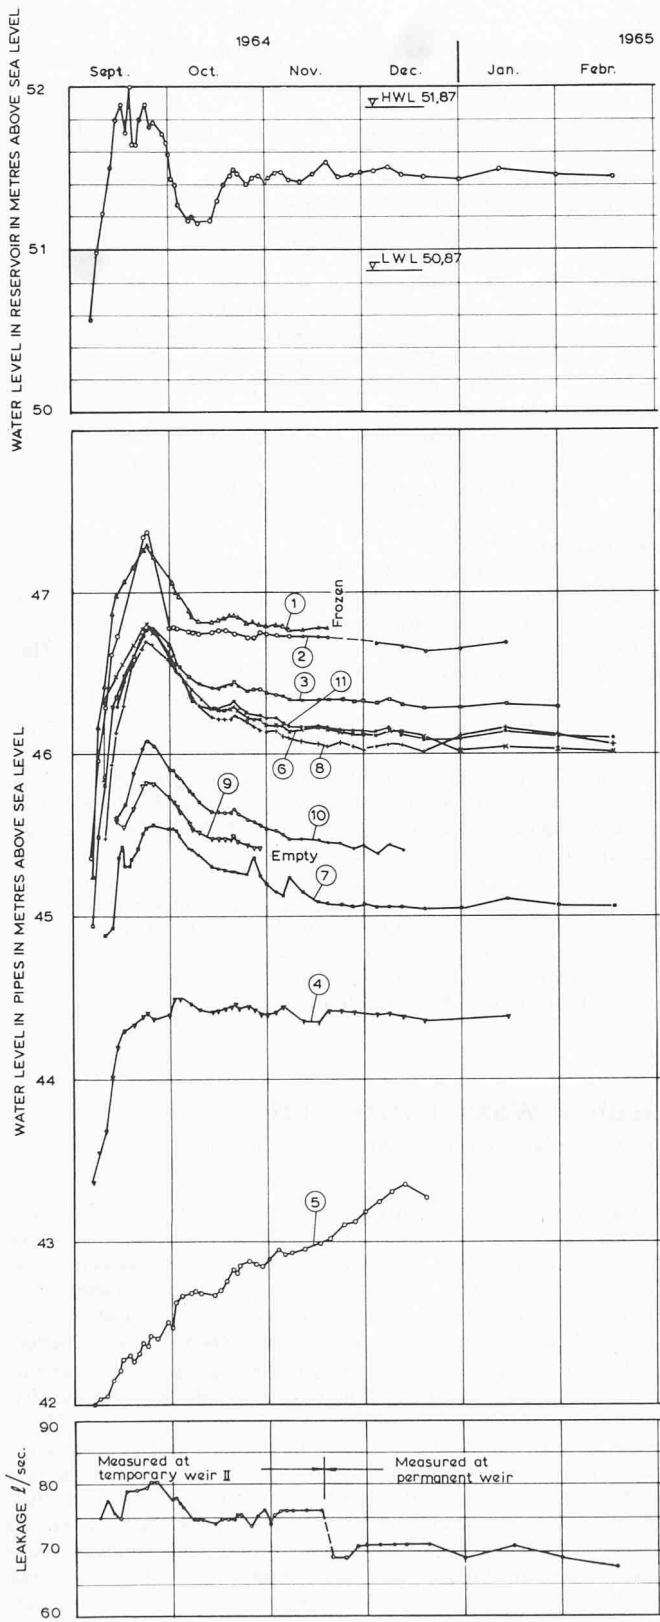
Fig. 7. Water Level in Reservoir, Standpipe Level and Leakage versus Time

The task of loading and draining the area downstream of the dam was completed as the water level in the reservoir reached its maximum at 52,0 m above sea level on September 18th. The leakage under full reservoir head increased to 78 l/s which is, of course, fairly large but of no economical importance for this hydroelectric development. Since then the water level in the reservoir has fluctuated between 51 and 52 m above sea level. The measured leakage as well as the standpipe levels for all installations are shown in Fig. 7.

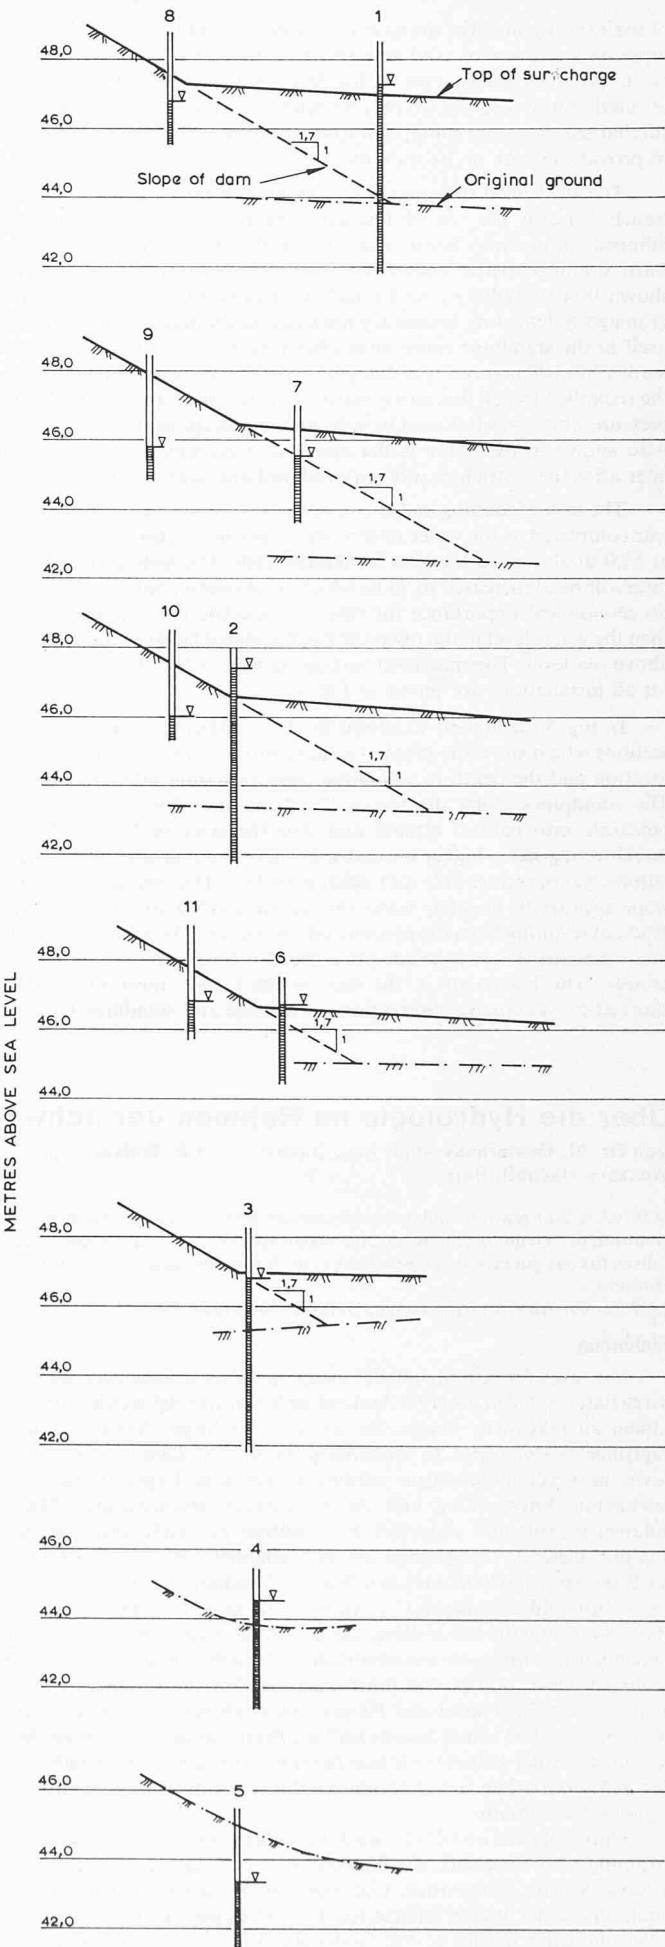
Fig. 8. Highest Standpipe Levels recorded

In Fig. 8 the highest standpipe levels are indicated in several cross sections which show the original ground surface, the surcharge at that location and the depth to which the pipes penetrate into the ground. The standpipes along the toe of the dam, numbers 1, 2, 3 and 6, penetrate into natural ground and into the layer of fine sand and therefore register a higher ground-water level than at the other installations that penetrate only into sandy gravel fill. The seepage line in the slope appears to be safely below the surface and the upward hydraulic gradient resulting from the pressure difference is safely below 1,0. From these sketches it was concluded that the structure could be considered as safe. The behaviour of the dam in the future, however, will be checked by systematic observations of leakage and standpipe levels.
