**Welding experiences
at the construction of the newest Danube and Tisza bridges
in Hungary**

Dr CH. SZÉCHY

Chief engineer, Highway-bridge Department in Hungary

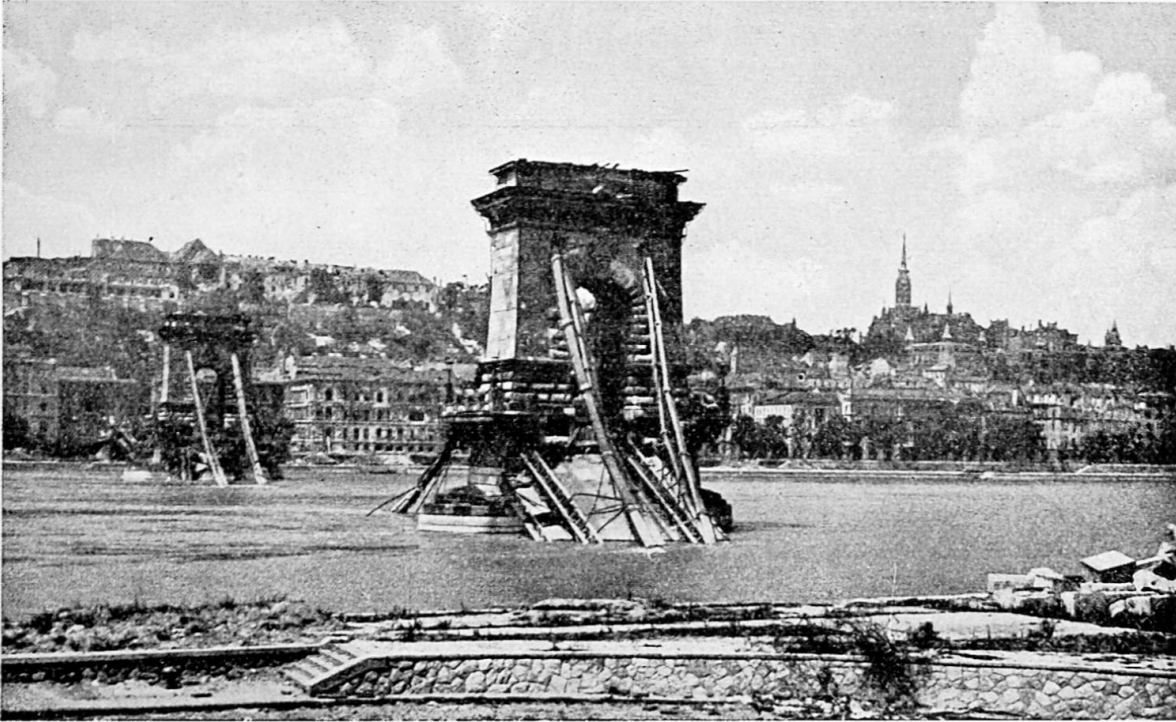
Fig. 4. View of the blown up « Chain-bridge » Budapest.

Budapest the German troops have blown up the left side anchoring chambers of the bridge, inducing so a mighty slip of the chains (16 meters = 53 ft 0 in over the left pylon and about 3 meters = 10 ft 0 in over the right pylon) which tremendous deformation led to the entire collapse of the bridge. Although many of the chains broke and many again suffered plastic torsion or buckling still it was evident, that a considerable part of them might be reutilized (fig. 4).
