Zeitschrift: **IABSE publications = Mémoires AIPC = IVBH Abhandlungen**

Band (Jahr): **17 (1957)**

Impact Resistance on Prestressed Concrete Masts¹⁾

P. W. ABELES, London

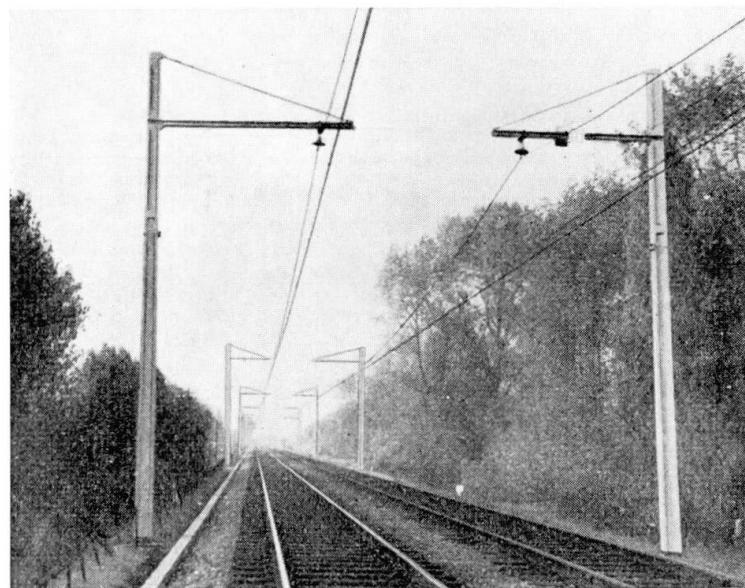
Fig. 1. Prestressed Concrete Cantilever Masts near Southend (England).

From figs. 1—3 it is seen that the prestressed concrete masts differed but little in size from the steel masts. This was achieved by making full use of the tensile resistance of the concrete under working conditions, which is particularly advantageous if loading in opposite directions occurs. Freedom from

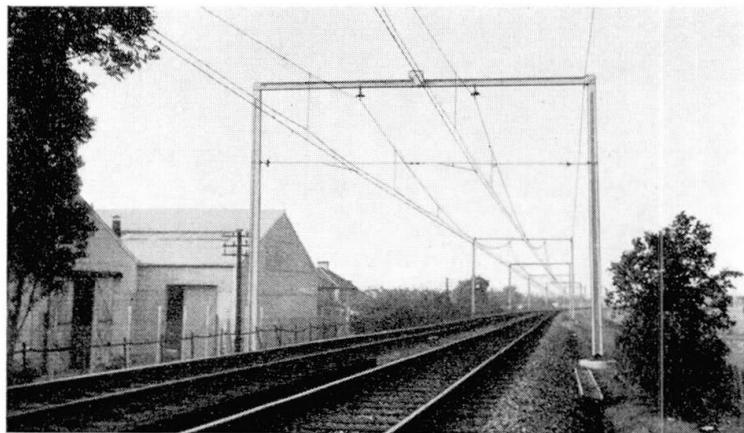
Fig. 2. Prestressed Concrete Portal Mast near Southend (England).

visible cracks is ensured under the static working load and untensioned steel has been included to assist in the resistance to impact by the increased resilience thus provided, and also to ensure the required factor of safety against failure. Note in fig. 2 the slight difference between prestressed concrete and steel portal masts, the former with hinges at the top and the latter (2nd mast and following masts) with rigid upper corners.

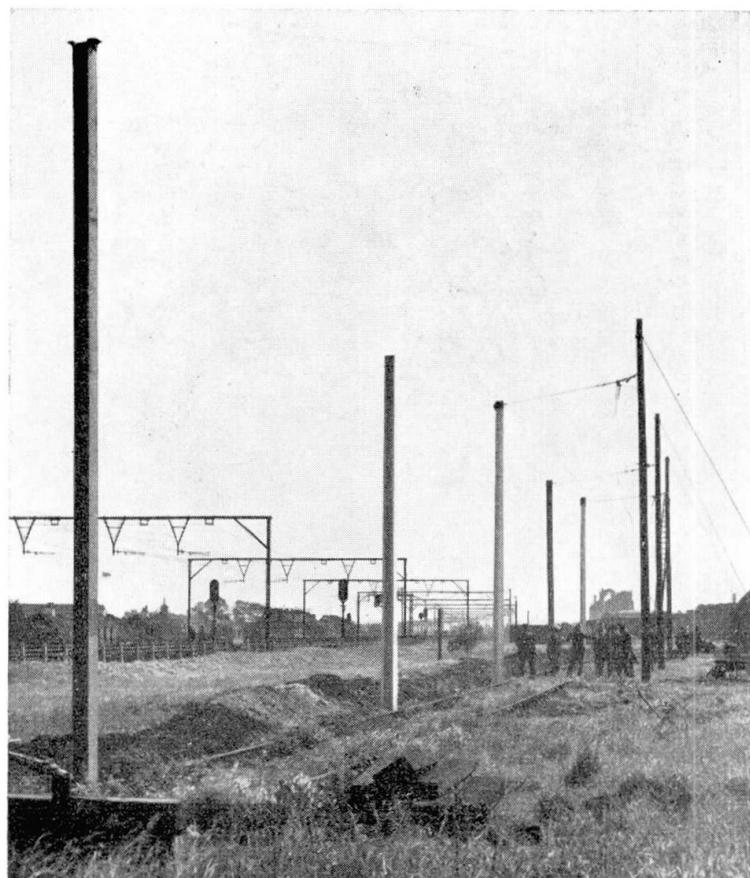
Fig. 3. Romford Impact Tests. General View.

might collapse instantaneously in the event of sudden impact. For this purpose, a number of steel and prestressed concrete cantilever masts were placed parallel to an auxiliary railway track (fig. 3) and subjected to impact while the full live load, a horizontal force of 800 lb., was applied at the top of each mast.

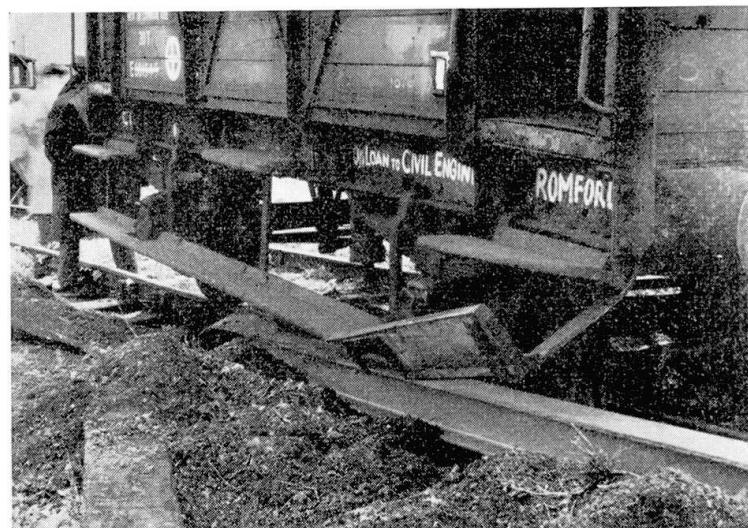
Fig. 4. Romford Impact Tests. Steel Mast After Direct Impact.

The impact was applied by means of a brake van of 20 tons weight which was projected into the mast with a speed of approximately 10 miles per hour. For each individual test the track was slewed so that either the entire mast or only part of a flange was hit. The tests have proved, as was to be expected, that in the event of a direct hit both types of mast become unserviceable. The steel mast was entirely bent down (fig. 4), although it had been expected by those favouring steel that it would only be bent slightly and would still be able to carry the high voltage wires in the air; the prestressed concrete

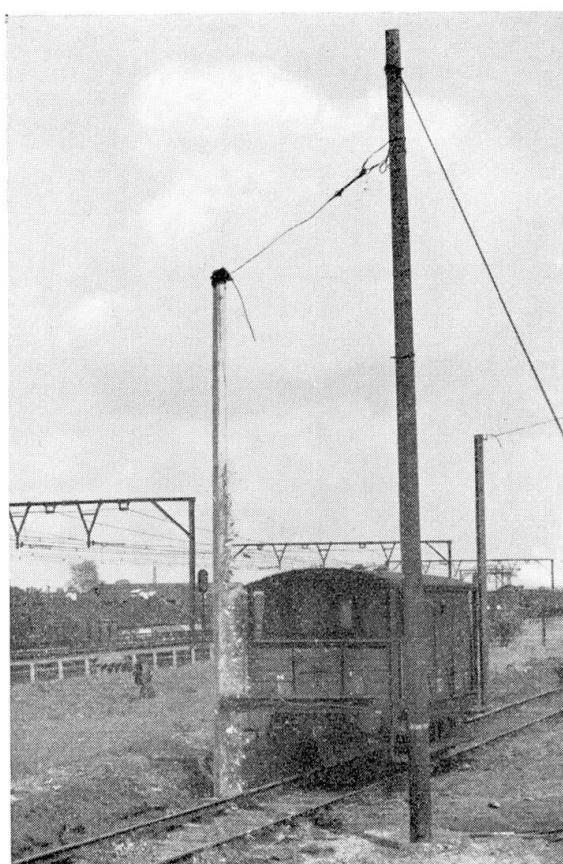
Fig. 5. Romford Impact Tests. Prestressed Concrete Mast During Impact.

In the case of a glancing blow only local damage occurred with the steel mast; with the prestressed concrete mast, a part of the flange was cut away (fig. 5) and two wires were severed. In addition, a number of heavy cracks occurred particularly near the bottom of the mast (fig. 6). Nevertheless, the mast was capable of carrying, in its damaged state, the maximum working load which would occur only occasionally when adverse weather conditions are involved (fig. 7). The equivalent of this load was re-applied and sustained for 24 hours without any noticeable deterioration.

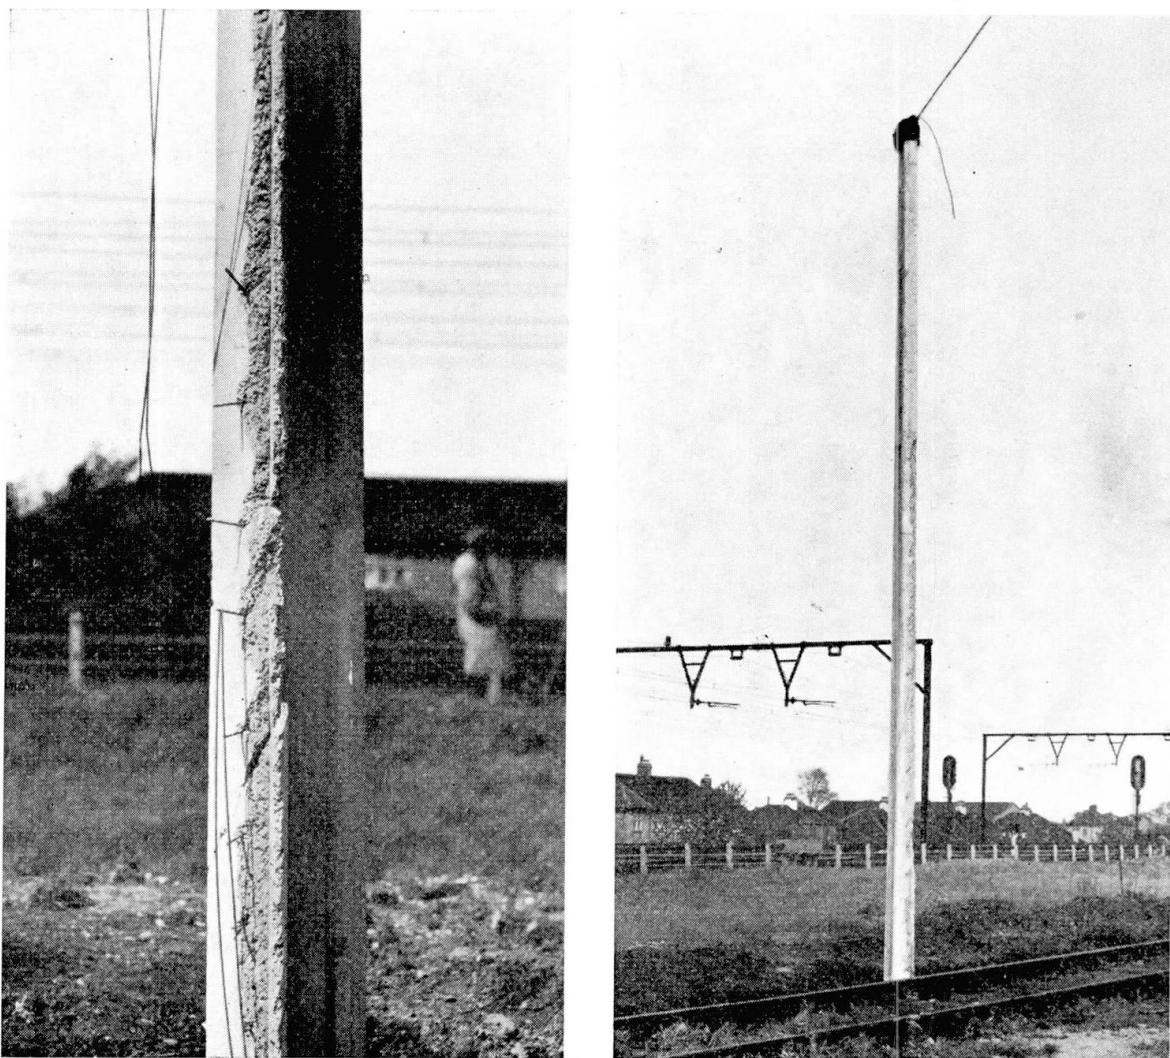
Fig. 6 and 7. Romford Impact Tests. After Glancing Blow.

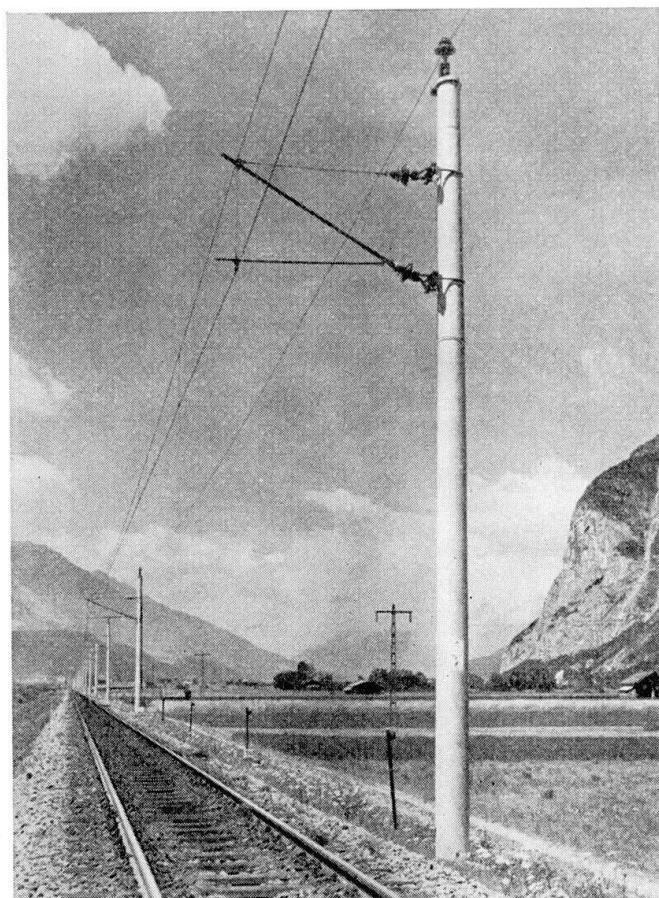
Fig. 8. Spun Concrete Cantilever Masts near Innsbruck (Austria).

The advantage of concrete, as compared with steel, is obviously the fact that maintenance is reduced to a minimum. When the concrete is dense, as obtained by centrifugal moulding or vibration, there is no danger of corrosion, even if there are permanent fine hair cracks which cannot be avoided with ordinary reinforced concrete. Fig. 8 shows cantilever masts of the Austrian Spun Concrete Works, Hoffman & Co., Kirchdorf, designed by the author in 1934 [1]. High strength steel of a strength of 142 000 lb/in² (100 kg/mm²) was used and the design was based on a factor of safety against failure of 3 with nominal working load stresses of approximately 40 000 lb/in² for steel and 3000 lb/in² for concrete. Hair cracks developed at half the working load. These masts have been in use since 1934 near Innsbruck (Tyrol, Austria) where the weather conditions are not too favourable and in spite of permanently open fine hair cracks they are still in good condition, as the chief engineer of the Austrian Federal Railways has informed the author; this is again a proof that fine hair cracks are harmless²⁾ [2]. With prestressed concrete, no cracks should occur under working load, though relatively fine cracks would develop due to occasional excess load which would however, close completely, even if the excess load had reached double the design load upon return to normal, as static tests have proved, provided that a factor of safety against failure of 2.5 is obtained.
