# Presentation Session 4b: Assessment of structures

Zeitschrift: **IABSE reports = Rapports AIPC = IVBH Berichte**

Band (Jahr): **57/1/57/2 (1989)**

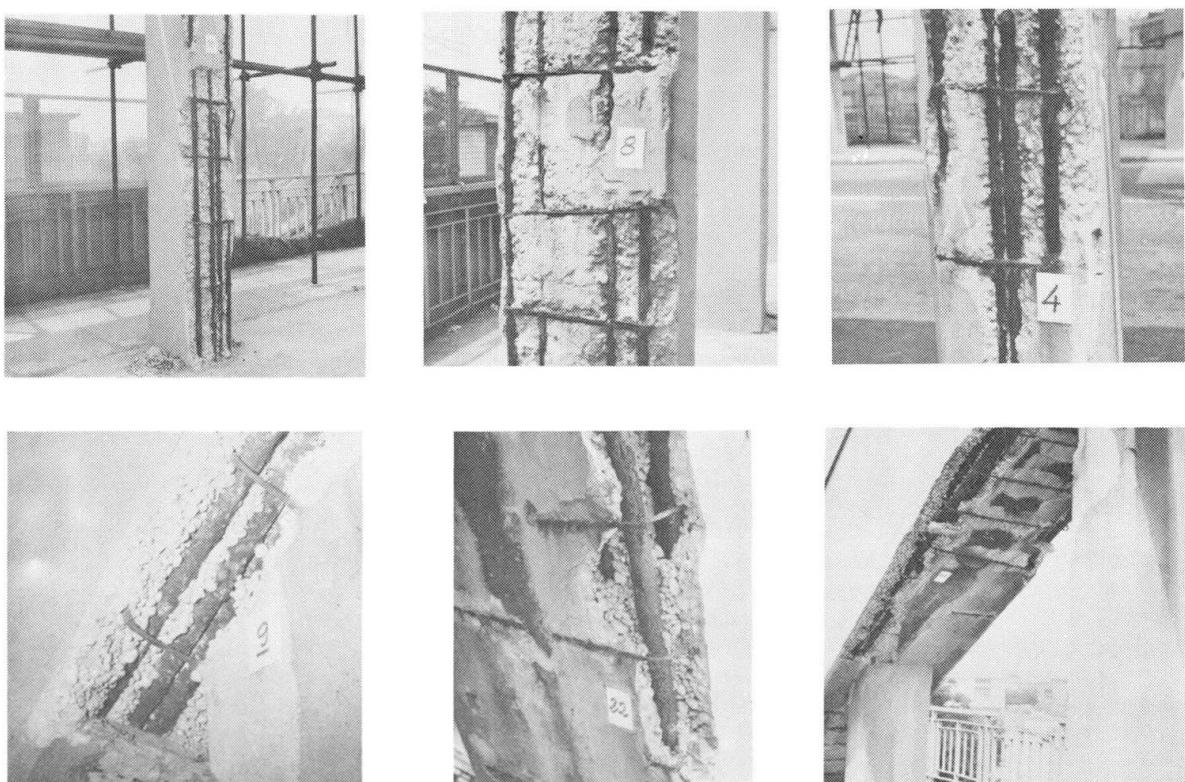
Fig. 2. Corrosion of reinforcement and spalling of concrete on various elements of the bridge
