**Artikel:** Survey of statical conditions of churches in Rome  
**Autor:** Menegotto, Marco / Tremi Proietti, Sergio  
**DOI:** <https://doi.org/10.5169/seals-53305>

## Survey of Statical Conditions of Churches in Rome

In this context, the writers have been commissioned by the Ministry of Public Works to undertake surveys and investigations on the statical conditions of three main basilicae in the heart of Rome: St. Augustine's, St. John of the Florentines' and the Gesù.

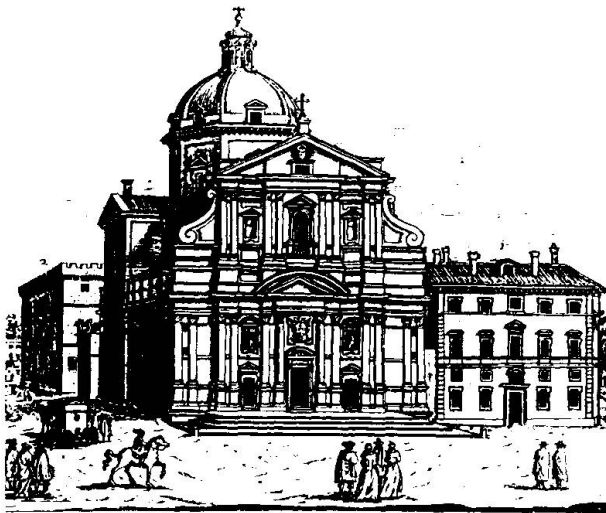
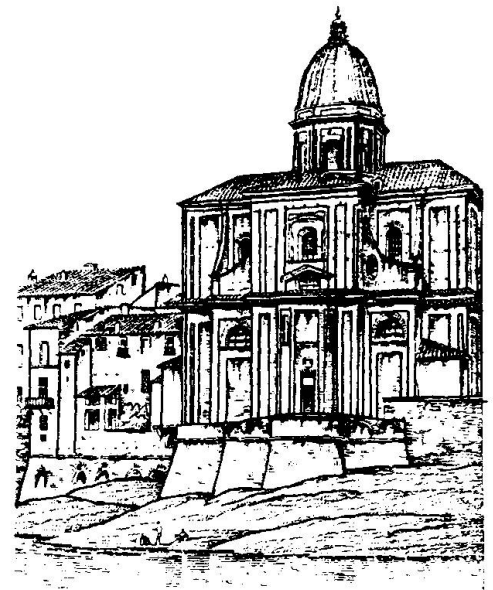
The survey has begun with historic research on structural data, geometric measurements and visual inspections. No evidence appears on overall static weaknesses, but typical degradations are present in all buildings, namely, roof timber aging and leakings, detachings of lead plates from domes, humidity from soil, settlement cracks in masonry. Particularly difficult is checking the foundations. In fact, inside the churches the underground space is filled with historic graves and, outside, streets and buildings hinder inspections. The survey will proceed by sampling the structural materials and monitoring the deformations, where needed. Finally, a maintenance plan will be established.
