Diagnosis and strengthening of the Brunelleschi Dome

Diagnosis and Strengthening of the Brunelleschi Dome

A. CHIARUGI

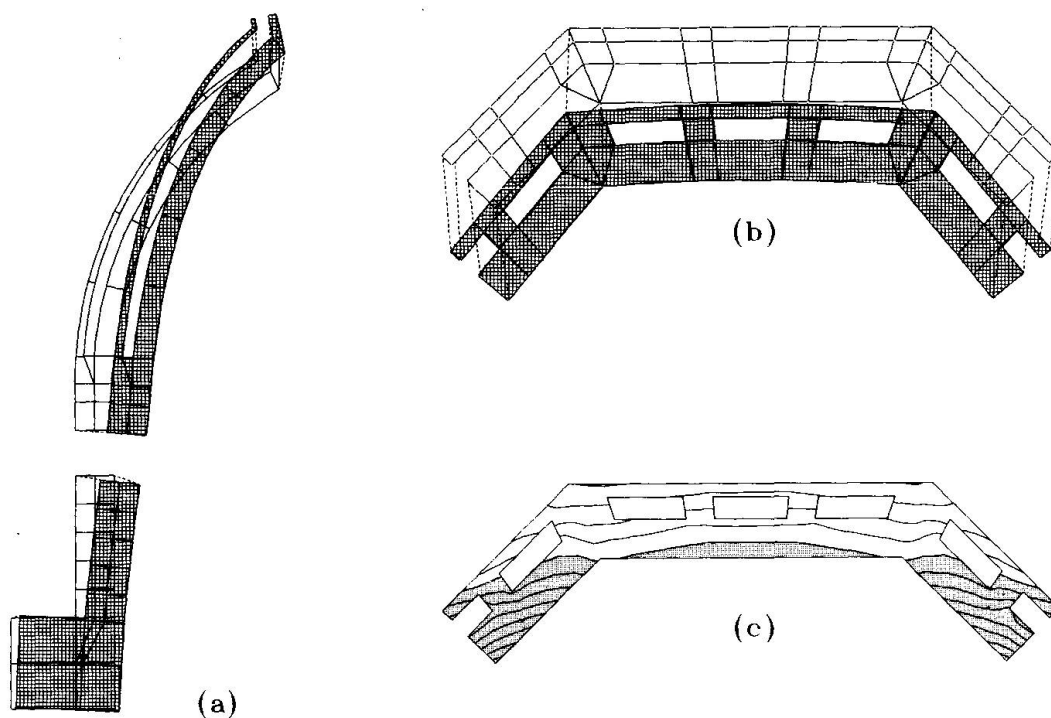
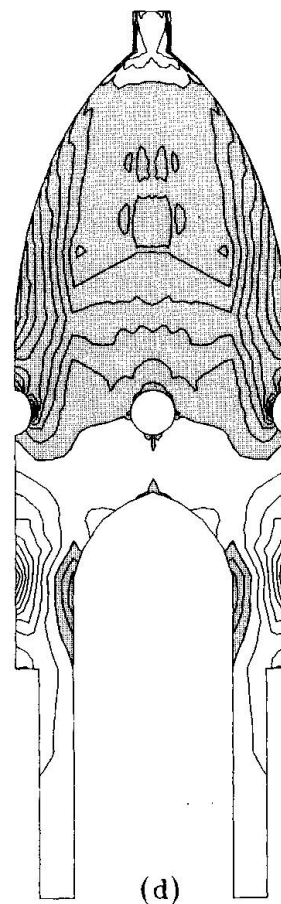
Fig. 6

"First identification model" under only strengthening effect:

- (a) deformed line of vertical section;
- (b) deformed line of section 3-3 at 66 m level;
- (c) stress distribution σ_z vertical in the section 3-3; with opponent distribution with respect to the dead-weight;
- (d) stress distribution σ_z vertical on intrados face;

Tension zone shaded.

The strengthening intervention could be effected through harmonic-steel cables placed at floor level in the first walking. The shape of these belts, pulled on at the midpoint of each side, would be octagonal; thus the interaction with the existing structure (apart from local effect) could be schematized by a system of radial forces, applied in the edges at the springing section of the dome.

Perusing the numerical simulation of this strengthening carried out on the "first-identification" model, one is surprised by the close- fitting antagonistic effect brought about by the intervention as against the dead-weight stress pattern (fig. 6 a, b, c, d).

One can remark that, according to the Betti theorem, the mutual work of the two force systems (dead-weight and prestressed belts) is obviously negative. However, one can moreover generally recognize that "almost everywhere" is negative also the local function which expressed the density of mutual work at every point of the structure.
