Conservation of the Lions Court at the Alhambra of Granada

Ugo ZEZZA

Eduardo SEBASTIAN PARDO

2.2 Colonnades in "Patio de los Leones"

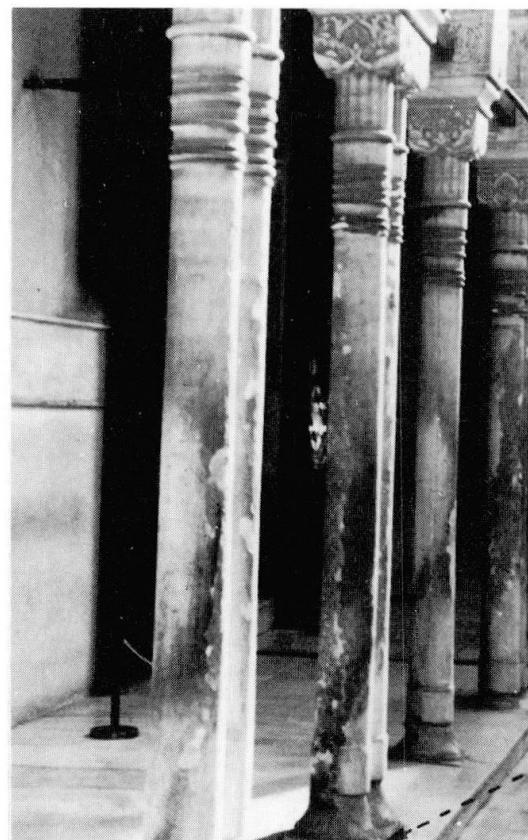
Fig. 3 Progressive reduction in height of bases, and damaged shafts according to mechanical weakness plane.

by direct correlations between the increases of the apparent decay degree and total anisotropy index, measured in marble artifacts. Moreover, this evolution has been related to: a) rotation of the foliation plane, consistent with the shaft placement, influencing the durability of the artifacts under the same exposure conditions; and b) evident displacements of the original static conditions (figure 2), and new signs of differential settlement and plumb-line diversifications in severely damaged shafts, recognized particularly in the "Galeria de Dos Hermanas" colonnade (figure 3).
