Strengthening of the Wooden Covering of the Archaeological Museum in Naples

Nicola AUGENTI
Professor
University Federico II
Naples, Italy

SUMMARY

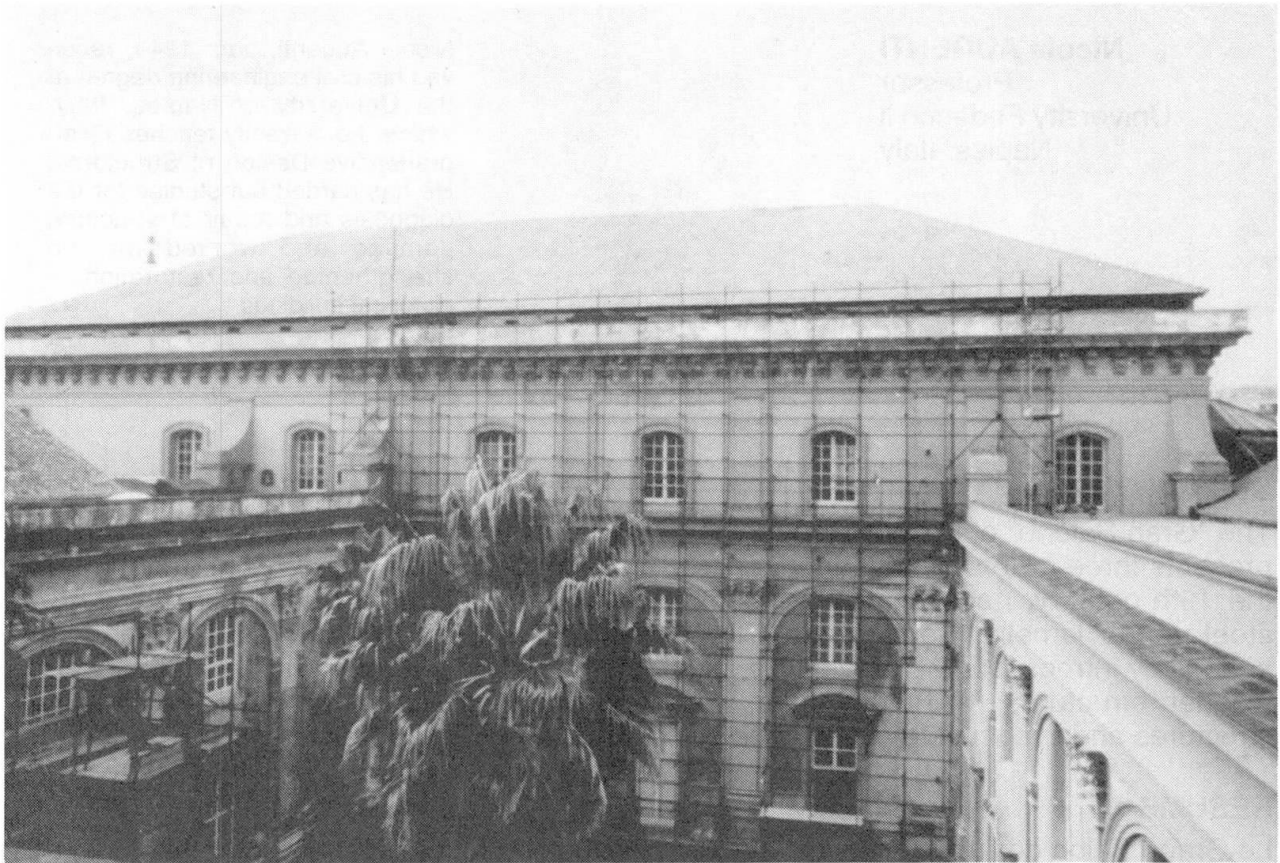
Fig. 1 Outside view of "Gran Salone" covering.
