Session B3: Maintenance of structures

Zeitschrift: **IABSE reports = Rapports AIPC = IVBH Berichte**

Band (Jahr): **73/1/73/2 (1995)**

Maintenance of Structures
Maintenance des structures
Instandhaltung der Tragwerke

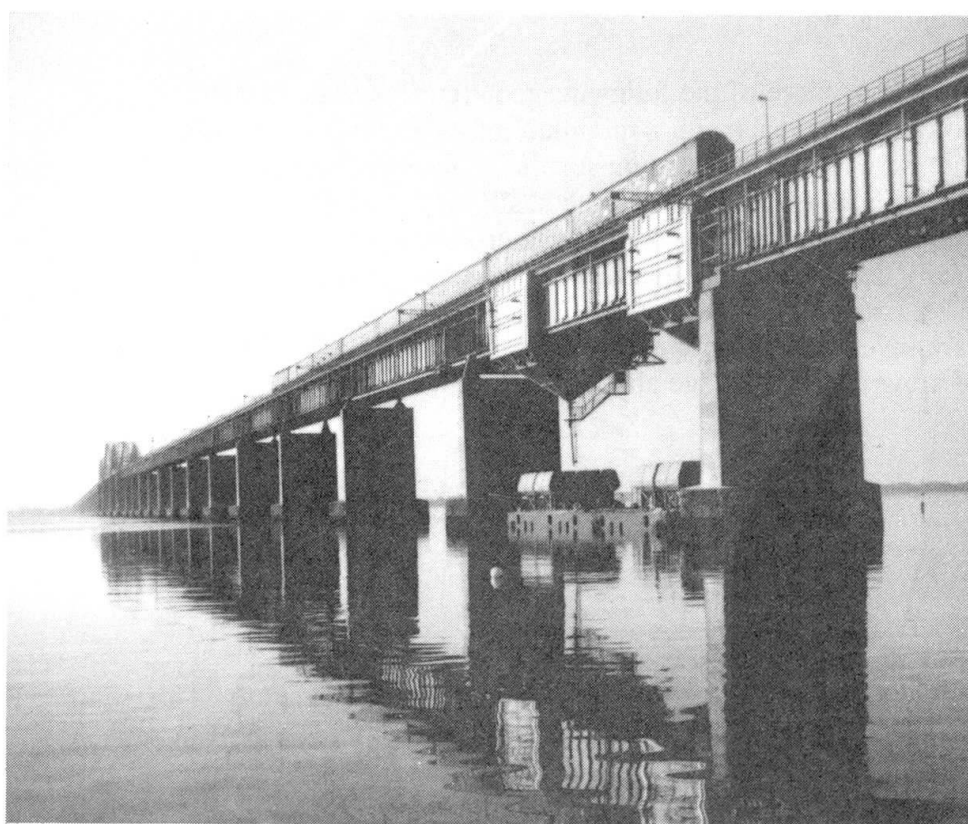
Photo 2 shows the mounting of the mobile platforms under the Storstrøm Bridge.
