## **Extending the Lifespan of the Architectural Heritage**

**Giorgio CROCI**  
Professor  
Univ. "La Sapienza"  
Rome, Italy

### **SUMMARY**

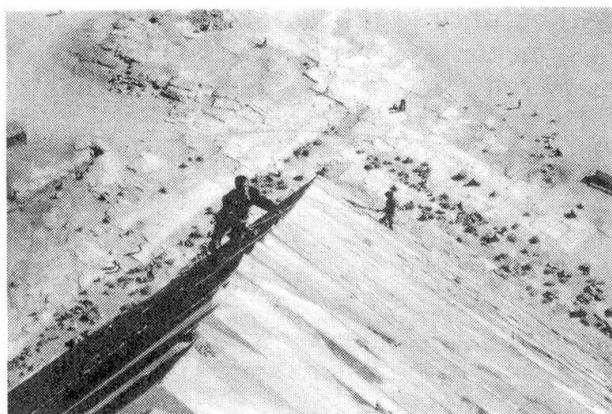
Fig. 1: The ascent of Chephren's Pyramid

On 17 November 1994, a scientific mission made an ascent of Chephren's Pyramid (Figure 1) to evaluate the role of temperature and wind in the decay of the stone and to assess the stability of some blocks that have been shifted by earthquakes in the past (Figure 2). On the one hand the survey contributed new and important elements for deeper understanding of the construction of the pyramid and, on the other, showed that, apart from the problem of weathering, no radical structural interventions were necessary, it being sufficient to add some supports in the same limestone to ensure the stability of blocks at risk.

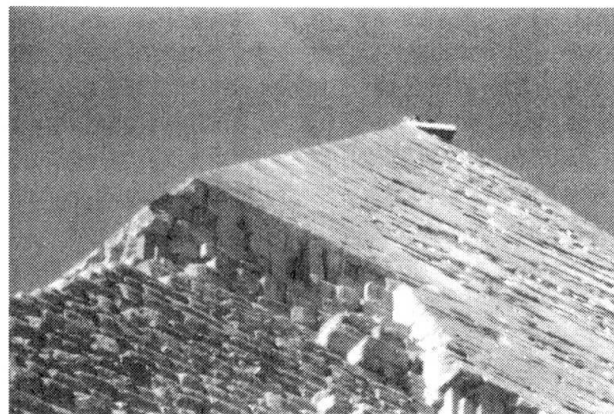
Fig. 2: Shifting of a block on the top of Chephren's Pyramid

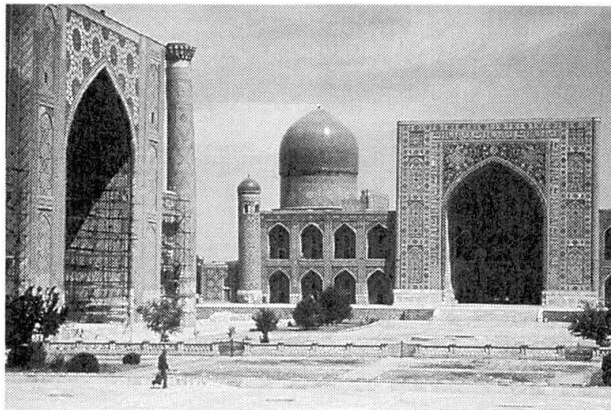
Fig. 9, 10: Leaning and deformations in minarets and mosques, Samarkand

Many of the monuments of Samarkand (Uzbekistan) are affected in this way and both minarets and disconnected walls have dangerous cracks or lean heavily. In the Tilla Kari Mosque on Registan Square (Figures 9 and 10) is an example in which the outward top displacements amount to tens of centimetres, creating unstable situations for both the walls and the connected vaults.
