Zeitschrift: IABSE reports = Rapports AIPC = IVBH Berichte
Band: 73/1/73/2 (1995)

Artikel: Repair of a building damaged by foundation settlement
Autor: Gusmao Filho, Jaime
DOI: <https://doi.org/10.5169/seals-55257>

Repair of a Building Damaged by Foundation Settlement

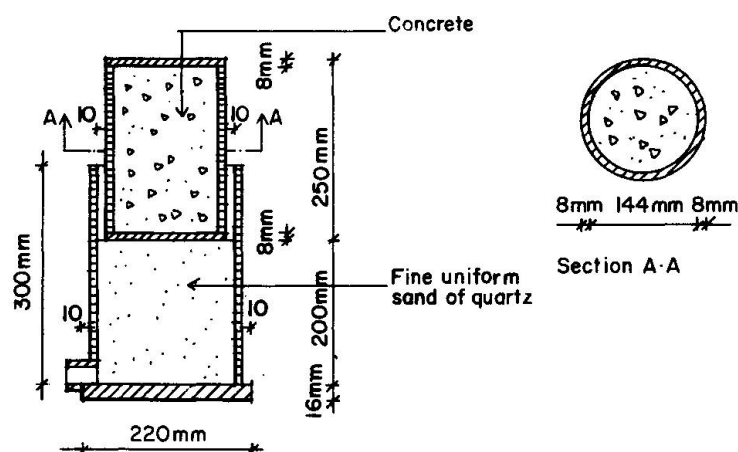
Figure 4 gives detail of the sand jack. Its 160 mm diameter piston should get out an extension of 150 mm which is the settlement predicted to be compensated along time. The cylinder below has an internal diameter of 180 mm. It is filled in by fine sand of quartz with uniform grain-size and pre-loaded to 350 kN. This load is higher than the maximum one to be transmitted by the tie system. The device has two little holes at the bottom. The sand takes out smoothly using a thin steel pointer through them. Two lateral defletometers measured the descent up to the value of the settlement to be compensated. Laboratory tests permitted to define the procedures to assure an even lowering of the piston. The field operations proved to be the sand jack a practical, simple and safe device to lower the conceived system.

Fig. 4 Detail of the sand jack

In the meantime, the sand jacks were removed once. In some jacks, their pistons had got the final course. In others, the strong confinement of the sand avoided its remotion during relaxation. The jacks were repaired and turned back to the tie system.

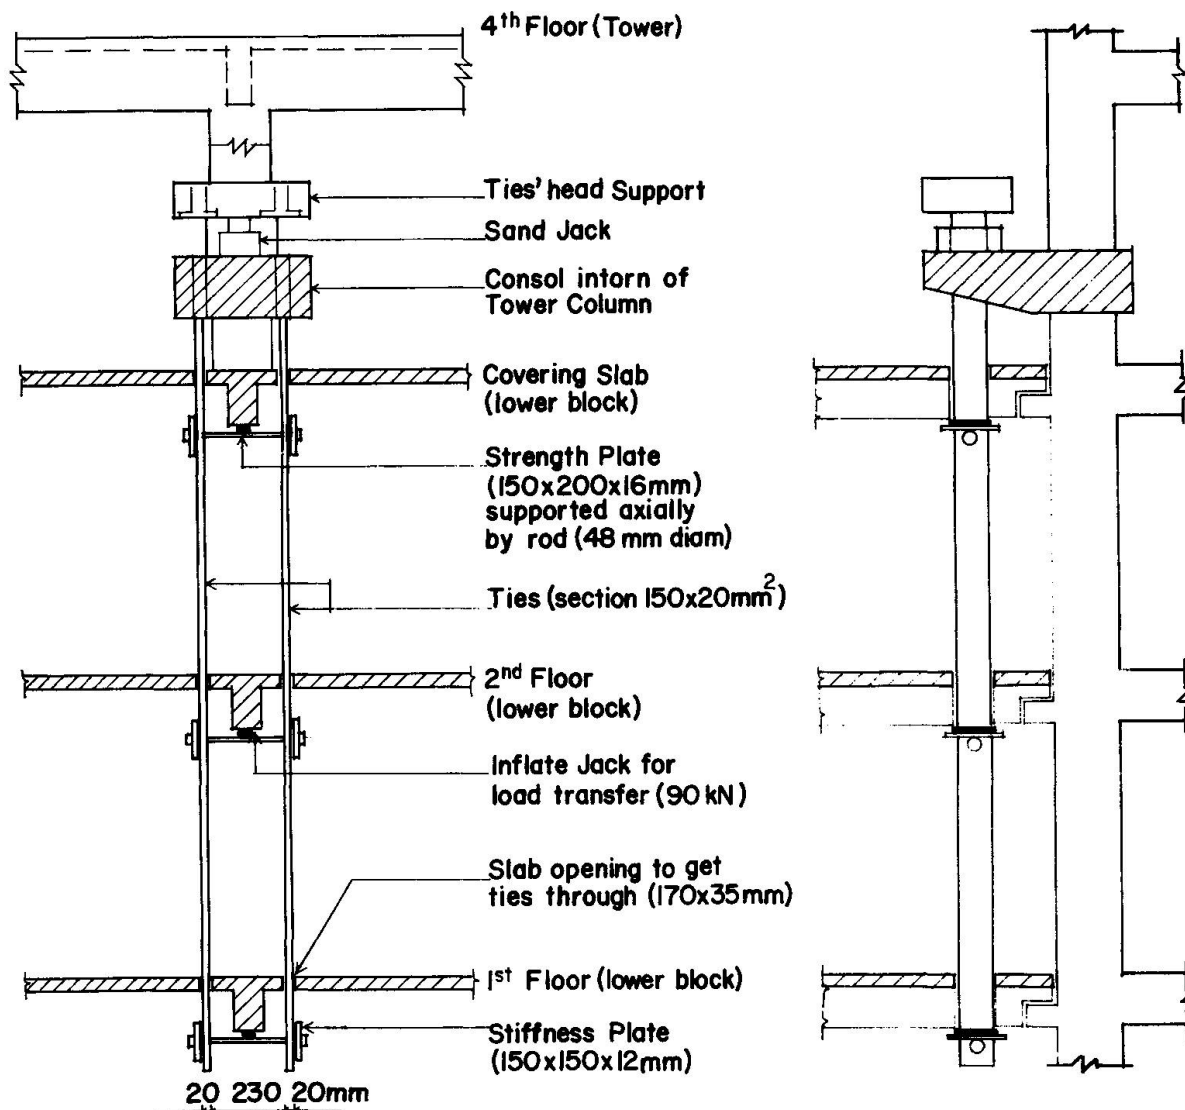
Rigid ties were used instead of cables having intermediate supports to receive the beams. The transfer of the beam's load from the fix consols to the tie should be made by parts, starting from the top beam to the one down, with the use of inflate jacks put at the contact between the beam and its support in the tie. Epoxic resin was used as fluid. In each level, the load transfer was made symmetrically in order to assure the load equilibrium at the central tower.

The system is shown in Figure 5. All parts of it as splice, hook, bolt, welding, connection, etc. were tested to failure. The system's details should facilitate the anticipated construction sequence, including provisions for its erection and descent, installation through openings made at the existing structure, change of the sand jacks, space to operate them and the placement of inflate jacks to support the beams. Finally, load test made at each installed tie system determined the load transferred by each beam using strain gages fixed on the ties.

Fig. 5 Tie device to compensate settlement

The load transfer is a delicate operation guided by instrumentation. The process starts with the toric jack applying 90 % of the dead load at the support. In the case of adhesion between beam and its fix support, the jack needs to apply an effort higher than the beam reaction. When the defletometer indicates movement, one stops to pressure the jack, the load is recorded and the register is closed. Then the fix support is broken and the beam is free to descend. Operation is repeated to the beam at the level below.
