Zeitschrift: **IABSE reports = Rapports AIPC = IVBH Berichte**

Band (Jahr): **73/1/73/2 (1995)**

Repair of a Building Damaged by Foundation Settlement

Jaime GUSMAO FILHO

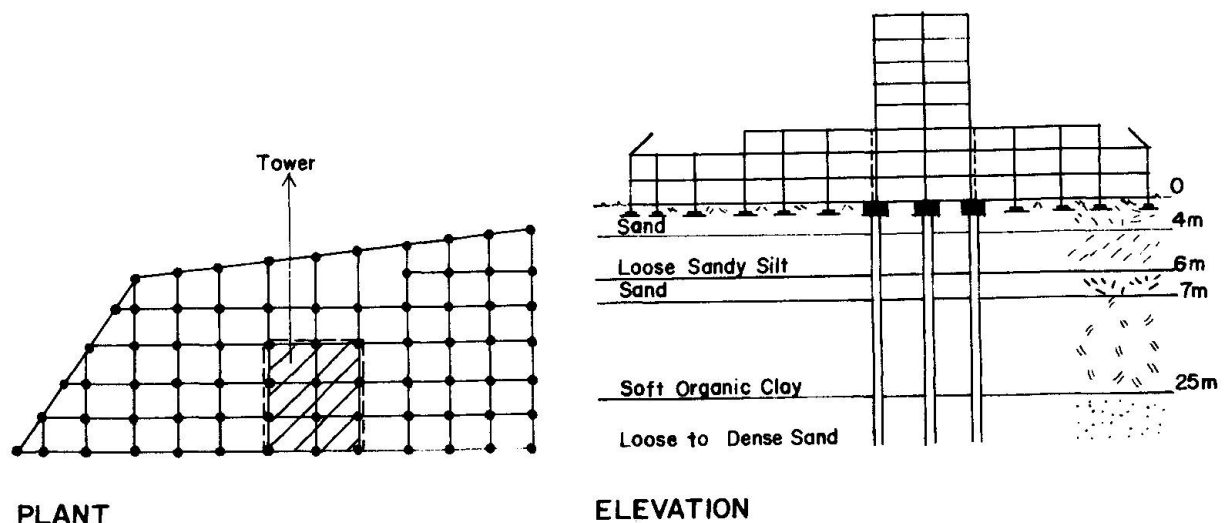
One building that is a medical center in Recife, Brazil, started having cracks due to foundation settlement soon after the end of its construction. It was a reinforced concrete structure with two types of foundation. The central block is an eight floors tower having deep foundation of steel piles near 40 m long. The outer block has three floors in spread foundation at the depth of 0.85 m with columns spaced 6m per 5m and takes 90 % of the ground area. The blocks are separated by a joint but the beams of the lower block were set on consols at the columns of the tower. Figure 1 shows the general lay-out.

Fig. 1 Lay-out of the structure and foundation conditions

The basic conception of the temporary solution is to compensate the settlement due to consolidation of the 18 m thick layer of soft organic clay. The solution implies on some procedures as to predict and measure settlement regularly, to loose the outer block from the tower where it is supported replacing the original fix supports of the beams by moveable ones and to descend the lower structure from time to time, according to the settlement occurred in the meantime. Figure 2 shows the succeeding phases of construction that was followed. Phase 1 is the initial situation. Phase 2 is the construction of consols in turn of the tower's columns at the 4th floor, above the roof level of the lower block. Phase 3 is the placement of moveable ties hung from these tower's consols, resting over sand jacks and supporting the three level's beams of the outer block. After the load transfer, the primitive consols are cut off giving way to the descent of the beams.

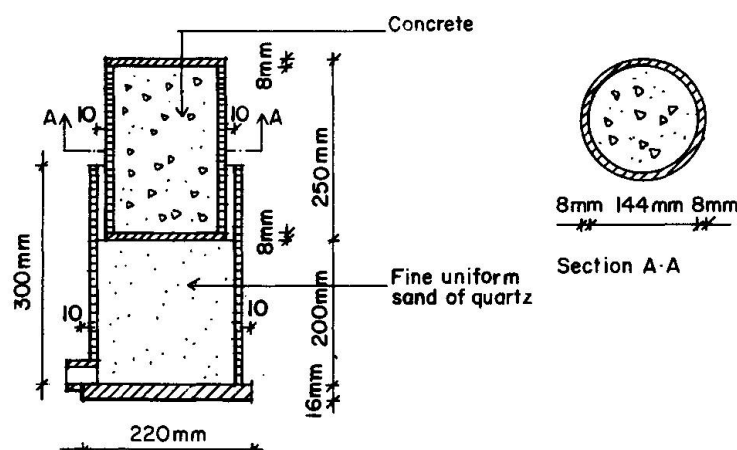
Figure 4 gives detail of the sand jack. Its 160 mm diameter piston should get out an extension of 150 mm which is the settlement predicted to be compensated along time. The cylinder below has an internal diameter of 180 mm. It is filled in by fine sand of quartz with uniform grain-size and pre-loaded to 350 kN. This load is higher than the maximum one to be transmitted by the tie system. The device has two little holes at the bottom. The sand takes out smoothly using a thin steel pointer through them. Two lateral defletometers measured the descent up to the value of the settlement to be compensated. Laboratory tests permitted to define the procedures to assure an even lowering of the piston. The field operations proved to be the sand jack a practical, simple and safe device to lower the conceived system.

Fig. 4 Detail of the sand jack

In the meantime, the sand jacks were removed once. In some jacks, their pistons had got the final course. In others, the strong confinement of the sand avoided its remotion during relaxation. The jacks were repaired and turned back to the tie system.
