**Zeitschrift:** IABSE reports = Rapports AIPC = IVBH Berichte  
**Band:** 76 (1997)

**Artikel:** Full scale laboratory fatigue tests on riveted steel bridges  
**Autor:** Helmerich, Rosemarie / Brandes, Klaus / Herter, Jürgen  
**DOI:** <https://doi.org/10.5169/seals-57473>

## Full Scale Laboratory Fatigue Tests on Riveted Steel Bridges

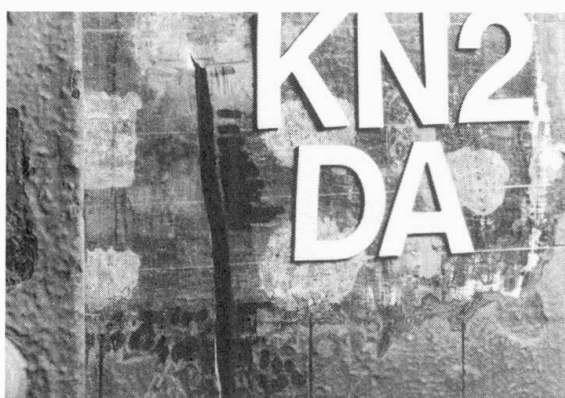
**Fig. 4** Detail of crack tip in a web plate

In the **plate girder** test series (mild steel, 1906, Kn), all cracks initiated in the cover plate, sandwiched between angles and additional cover plates. Cracks were found after deflection and strains increased or when the crack was long enough to reach the edge of the sheet plate. When cracks reached the edge, they were only visible when the girder was loaded. All tests were continued to find out if crack growth became unstable. The result was plastification at the crack tip and crack dividing into two tips, but no unstable growth. In one of these tests the crack tip in the web plate had been cooled down to  $-30^{\circ}\text{C}$  on both sides of the web plate. The crack tip detail is shown in Figure 4.

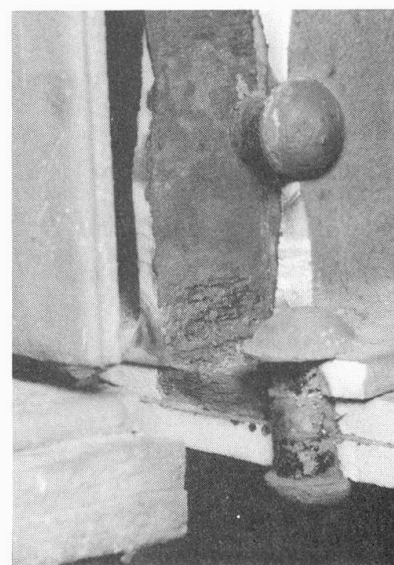
**Fig. 5** Crack in the tension flange

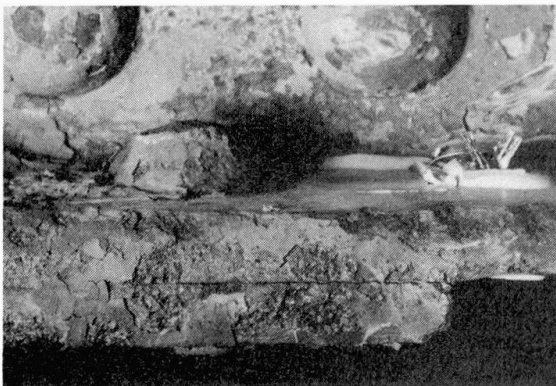
*Fig. 6 Cracked angle in tension flange*

In the last cross girder test, the last rivets of the cover plates were replaced by prestressed bolts. In this case, from the point at which strains had increased by 1%, it took 2 million high-stress-range load cycles until failure of the web-to-flange angle.
