**Artikel:** Flood incident at the National Library of Scotland  
**Autor:** Jackson, R.  
**DOI:** <https://doi.org/10.5169/seals-768675>

# Flood incident at the National Library of Scotland

R. Jackson, Preservation and Conservation Manager, National Library of Scotland

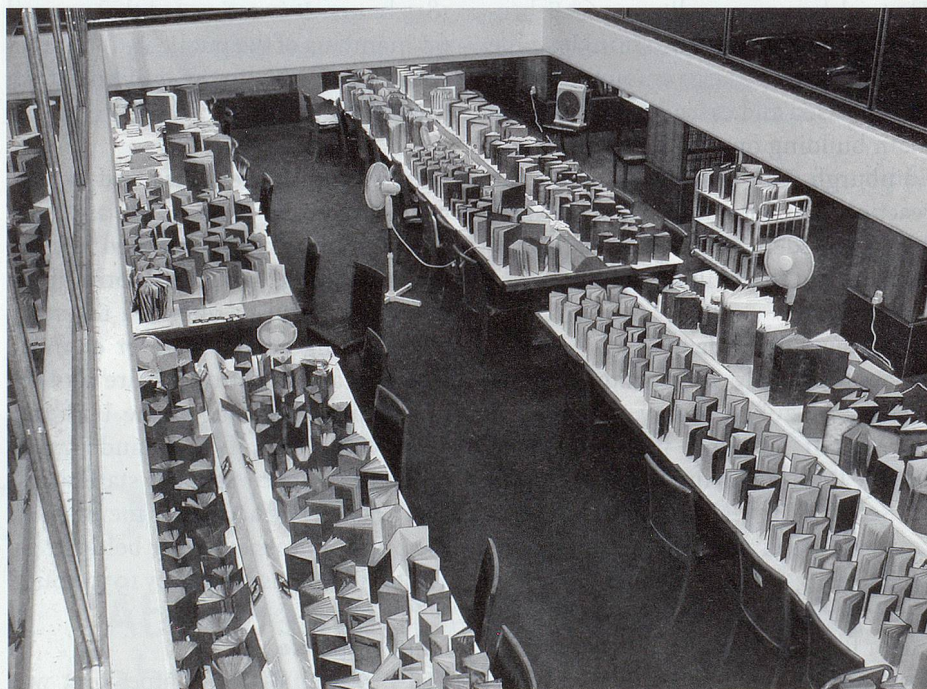
Overview of books drying

We used several different methods to dry out the unboxed books affected by the flood, mainly interleaving, air-drying and wind tunnels. Material with coated paper was frozen and bagged and dealt with at a later stage. When the incident happened, it was just after 1800 hours on a Thursday evening. Early indications showed that many thousands of items were affected by the flood and a drying space was essential. A management decision was taken to close the library on Friday and over the weekend to allow the drying process to begin. Air-drying tables were set up in the main reading room and wind tunnels set up at our Preservation Services Unit based six miles west from the main George IV Bridge building in central Edinburgh. Books were fanned out and positioned on drying tables to allow free air movement to accelerate the drying process. To assist drying we set up oscillating fans directed toward the wet material held on the drying tables in the main reading room and wind tunnels at the Preservation Services Unit.
