Artikel: Regeneration of vegetation on stabilising and eroding slopes in eastern Nepal : an evaluation 14 years after the first survey
Autor: Schaffner, Ruth
DOI: <https://doi.org/10.5169/seals-377825>

Regeneration of vegetation on stabilising and eroding slopes in eastern Nepal: an evaluation 14 years after the first survey

Bulletin of the Geobotanical Institute ETH (1999), 65, 43–58

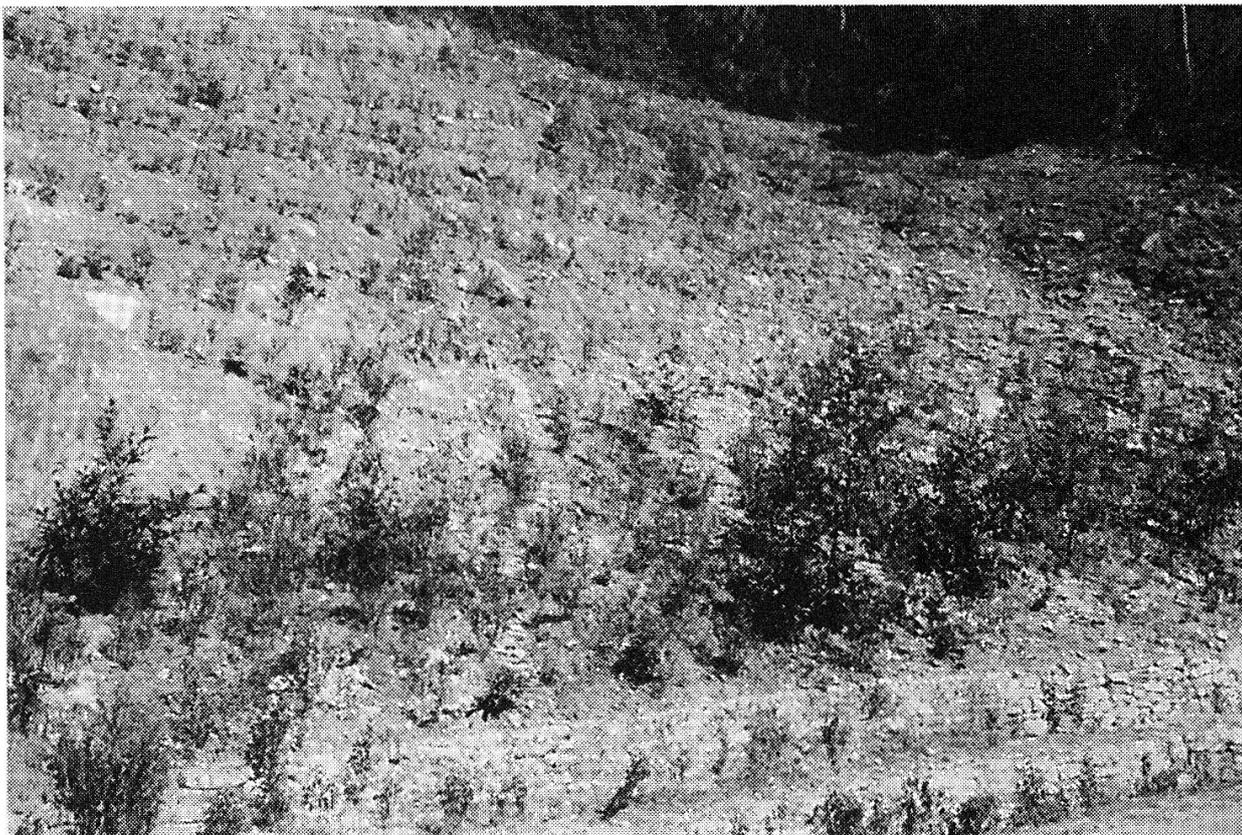
Fig. 2. Regeneration of vegetation on study plot 3, a landslide in Pinus roxburghii forest at 1450 m; (a) 2.11.1983 shortly after road construction, (b) 10.6.1997.

Figures 2a,b show the development on a south facing plot 3 (1450 m) which lies in a well preserved xerophilous *Pinus roxburghii* forest, protected from grazing. By 1997, the steep slope was densely covered with young chir pines. Amongst the young trees, *Schima wallichii* recovers well and there are even a few young *Rhododendron arboreum*, although this is rather a low altitude for this species. *Alnus nepalensis* (planted on top of the breast wall in 1982) has had some stabilising effect at the base of the slide, but it grows poorly on this dry site. *Eupatorium adenophorum*, planted in 1982 as a first cover on the bare slope (Fig. 2a), is no longer important. Beneath the chir pines a dense grass layer has developed.

On the former bare landslides and road cuts the development from the bare soil to shrubland and even to young forest is quickly going on, especially on fenced and inaccessible slopes such as plots 3, 9, 27, 28 (Figs. 2, 3). On better accessible and therefore more disturbed slopes (e.g. by grazing) a development to open shrubland is taking place, as can be observed e.g. on plots 2, 28 (partly) and 19.

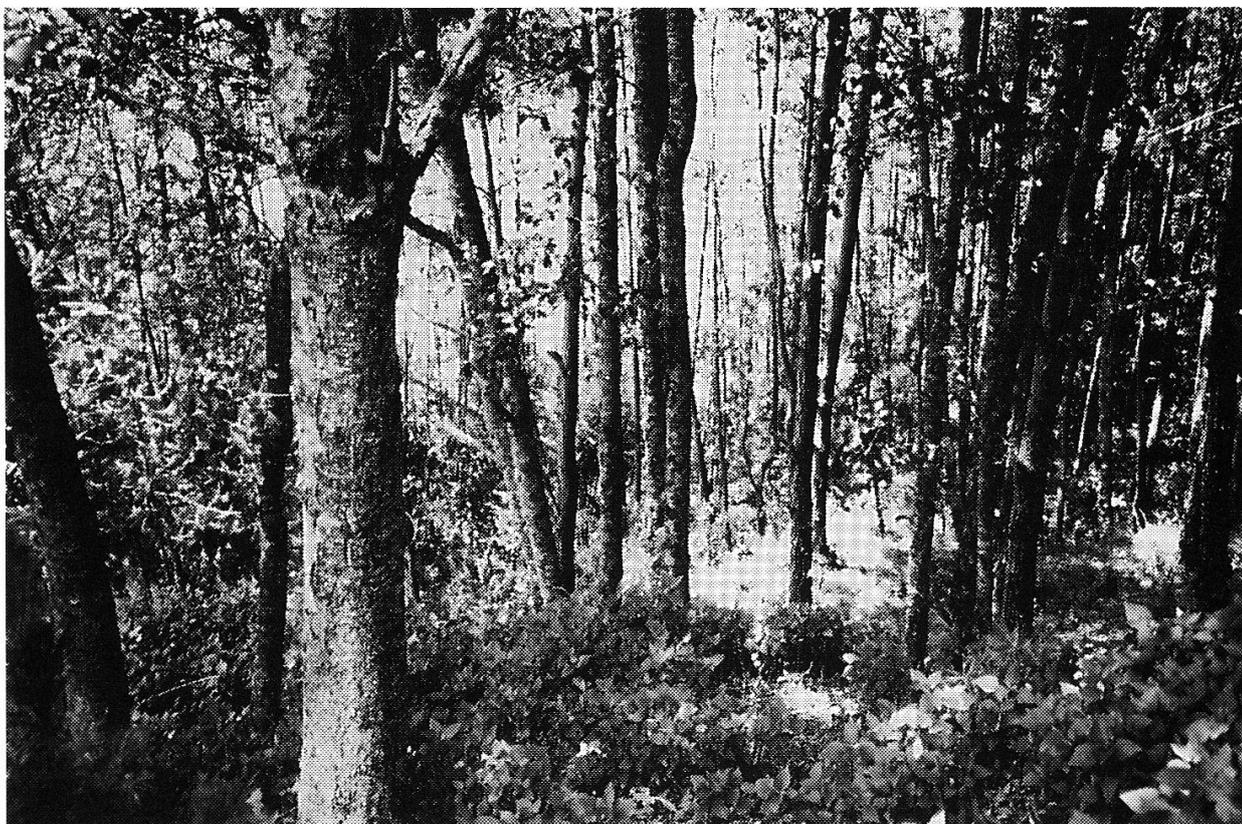
Fig. 3. *Regeneration of vegetation on study plot 27 at 1975 m, a landslide which occurred in 1970; (a) 7.10.1983, (b) 10.6.1997.*

Figures 3a,b are photographs taken from the same place to compare the plot 27 (1975

m) in the years 1983 and 1997. This plot is the site of a south-east facing landslide which occurred around 1970 and, though not very steep, was still unstable in 1982; it was therefore protected by a fence after planting *Alnus nepalensis*. In the shade of the strongly grown alder (some higher than 10 m), the herb layer which was already well developed by 1983 could persist. The densely covered site with its straight growing pole trees gives the impression of now having stabilised.

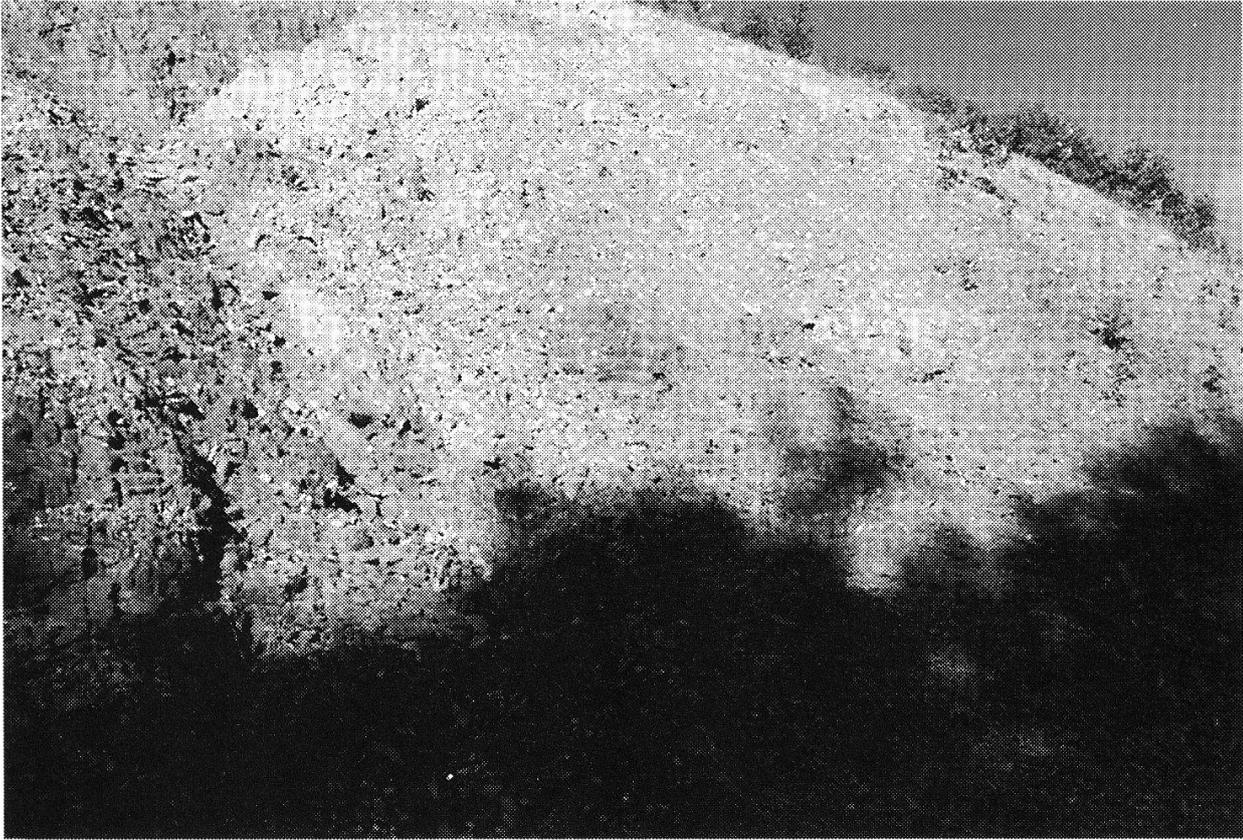
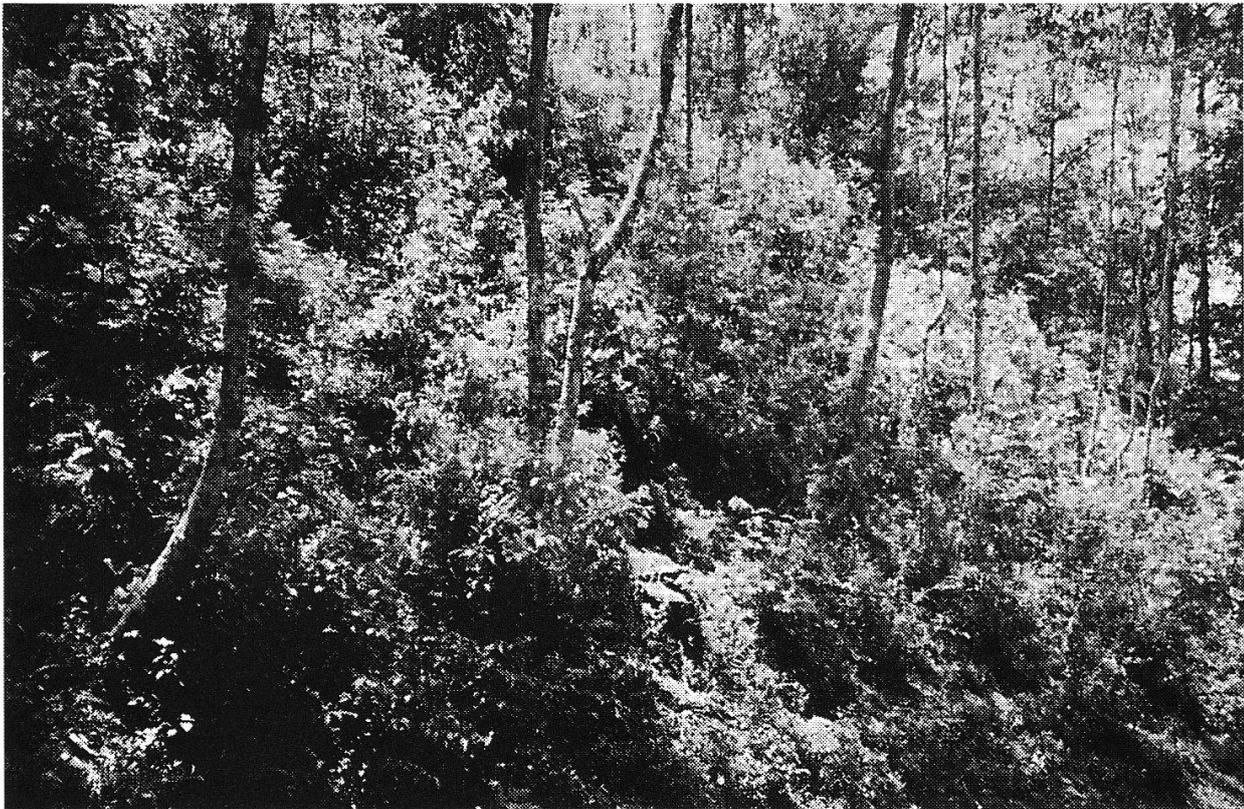
Fig. 4. Natural restoration of study plot 9, a rocky road cut at 1990 m; (a) 26.10.1983, (b) 10.6.1997.

The development of plant cover on plot 9 (north-east facing, 1990 m), a former steep and coarse rocky road cut, is striking (Figs. 4a,b). In 1982, when the road was built, some *Alnus* seedlings were established with difficulty on the plain lithosol. These plants have grown well, and some are higher than 10 m. The dense cover evident in 1997 is formed by a great diversity of young (climax) trees and shrubs, mainly *Rhododendron arboreum*, *Lyonia ovalifolia*, *Gleichenia gigantea* and many more. *Eupatorium adenophorum* could only establish at the foot of the steep slope which is disturbed by passers-by.

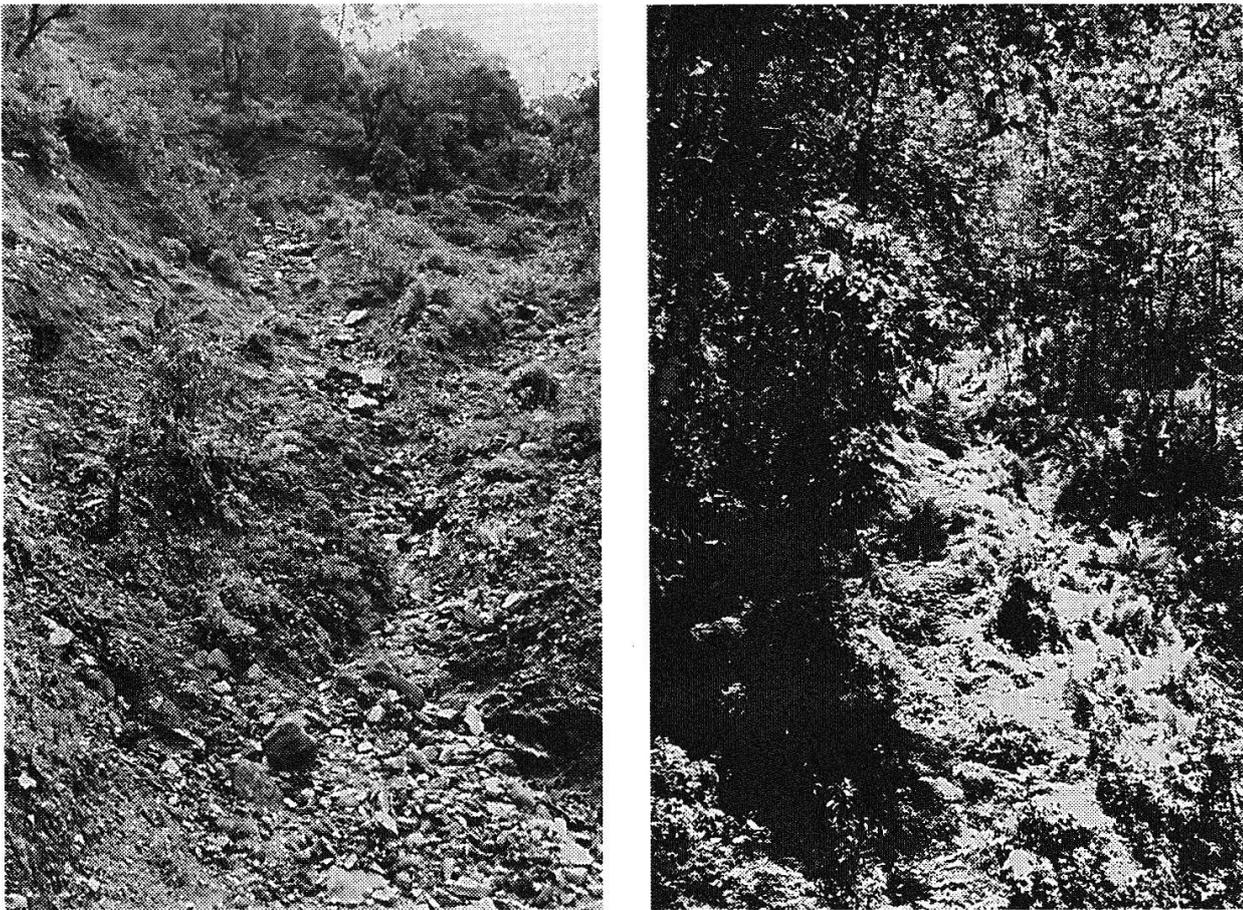
Fig. 5. Regeneration of vegetation on study plot 14 at 2120 m, a landslide in *Daphniphyllum himalayense* forest dating from monsoon 1978; (a) 2.10.1984, (b) 10.6.1997.

Plot 14 (north facing, 2120 m) lies in a hygrophilous *Daphniphyllum* forest which was recorded in 1983 as rich in species; the regeneration potential here again proved to be very high, as can be seen in Figs. 5a,b taken from the same spot 13 years apart. The slide below the road, triggered by road construction during monsoon rainfall in 1978, is now lushly vegetated by a variety of shrubs and ferns, and from both sides climax forest trees and shrubs are pushing in.
