**Artikel:** Regeneration of vegetation on stabilising and eroding slopes in eastern

Nepal: an evaluation 14 years after the first survey

# Regeneration of vegetation on stabilising and eroding slopes in eastern Nepal: an evaluation 14 years after the first survey

Bulletin of the Geobotanical Institute ETH (1999), 65, 43–58

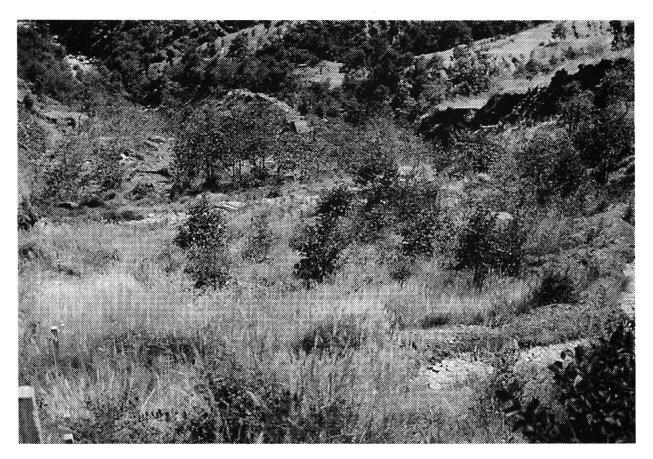
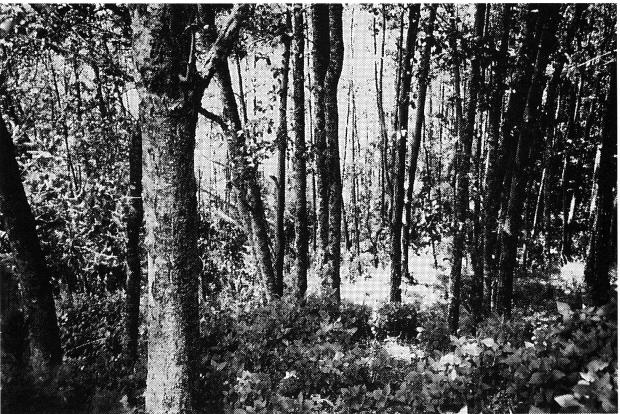
Fig. 3. Regeneration of vegetation on study plot 27 at 1975 m, a landslide which occurred in 1970; (a) 7.10.1983, (b) 10.6.1997.

Figures 3a,b are photographs taken from the same place to compare the plot 27 (1975

m) in the years 1983 and 1997. This plot is the site of a south-east facing landslide which occurred around 1970 and, though not very steep, was still unstable in 1982; it was therefore protected by a fence after planting *Alnus nepalensis*. In the shade of the strongly grown alder (some higher than 10 m), the herb layer which was already well developed by 1983 could persist. The densely covered site with its straight growing pole trees gives the impression of now having stabilised.

On the former bare landslides and road cuts the development from the bare soil to shrubland and even to young forest is quickly going on, especially on fenced and inaccessible slopes such as plots 3, 9, 27, 28 (Figs. 2, 3). On better accessible and therefore more disturbed slopes (e.g. by grazing) a development to open shrubland is taking place, as can be observed e.g. on plots 2, 28 (partly) and 19.

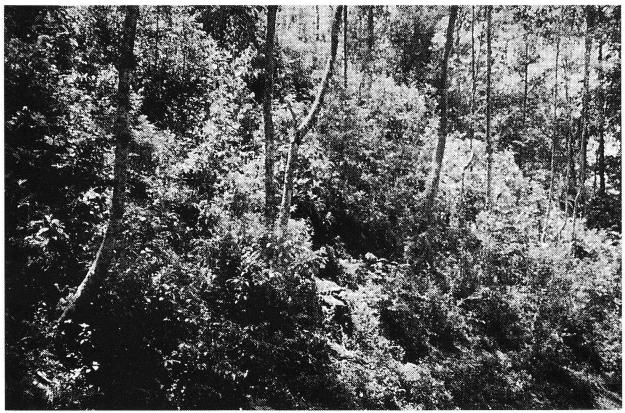
Fig. 4. Natural restoration of study plot 9, a rocky road cut at 1990 m; (a) 26.10.1983, (b) 10.6.1997.

The development of plant cover on plot 9 (north-east facing, 1990 m), a former steep and coarse rocky road cut, is striking (Figs. 4a,b). In 1982, when the road was built, some *Alnus* seedlings were established with difficulty on the plain lithosol. These plants have grown well, and some are higher than 10 m. The dense cover evident in 1997 is formed by a great diversity of young (climax) trees and shrubs, mainly *Rhododendron arboreum*, *Lyonia ovalifolia*, *Gleichenia gigantea* and many more. *Eupatorium adenophorum* could only establish at the foot of the steep slope which is disturbed by passers-by.

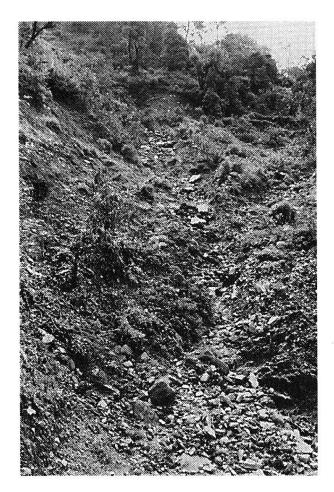
Fig. 5. Regeneration of vegetation on study plot 14 at 2120 m, a landslide in Daphnipyllum himalayense forest dating from monsoon 1978; (a) 2.10.1984, (b) 10.6.1997.

Plot 14 (north facing, 2120 m) lies in a hygrophilous *Daphniphyllum* forest which was recorded in 1983 as rich in species; the regeneration potential here again proved to be very high, as can be seen in Figs. 5a,b taken from the same spot 13 years apart. The slide below the road, triggered by road construction during monsoon rainfall in 1978, is now lushly vegetated by a variety of shrubs and ferns, and from both sides climax forest trees and shrubs are pushing in.
