Regeneration of vegetation on stabilising and eroding slopes in eastern Nepal: an evaluation 14 years after the first survey

RUTH SCHAFFNER

Bulletin of the Geobotanical Institute ETH (1999), 65, 43–58

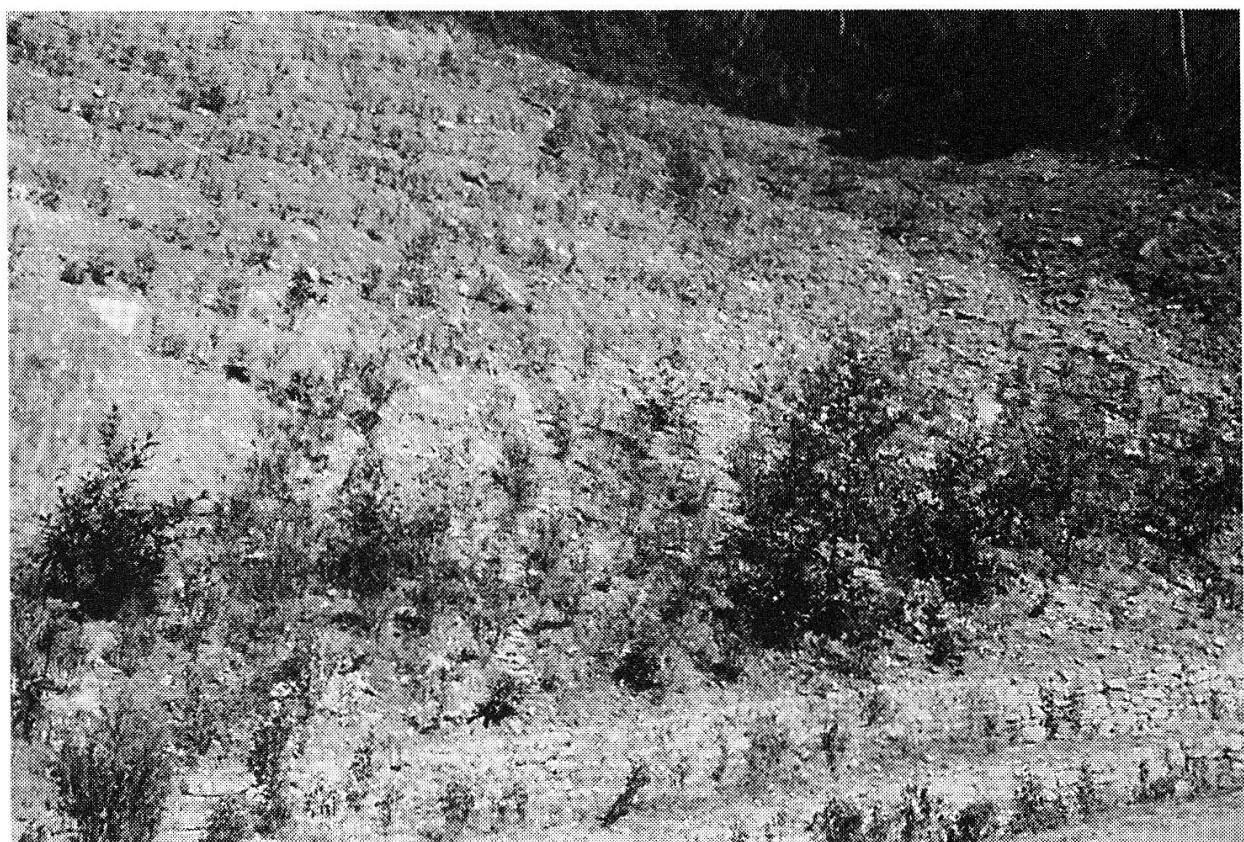
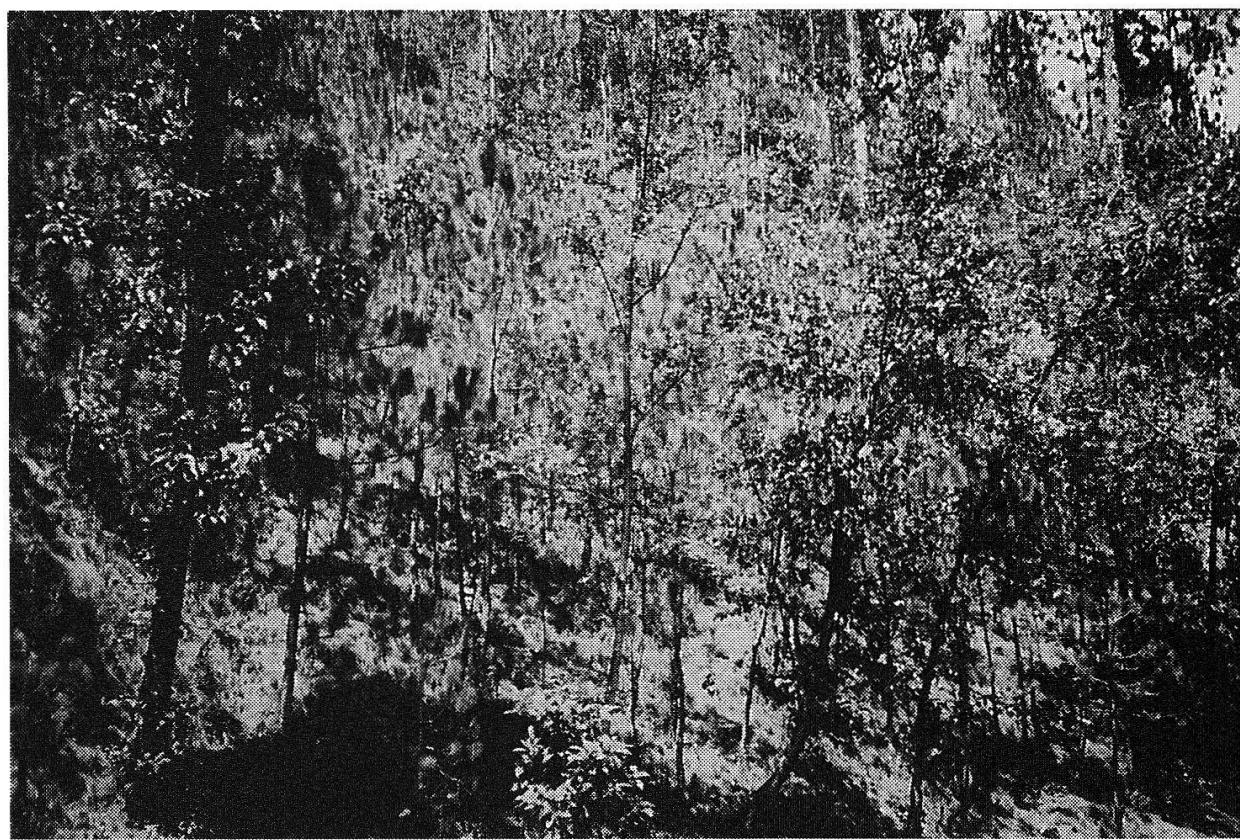
*Fig. 2. Regeneration of vegetation on study plot 3, a landslide in *Pinus roxburghii* forest at 1450 m; (a) 2.11.1983 shortly after road construction, (b) 10.6.1997.*

Figures 2a,b show the development on a south facing plot 3 (1450 m) which lies in a well preserved xerophilous *Pinus roxburghii* forest, protected from grazing. By 1997, the steep slope was densely covered with young chir pines. Amongst the young trees, *Schima wallichii* recovers well and there are even a few young *Rhododendron arboreum*, although this is rather a low altitude for this species. *Alnus nepalensis* (planted on top of the breast wall in 1982) has had some stabilising effect at the base of the slide, but it grows poorly on this dry site. *Eupatorium adenophorum*, planted in 1982 as a first cover on the bare slope (Fig. 2a), is no longer important. Beneath the chir pines a dense grass layer has developed.

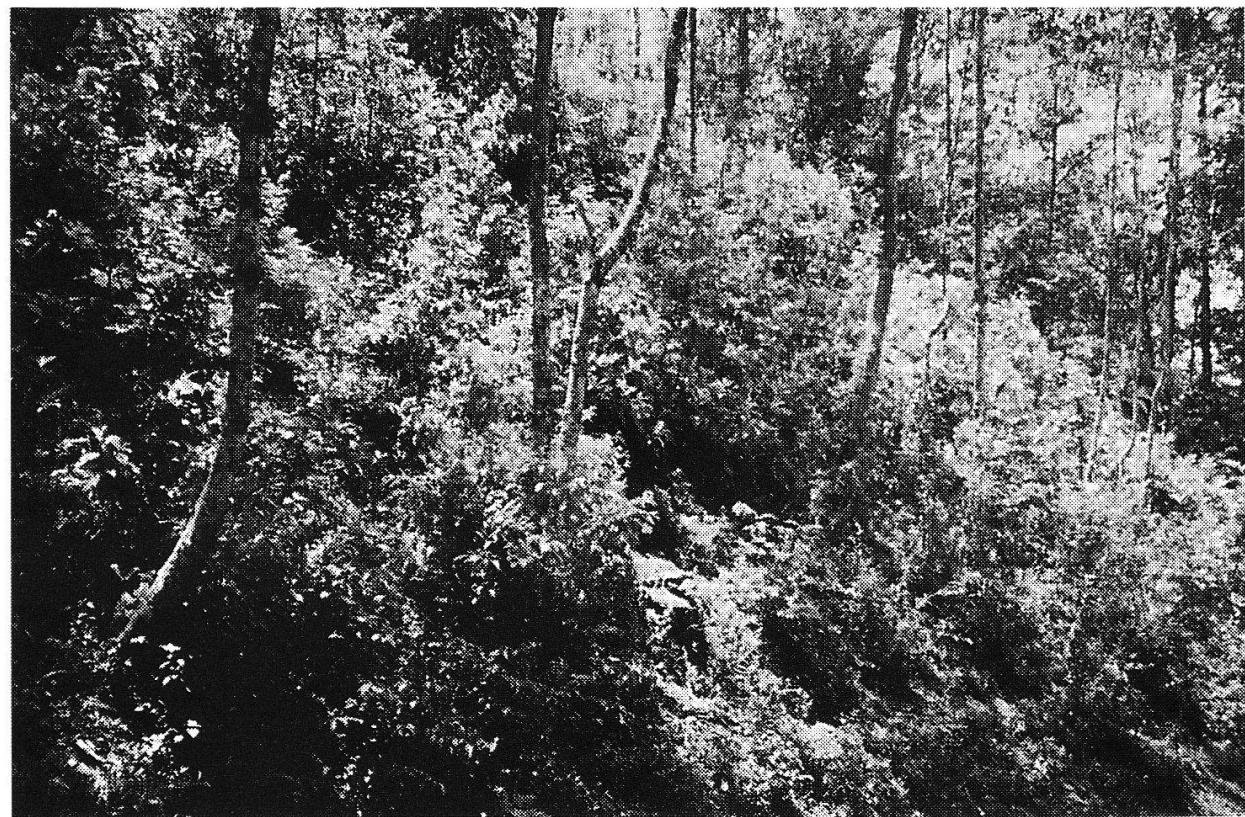
Fig. 4. Natural restoration of study plot 9, a rocky road cut at 1990 m; (a) 26.10.1983, (b) 10.6.1997.

The development of plant cover on plot 9 (north-east facing, 1990 m), a former steep and coarse rocky road cut, is striking (Figs. 4a,b). In 1982, when the road was built, some *Alnus* seedlings were established with difficulty on the plain lithosol. These plants have grown well, and some are higher than 10 m. The dense cover evident in 1997 is formed by a great diversity of young (climax) trees and shrubs, mainly *Rhododendron arboreum*, *Lyonia ovalifolia*, *Gleichenia gigantea* and many more. *Eupatorium adenophorum* could only establish at the foot of the steep slope which is disturbed by passers-by.

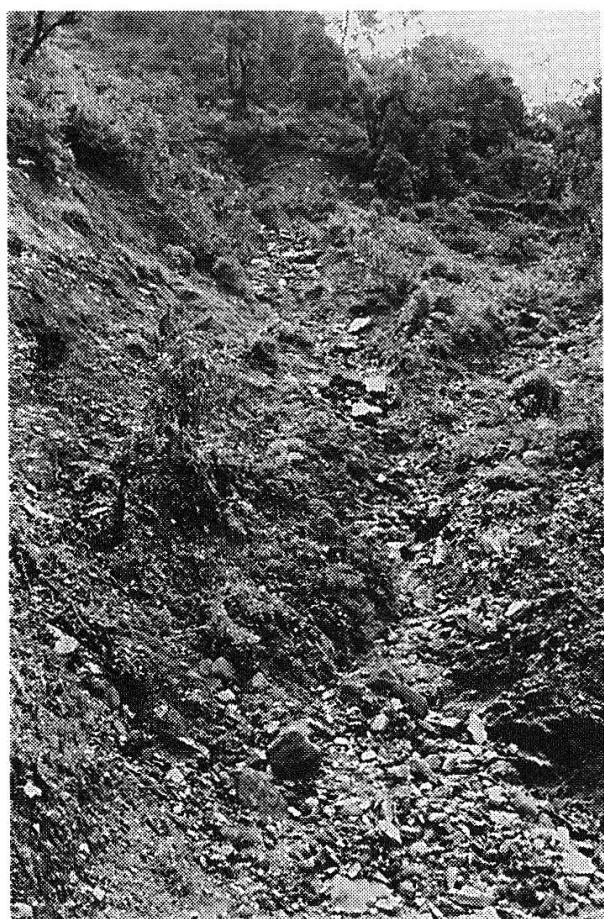
Fig. 5. Regeneration of vegetation on study plot 14 at 2120 m, a landslide in *Daphniphyllum himalayense* forest dating from monsoon 1978; (a) 2.10.1984, (b) 10.6.1997.

Plot 14 (north facing, 2120 m) lies in a hygrophilous *Daphniphyllum* forest which was recorded in 1983 as rich in species; the regeneration potential here again proved to be very high, as can be seen in Figs. 5a,b taken from the same spot 13 years apart. The slide below the road, triggered by road construction during monsoon rainfall in 1978, is now lushly vegetated by a variety of shrubs and ferns, and from both sides climax forest trees and shrubs are pushing in.

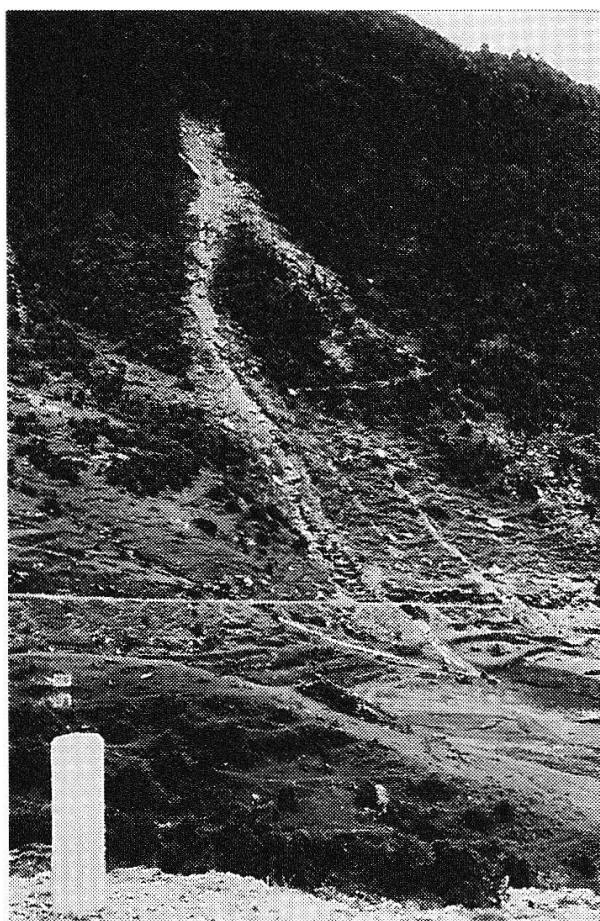
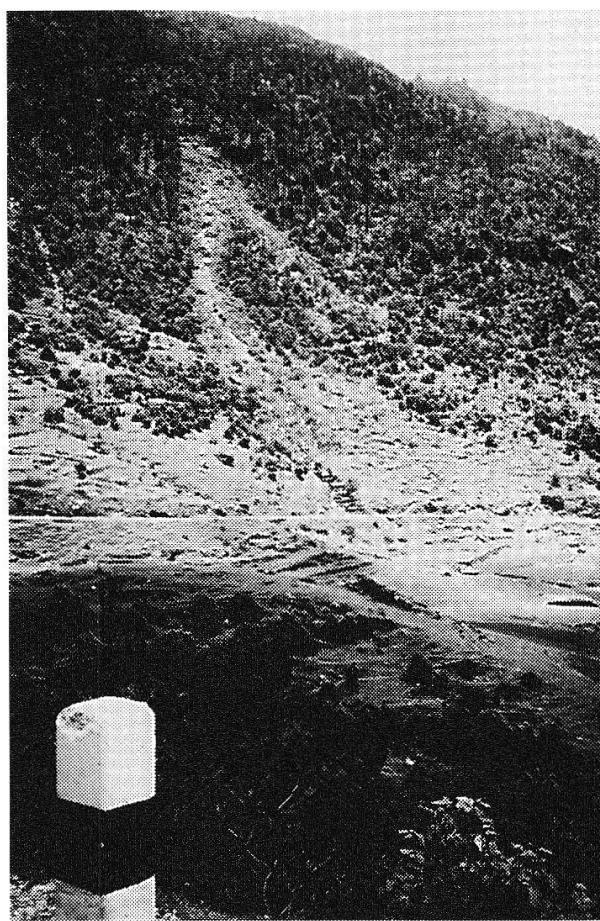
Fig. 6. Overview of study plot 22 at 2550 m, a landslide in *Quercus semecarpifolius* forest dating from monsoon 1982; (a) 12.10.1984, (b) 10.6.1997.

The long landslide in the mesohygrophilous *Quercus semecarpifolia* forest, study plot 22 (south-west facing, 2550 m, Figs. 6 a,b) seems to be stable now. However, it is grazed and the oak trees are still heavily lopped, and there is no sign of forest vegetation extending into the slide area.
