**Artikel:** Regeneration of vegetation on stabilising and eroding slopes in eastern Nepal : an evaluation 14 years after the first survey  
**Autor:** Schaffner, Ruth  
**DOI:** <https://doi.org/10.5169/seals-377825>

## Regeneration of vegetation on stabilising and eroding slopes in eastern Nepal: an evaluation 14 years after the first survey

*Bulletin of the Geobotanical Institute ETH (1999), 65, 43–58*

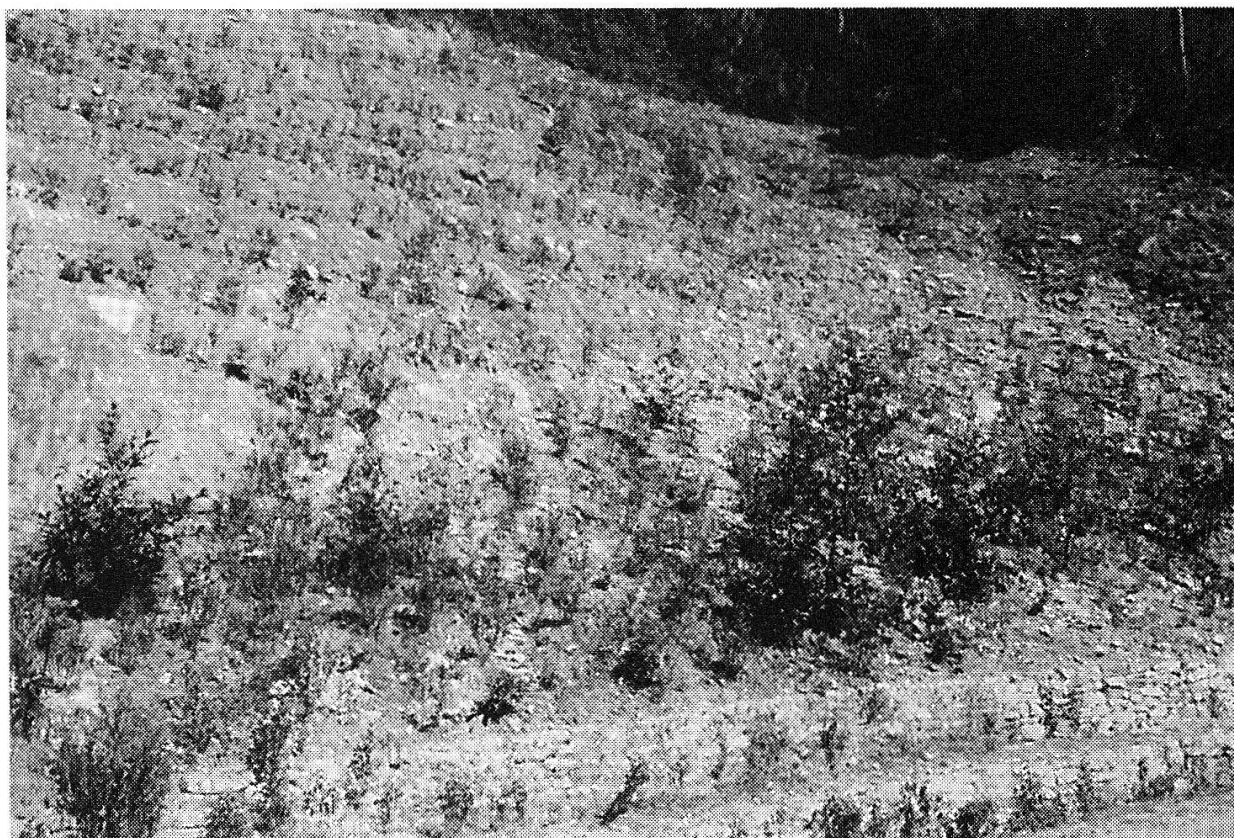
*Fig. 2. Regeneration of vegetation on study plot 3, a landslide in Pinus roxburghii forest at 1450 m; (a) 2.11.1983 shortly after road construction, (b) 10.6.1997.*

Figures 2a,b show the development on a south facing plot 3 (1450 m) which lies in a well preserved xerophilous *Pinus roxburghii* forest, protected from grazing. By 1997, the steep slope was densely covered with young chir pines. Amongst the young trees, *Schima wallichii* recovers well and there are even a few young *Rhododendron arboreum*, although this is rather a low altitude for this species. *Alnus nepalensis* (planted on top of the breast wall in 1982) has had some stabilising effect at the base of the slide, but it grows poorly on this dry site. *Eupatorium adenophorum*, planted in 1982 as a first cover on the bare slope (Fig. 2a), is no longer important. Beneath the chir pines a dense grass layer has developed.

On the former bare landslides and road cuts the development from the bare soil to shrubland and even to young forest is quickly going on, especially on fenced and inaccessible slopes such as plots 3, 9, 27, 28 (Figs. 2, 3). On better accessible and therefore more disturbed slopes (e.g. by grazing) a development to open shrubland is taking place, as can be observed e.g. on plots 2, 28 (partly) and 19.

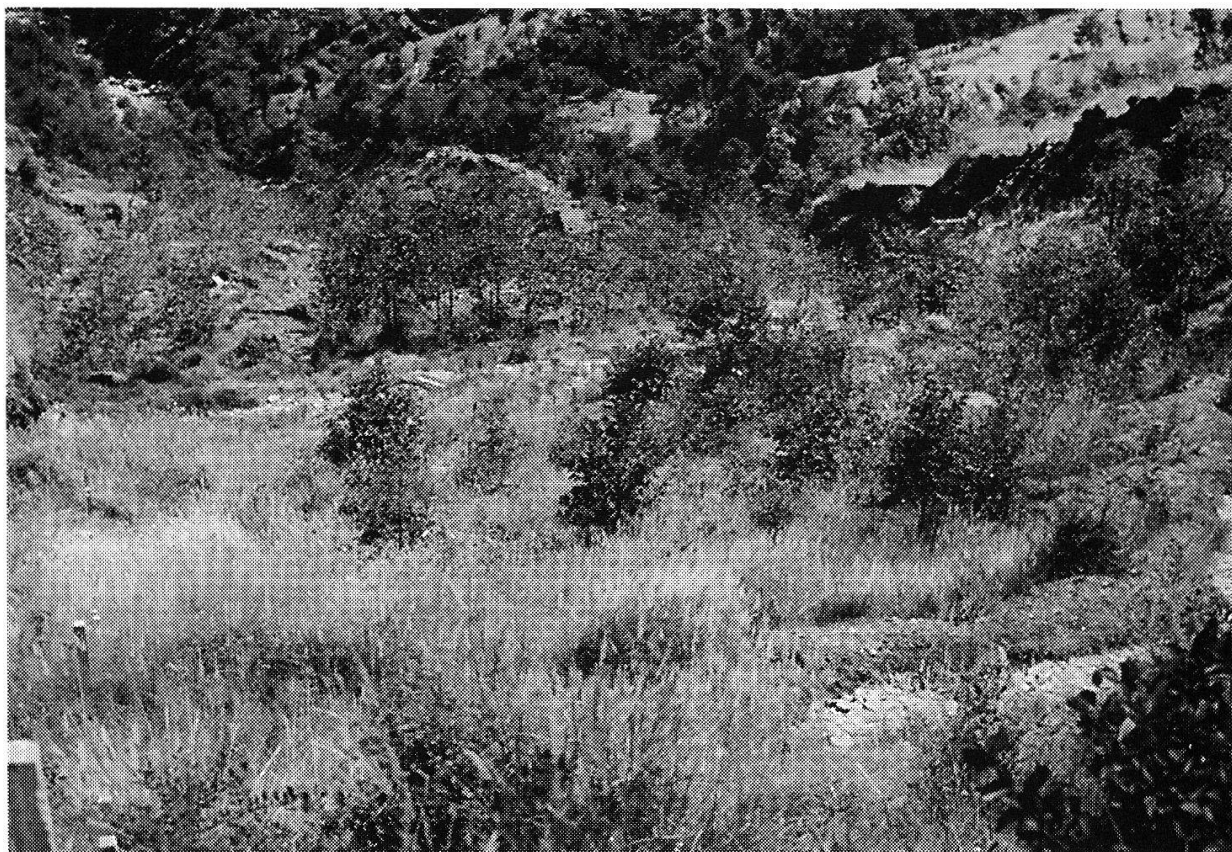
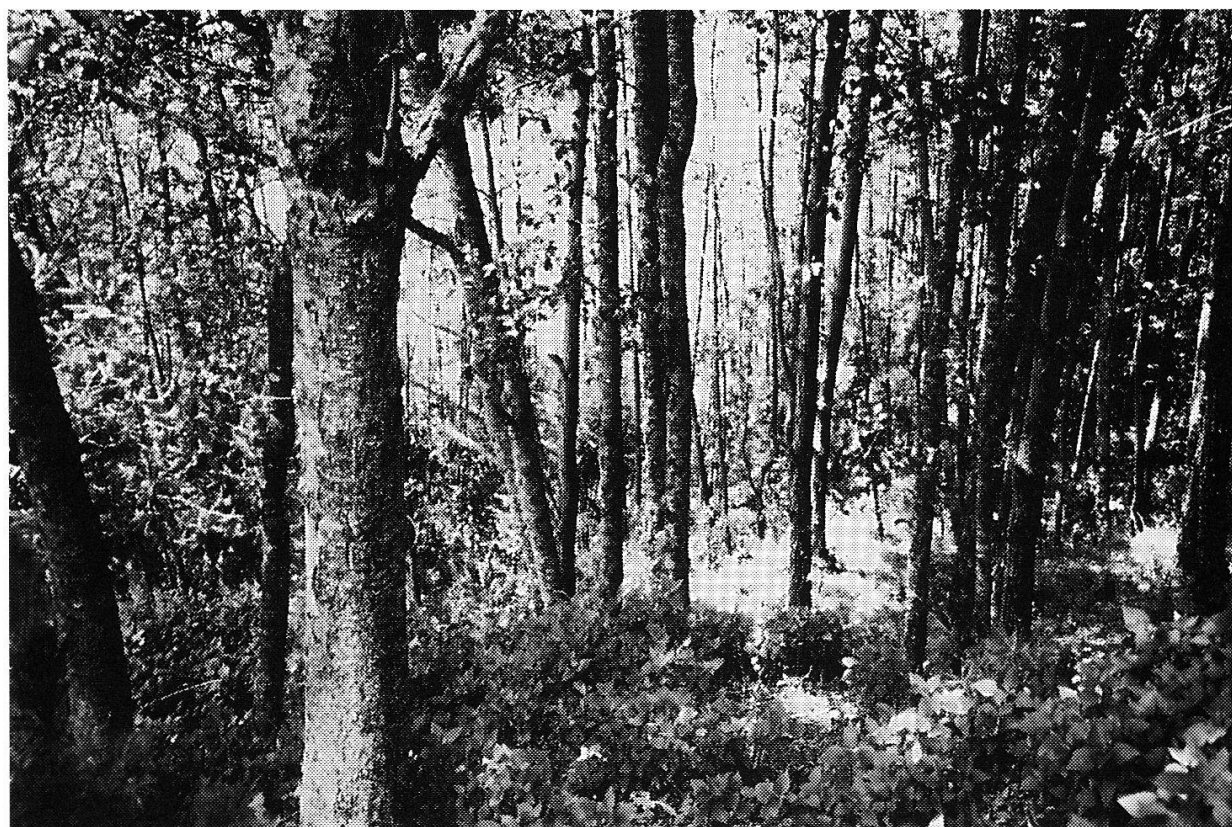
**Fig. 3.** *Regeneration of vegetation on study plot 27 at 1975 m, a landslide which occurred in 1970; (a) 7.10.1983, (b) 10.6.1997.*

Figures 3a,b are photographs taken from the same place to compare the plot 27 (1975

m) in the years 1983 and 1997. This plot is the site of a south-east facing landslide which occurred around 1970 and, though not very steep, was still unstable in 1982; it was therefore protected by a fence after planting *Alnus nepalensis*. In the shade of the strongly grown alder (some higher than 10 m), the herb layer which was already well developed by 1983 could persist. The densely covered site with its straight growing pole trees gives the impression of now having stabilised.

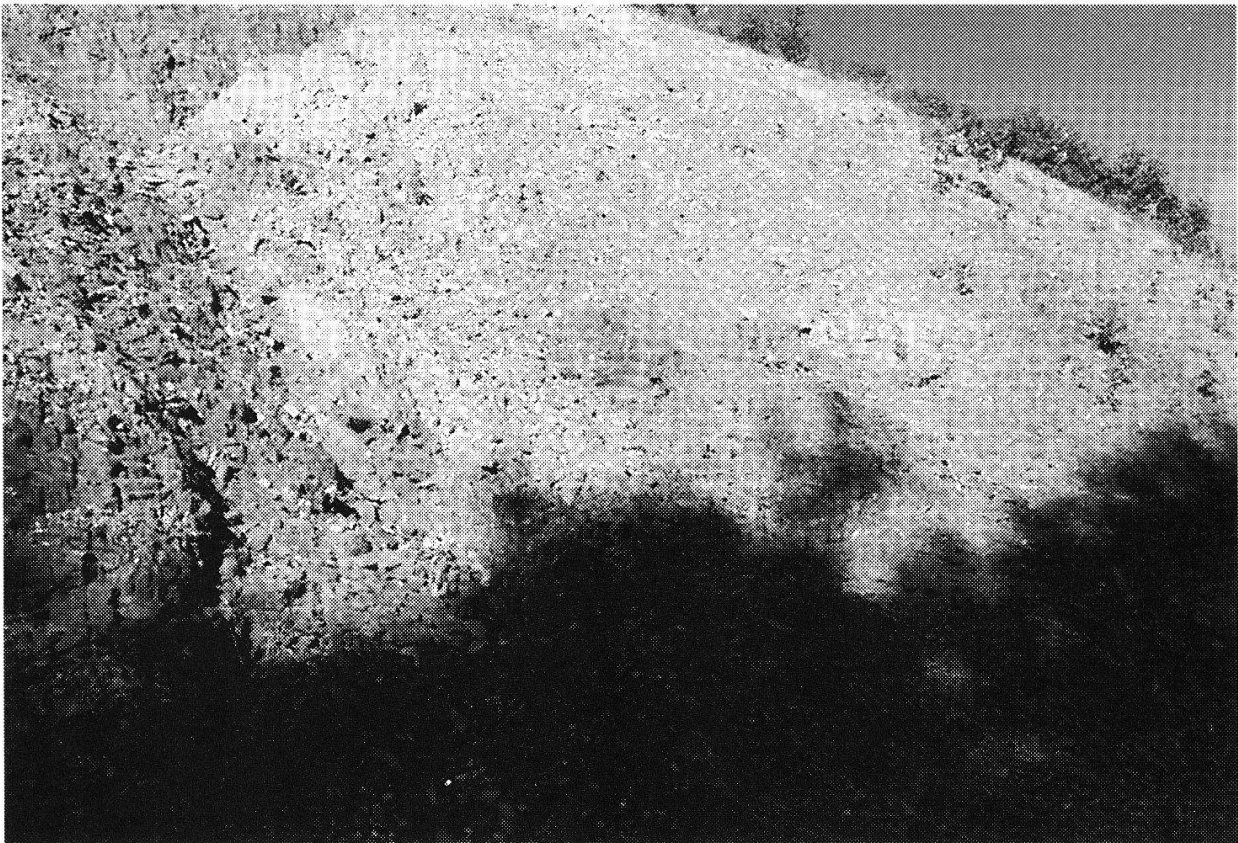
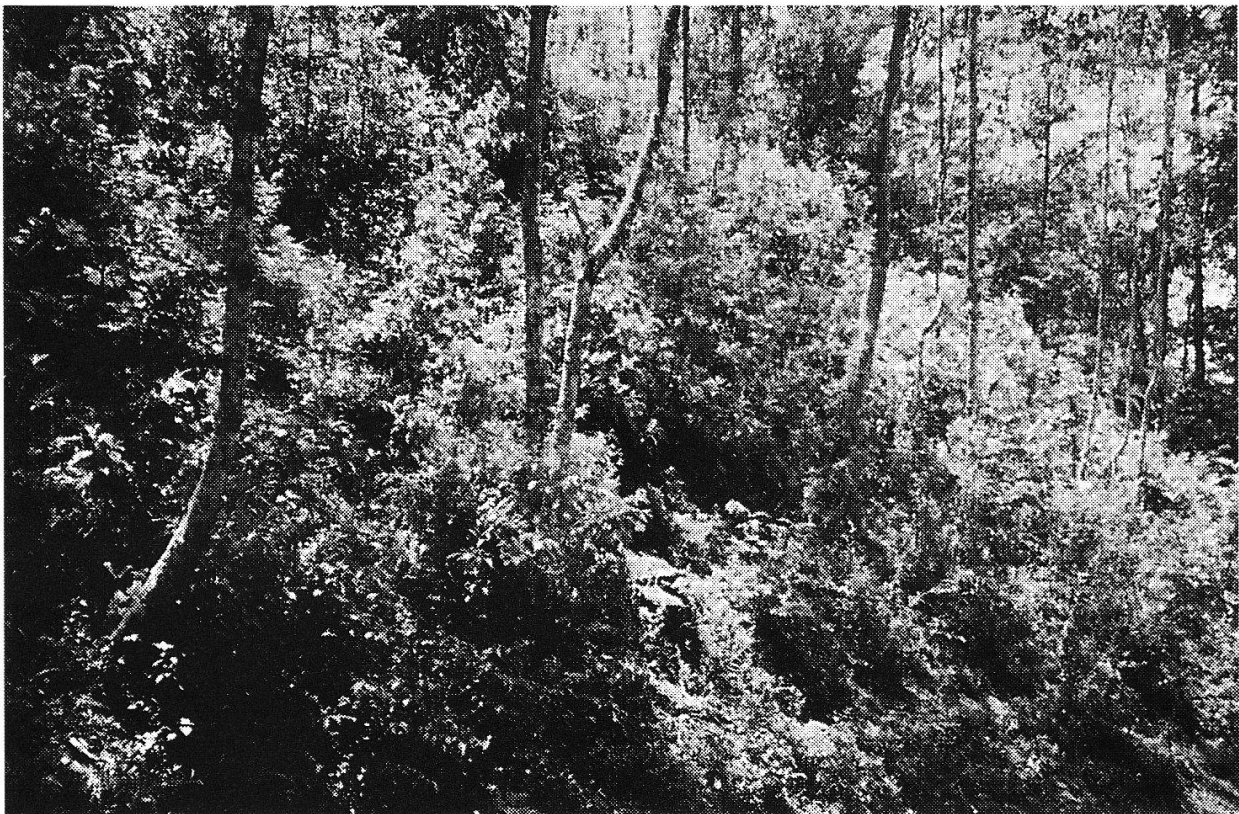
The development of plant cover on plot 9 (north-east facing, 1990 m), a former steep and coarse rocky road cut, is striking (Figs. 4a,b). In 1982, when the road was built, some *Alnus* seedlings were established with difficulty on the plain lithosol. These plants have grown well, and some are higher than 10 m. The dense cover evident in 1997 is formed by a great diversity of young (climax) trees and shrubs, mainly *Rhododendron arboreum*, *Lyonia ovalifolia*, *Gleichenia gigantea* and many more. *Eupatorium adenophorum* could only establish at the foot of the steep slope which is disturbed by passers-by.

*Fig. 4. Natural restoration of study plot 9, a rocky road cut at 1990 m; (a) 26.10.1983, (b) 10.6.1997.*
