Zeitschrift: IABSE congress report = Rapport du congrès AIPC = IVBH
Kongressbericht

Artikel: Anchors: an efficient means for disaster resisting structures

Anchors — an Efficient Means for Disaster Resisting Structures

Franz FISCHLI
Civil Engineer
VSL International Ltd.
Berne, Switzerland

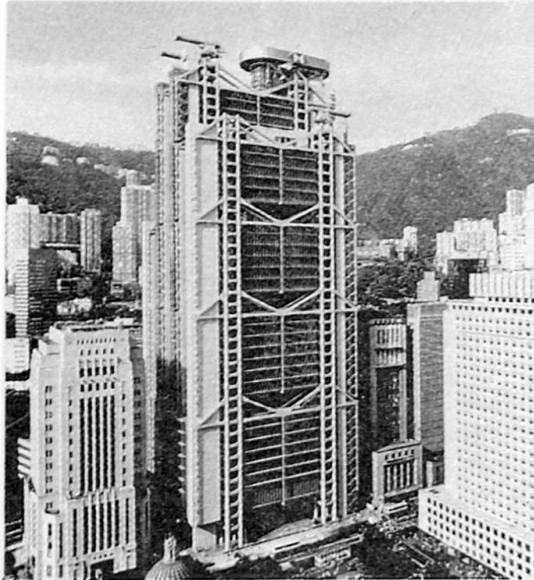
Figure 1: Hong Kong and Shanghai Bank

The spectacular appearance of the Hong Kong and Shanghai Bank (Fig.1) was achieved by hanging the structure from 8 towers. Each tower comprises 4 braced steel tubular masts. In addition to the primary caissons forming the immediate foundation for these towers, the structure loads are also distributed to a series of secondary caissons to complete the substructure of the building. To provide stability against wind and ground buoyancy effects from the high water table a total of 314 permanent, restressable and monitorable anchors, ranging in working load from 650 to 2100 kN had to be installed. The maximum anchor length is 32 m. The design life of the anchors is 100 years.

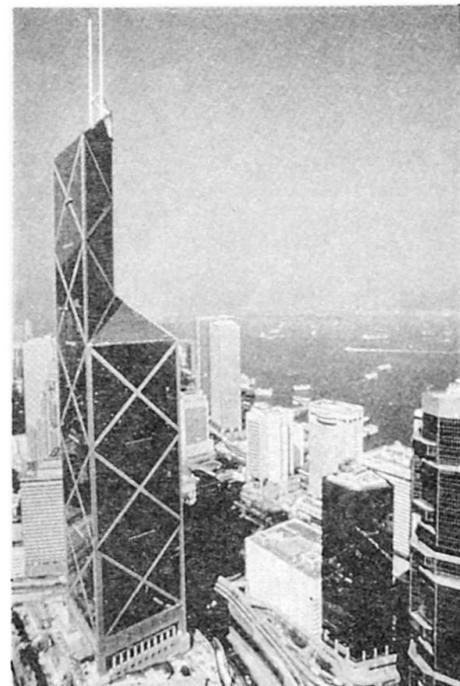
Figure 2: The Bank of China

The Bank of China which rises to a height of 315 m with 70 floors is presently the tallest building in Hong Kong (Fig. 2). The structure is reinforced concrete and steel framed with a composite metal tray and reinforced concrete floor system. The structural concept consists of a space truss which acts to carry both the vertical loads as well as the wind forces.
