Zeitschrift: IABSE congress report = Rapport du congrès AIPC = IVBH
Kongressbericht

Band: 14 (1992)

Autor: Croci, Giorgio

Preservation of Newly Built and Historical Buildings

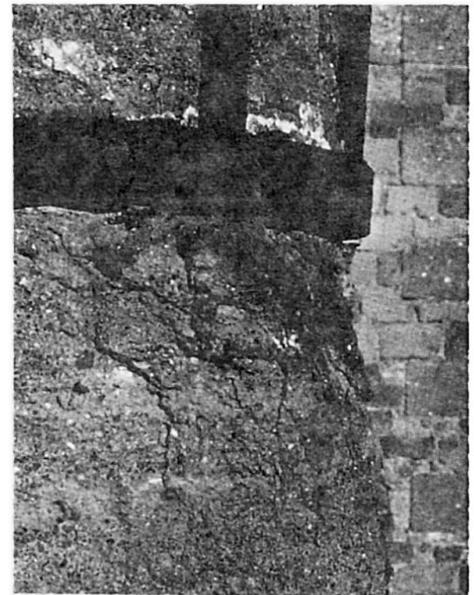
Pic.3: Effect on the columns of Tabularium

The first point to examine in the preservation of a structure is the analysis of the deterioration of the materials. This deterioration in the oldest buildings is linked not only to the chemical and physical phenomena, but also to the countless alterations, that, as in the case of Palazzo Senatorio in Campidoglio, Rome, (fig. 1) have occurred during the centuries (fig. 2), sometime stressed by incorret reinforcements (fig. 3).

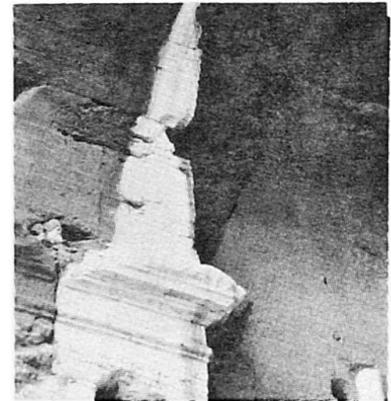
Pic.10,11: Displacements and discontinuities in the structure of Colosseum

Consequences of this outward movement are relative displacement of the blocks (fig. 10) and discontinuity between the outer elliptical structure and the radial masonry (fig. 11).

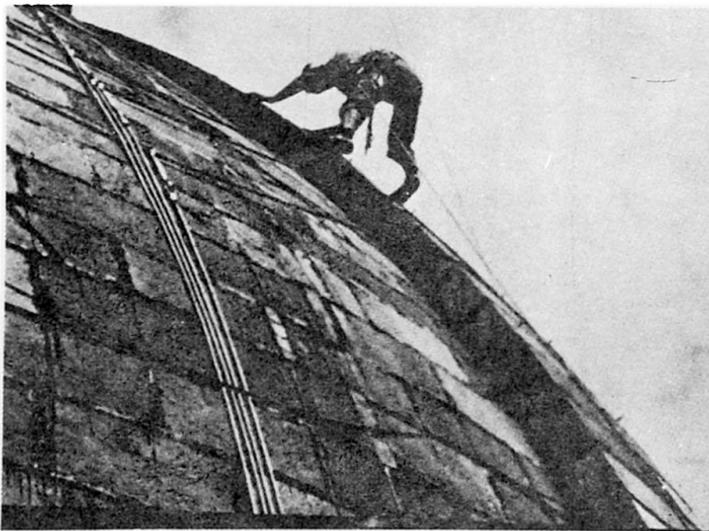
Pic.33: The operations to place the cables

The stainless steel cables have been put in place by "escaladores" (fig. 33) and the phase of pretensioning has been monitored (fig. 34).
