Preservation of Newly Built and Historical Buildings

Giorgio CROCI
Prof. of Civil Eng.
University of Rome
Rome, Italy

This paper deals with the preservation of existing buildings. The main problem is the evaluation of the safety level, taking into account the crack patterns, the deterioration of materials, etc. As a result of this analysis, decisions can be taken about the opportunity and the criteria for intervention. The paper illustrates some cases, referring especially to historical buildings in Italy and Spain.

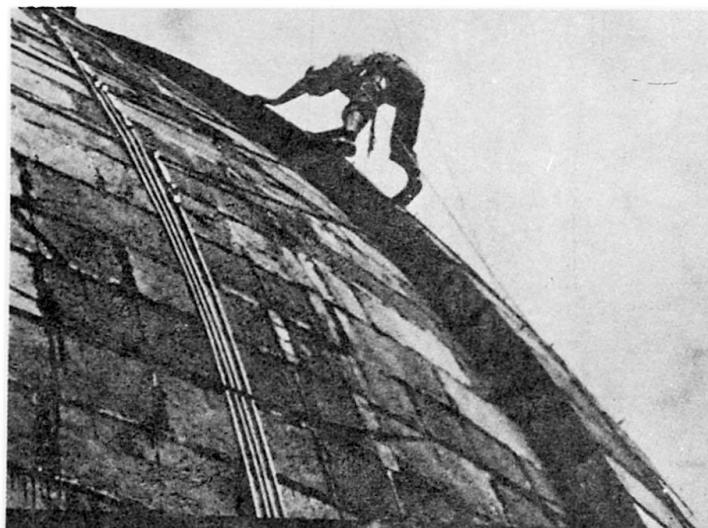
Pic.34: Monitoring of the phases of prestressing

Pic.33: The operations to place the cables

The stainless steel cables have been put in place by "escaladores" (fig. 33) and the phase of pretensioning has been monitored (fig. 34).
