Artikel: Welding experiences at the construction of the newest Danube and
Tisza bridges in Hungary

**Welding experiences
at the construction of the newest Danube and Tisza bridges
in Hungary**

D^r CH. SZÉCHY

Chief engineer, Highway-bridge Department in Hungary

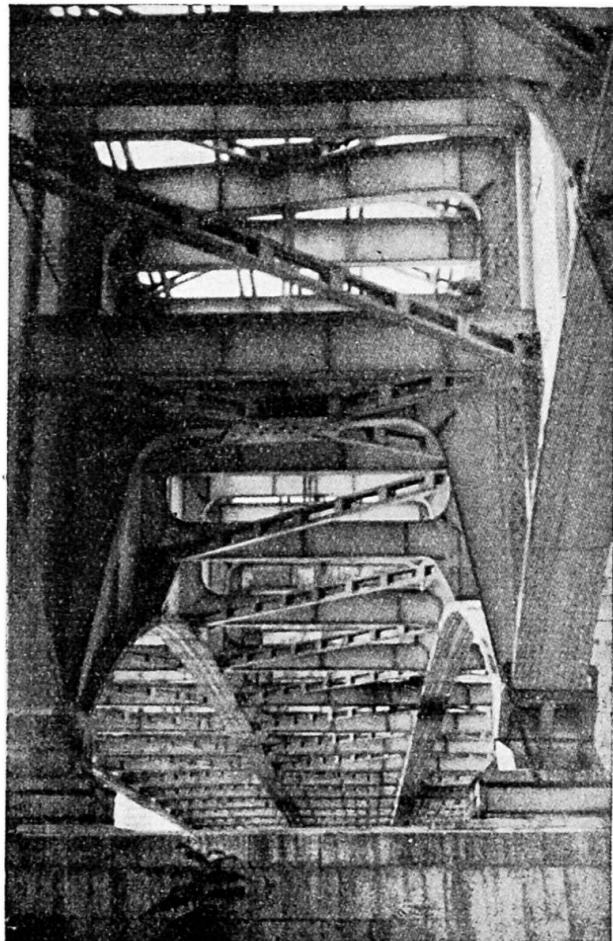
Fig. 2. View of the steel construction of the Arpd-bridge showing welded elements from underneath.

The process has secured perfectly uniform and smooth weld-surfaces, reliable fusion at the root of the weld (3) and the welded structure altogether made a pleasing appearance, inspite of the skew lay out of the steel construction (fig. 2).

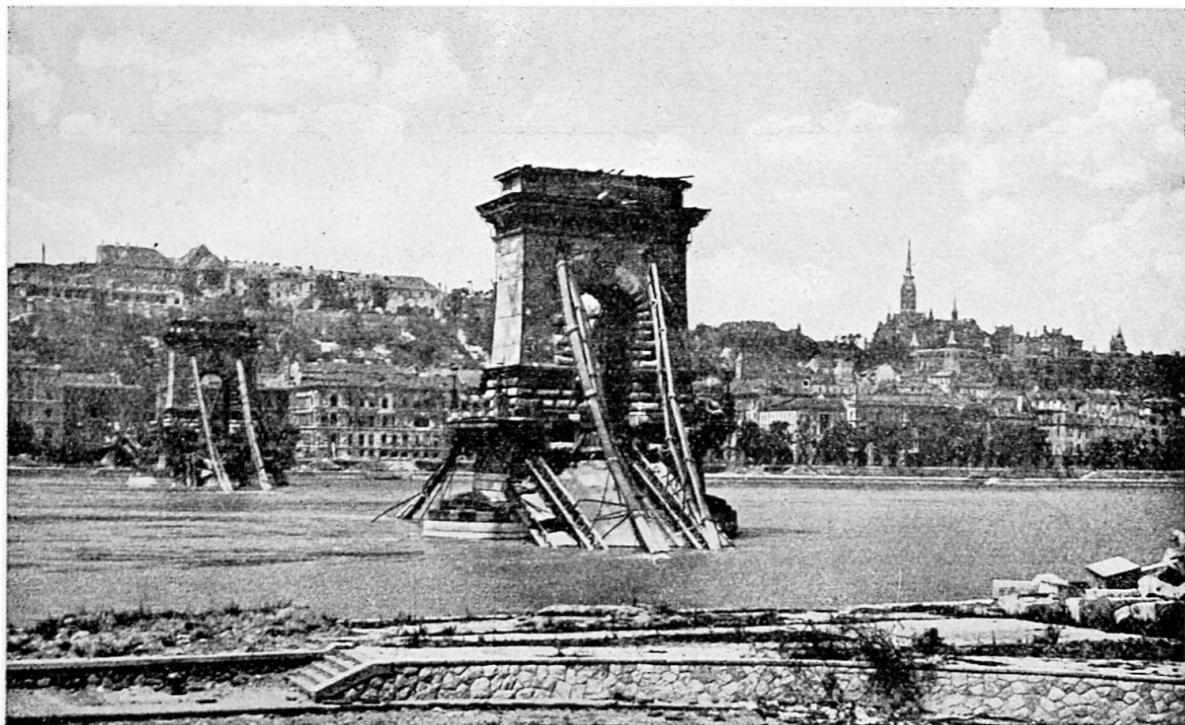
Fig. 4. View of the blown up « Chain-bridge » Budapest.

Budapest the German troops have blown up the left side anchoring chambers of the bridge, inducing so a mighty slip of the chains (16 meters = 53 ft 0 in over the left pylone and about 3 meters = 10 ft 0 in over the right pylone) which tremendous deformation led to the entire collapse of the bridge. Although many of the chains broke and many again suffered plastic torsion or buckling still it was evident, that a considerable part of them might be reutilized (fig. 4).

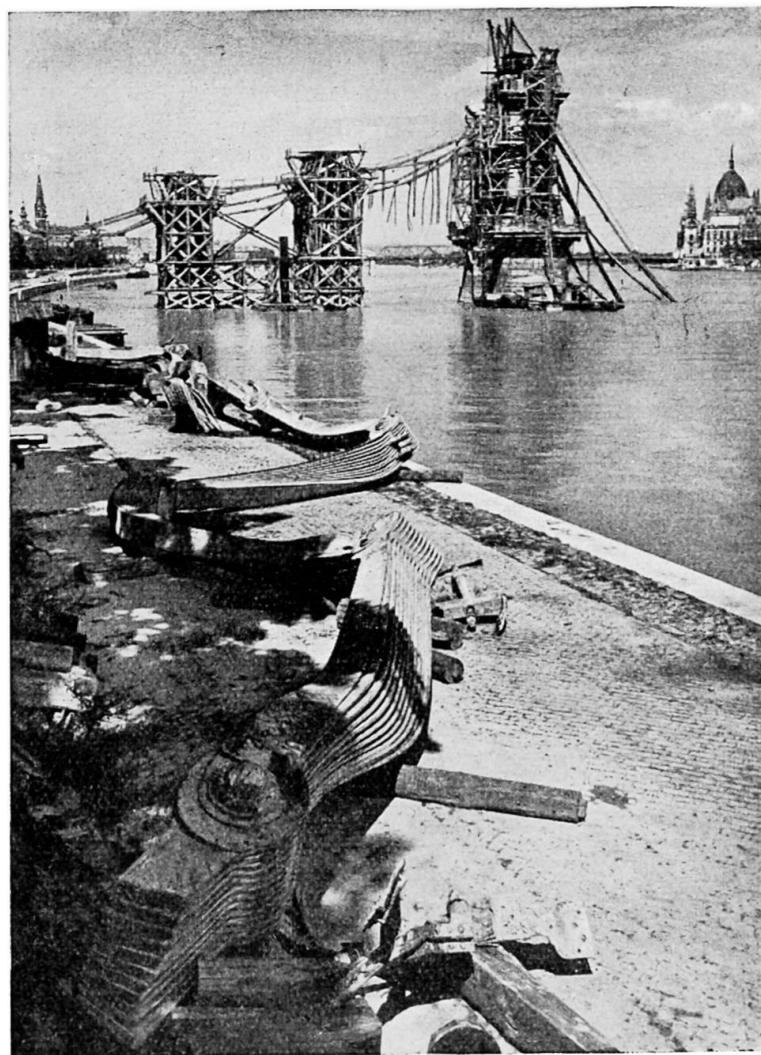
Fig. 9. Recuperated, crooked chain-bundles in foreground, supporting and staging, with the saved chain-line of the right span to be readjusted in the background.

Simultaneously experiments were made with the straightening of the badly crooked chain-plates (fig. 9).

and a general embrittlement of the steel-material (fig. 9). In the total length of the chain elements in one bundle this difference amounted up to 2-5 mm. This involved also reboring of the chain bundles and required new pins. Test specimens were taken from the restraightened parts of the chain material to check any deterioration of the mechanical properties due to this cold machining of the steel material. But the tests have delivered no considerable change as compared to the original.

own weight, the total dead load of the chains which suffered the least displacement and may be easily readjusted from a temporary scaffolding built on the stiffening girder, which is of course not dimensioned for this overloading. The stiffening girder is erected by floating crane on temporary supports which must be removed before the appearance of drifting-ice and will then be replaced by this tie (fig. 9 and 10).
