Zeitschrift: IABSE congress report = Rapport du congrès AIPC = IVBH
Kongressbericht

**Welding experiences
at the construction of the newest Danube and Tisza bridges
in Hungary**

Dr CH. SZÉCHY

Chief engineer, Highway-bridge Department in Hungary

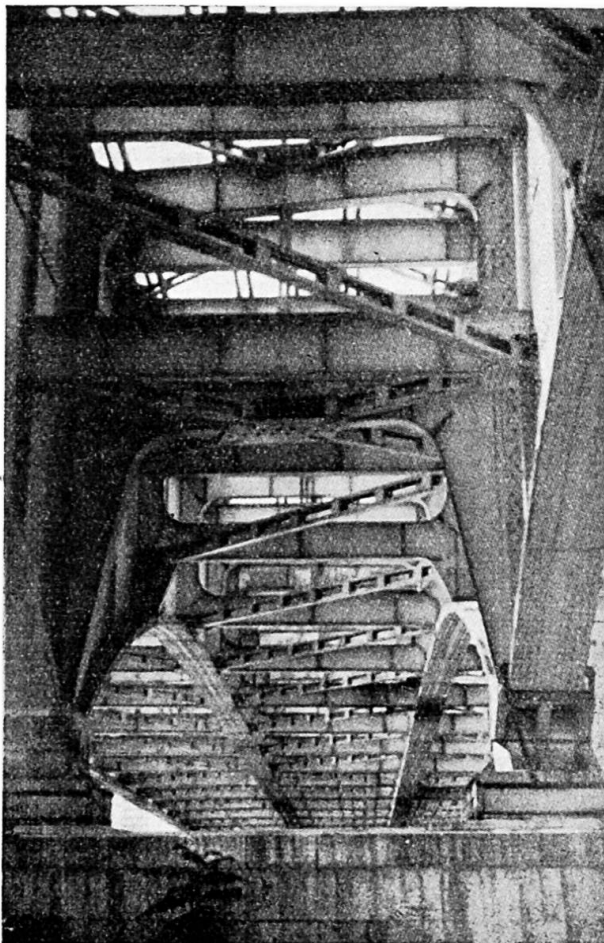
Fig. 2. View of the steel construction of the Arpád-bridge showing welded elements from underneath.

The process has secured perfectly uniform and smooth weld-surfaces, reliable fusion at the root of the weld ⁽³⁾ and the welded structure altogether made a pleasing appearance, inspite of the skew lay out of the steel construction (fig. 2).

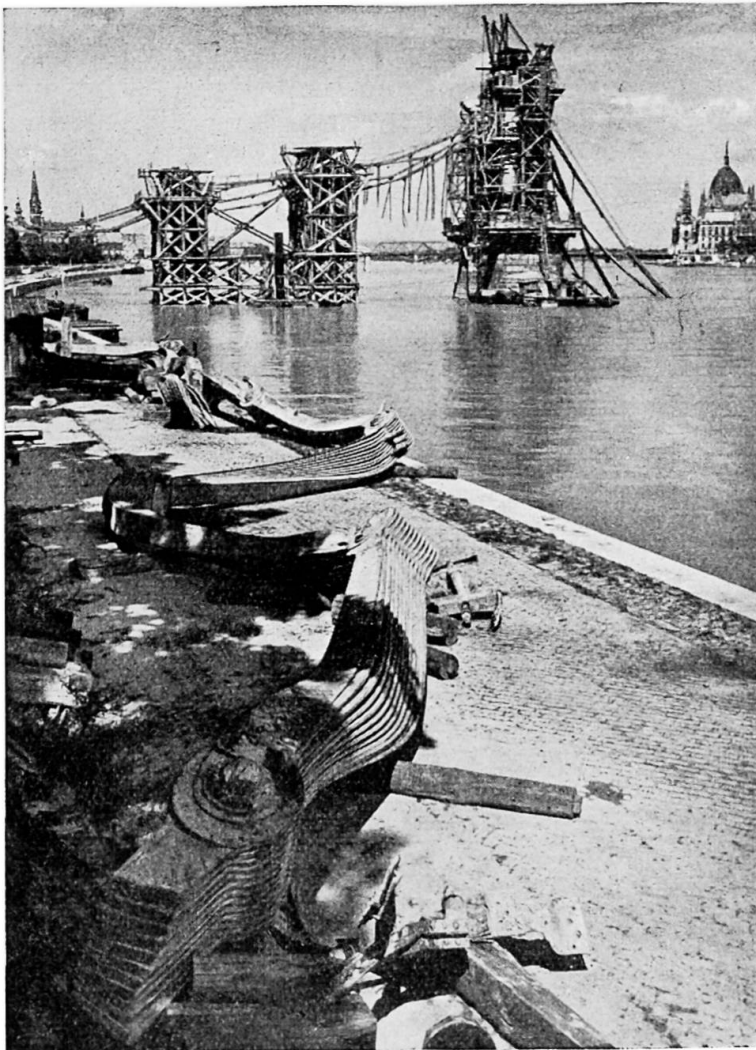
Fig. 9. Recuperated, crooked chain-bundles in foreground, supporting and staging, with the saved chain-line of the right span to be readjusted in the background.

Simultaneously experiments were made with the restraightening of the badly crooked chain-plates (fig. 9).

This operation was done by cold mongering of the single elements which suffered in most cases serious plastic deformation. This procedure proved also successful but resulted naturally in a different elongation for each member of the chain bundle varying according to the radius and to the angle of curvature

and a general embrittlement of the steel-material (fig. 9). In the total length of the chain elements in one bundle this difference amounted up to 2-5 mm. This involved also reboring of the chain bundles and required new pins. Test specimens were taken from the restraightened parts of the chain material to check any deterioration of the mechanical properties due to this cold machining of the steel material. But the tests have delivered no considerable change as compared to the original.
