**Welding experiences
at the construction of the newest Danube and Tisza bridges
in Hungary**

Dr CH. SZÉCHY

Chief engineer, Highway-bridge Department in Hungary

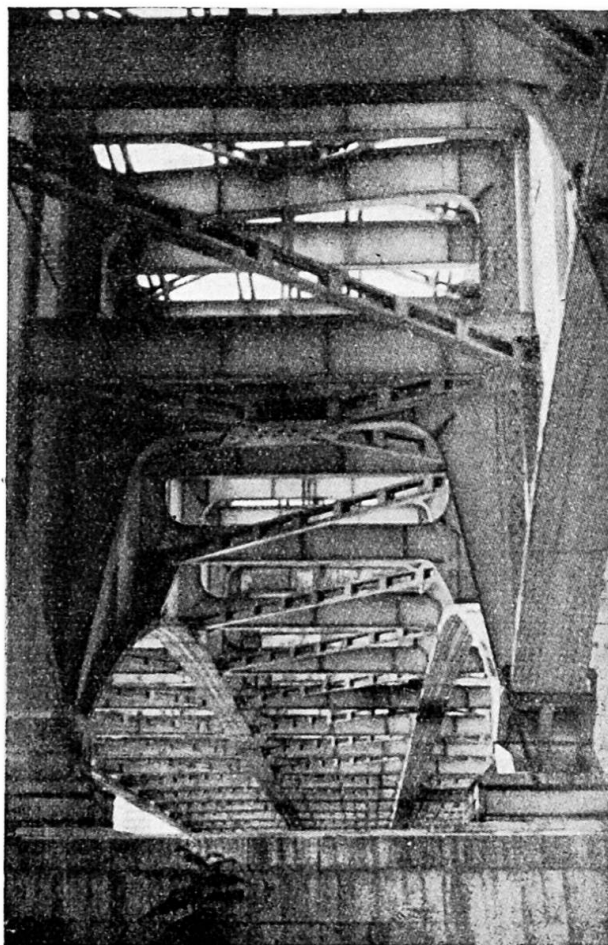
Fig. 2. View of the steel construction of the Arpád-bridge showing welded elements from underneath.

The process has secured perfectly uniform and smooth weld-surfaces, reliable fusion at the root of the weld ⁽³⁾ and the welded structure altogether made a pleasing appearance, inspite of the skew lay out of the steel construction (fig. 2).

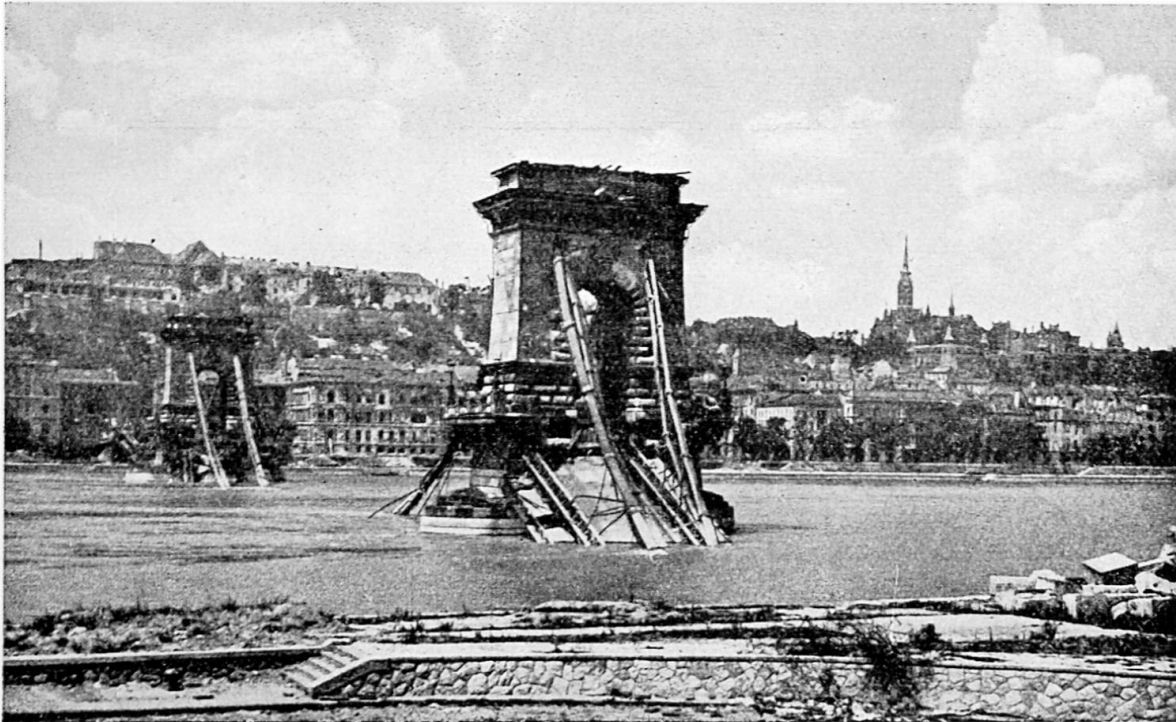
Fig. 4. View of the blown up « Chain-bridge » Budapest.

Budapest the German troops have blown up the left side anchoring chambers of the bridge, inducing so a mighty slip of the chains (16 meters = 53 ft 0 in over the left pylon and about 3 meters = 10 ft 0 in over the right pylon) which tremendous deformation led to the entire collapse of the bridge. Although many of the chains broke and many again suffered plastic torsion or buckling still it was evident, that a considerable part of them might be reutilized (fig. 4).
