**Artikel:** Preservation of the Menai suspension bridge

**Preservation of the Menai suspension bridge**

G. A. MAUNSELL  
M. Inst. C. E., F. R. S. A., London

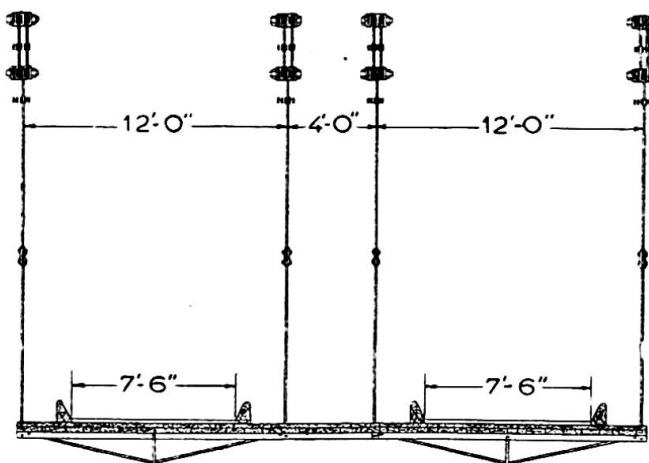
Fig. 1. Cross section of Telford's original deck.

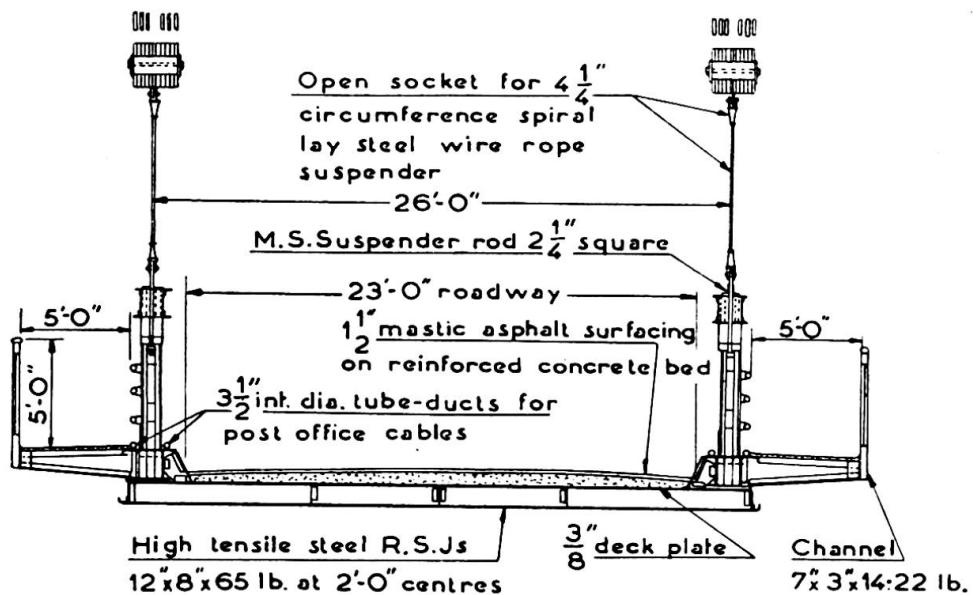
**Fig. 2.** Cross section of deck as reconstructed in 1940.

The roadway of the bridge was surfaced with a layer of Trinidad mastic asphalt into the surface of which were rolled clean  $\frac{5}{8}$  inch cubical granite chippings applied hot. A special white mastic line  $4\frac{1}{2}$  inches wide and in three foot lengths laid at nine foot intervals was embedded in the original asphalt surface to mark the centre of the roadway on the main span.

The asphalt  $1\frac{1}{2}$  inches thick was laid on a plain screeded concrete base six inches thick and the concrete base beneath was rather heavily reinforced with a steel mesh and was itself laid directly upon the steel plating of the deck structure. The traffic surface obtained in this way appears to be in almost perfect condition after six years use.

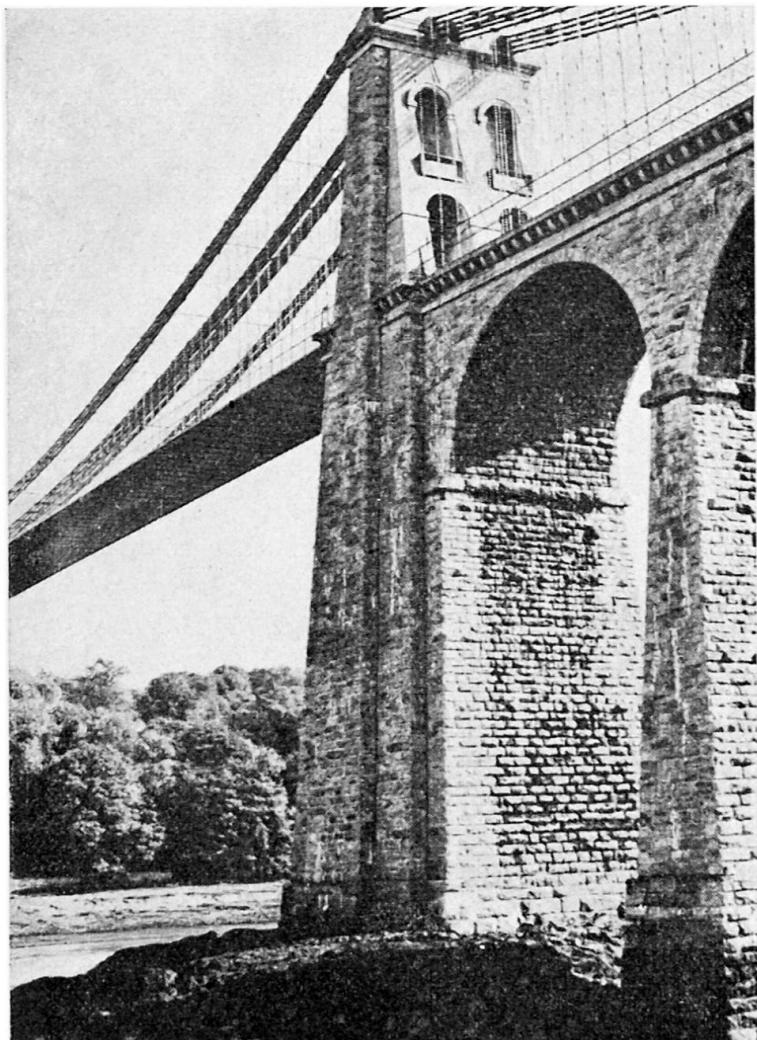
**Fig. 3.** One of the main masonry piers showing the four chains deck and roadway arches of the original structure.

To understand what was actually done it is first necessary to realise that the old bridge was suspended from four separate chains, one chain on either side and two close together in the middle between the two carriageways. The four chains rested on top of two main piers flanking the main span. Upon each of these two main piers a temporary steel girder or cap was erected and mounted above the old chain seatings and on top of this cap were slung two steel wire rope suspension cables capable temporarily of replacing the outer two sets of the old chains above mentioned.

In the reconstructed bridge the four chains each composed of a tier of eyebar links five abreast and four deep were to be replaced by two chains each composed of a tier of six eyebar links two deep and the new chains had perforce to occupy very nearly the same physical position on top of

the piers as had originally been occupied by the two outer tiers of the four original chains. It will be seen, therefore, that it was necessary to remove the two outer tiers of old chains before the new permanent chains could be erected in their place and explains why it was necessary to provide temporary cables for supporting the outer edges of the roadway deck while the work of chain replacement was in progress. The cables were mounted directly above the chains that were to be removed and replaced by new chains and were supported by the temporary cap girders above mentioned. After the cables had been strung across and anchored to the hillsides they were connected by temporary hangers so as to support the outer edges of the old bridge deck and after that the old outer chains were removed and were replaced by the new chains. While this was going on the old inner central tiers of chains were left in service, and traffic continued to use the deck of the bridge without any interruption or interference.

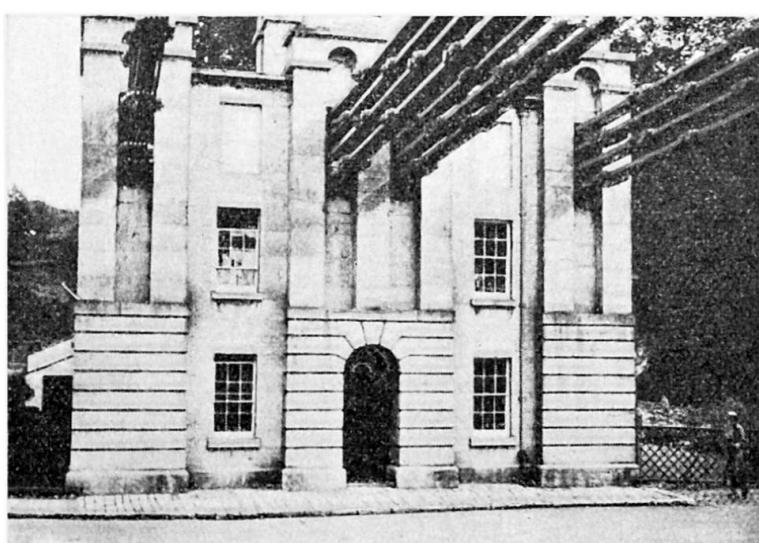
**Fig. 4.** Old chains entering the anchorage on the Welsh side.

While on the subject of corrosion and painting it is interesting to note that Thomas Telford when designing the original wrought iron structure in or about the year 1820 conceived that corrosion of the chains inside the anchorage tunnels would be much more severe than outside in the open air, and he accordingly stiffened up the sizes of the links where

they traverse the underground tunnels making them nearly twice as thick as those in use outside so as to allow a margin for rusting. The tunnels consist of narrow passageways cut in the virgin rock where the humidity is considerable and the temperature does not vary very much summer or winter. Telford's conception that rusting in such conditions would be much more active than in the open air has been entirely falsified in the result, experience having proved the exact opposite, there being practically no rusting of the ironwork anywhere in the tunnels during a period of 120 years whereas rusting outside was considerable.

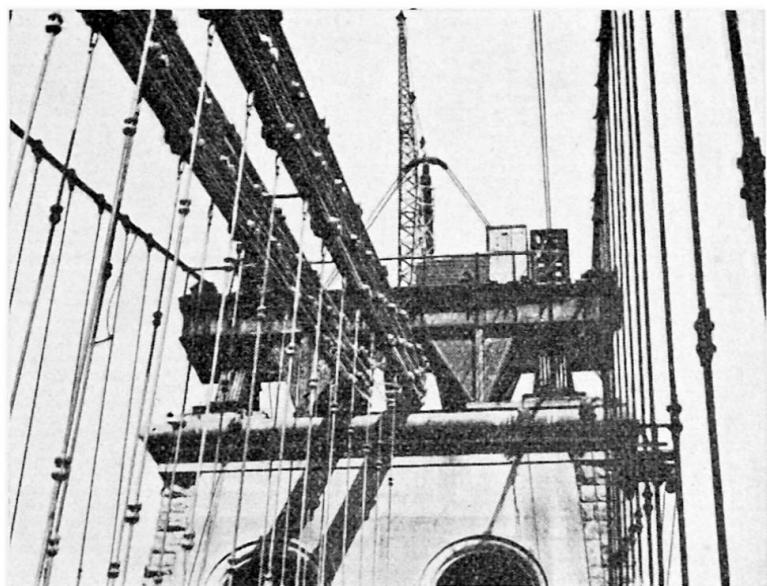
**Fig. 5.** Top of one of the main piers during reconstruction. The two old central chains are seen in position but the two old outer chains have been removed and the roller bearing saddles for supporting the new chains have been erected on top of the pier. Above the pier is the temporary steel horsehead girder supporting the temporary wire rope cables and suspenders and above them the blondin wires. The suspended walkways for supporting the new chains during erection have not yet been set up.

to be allowed for, but where the two new chains traversed the main span they had to be put together link by link upon two suspended walkways, each of which consisted of five catenary wire ropes hanging side by side and decked over without any stiffening. The stretch of these ropes when the weight of the chain links came upon them was considerable and the sequence in which the chain links were assembled upon the walkway also created distortion away from the catenary. In the stage when the eyebar links were being assembled and before they were connected at both ends to the links on the side spans there was a period of some instability when wire rope walkways tended to twist out of line from under and capsize the load. All these tendencies had to be taken into consideration as the work progressed. The new chains were assembled on the suspended walkways by means of blondins rigged above them.

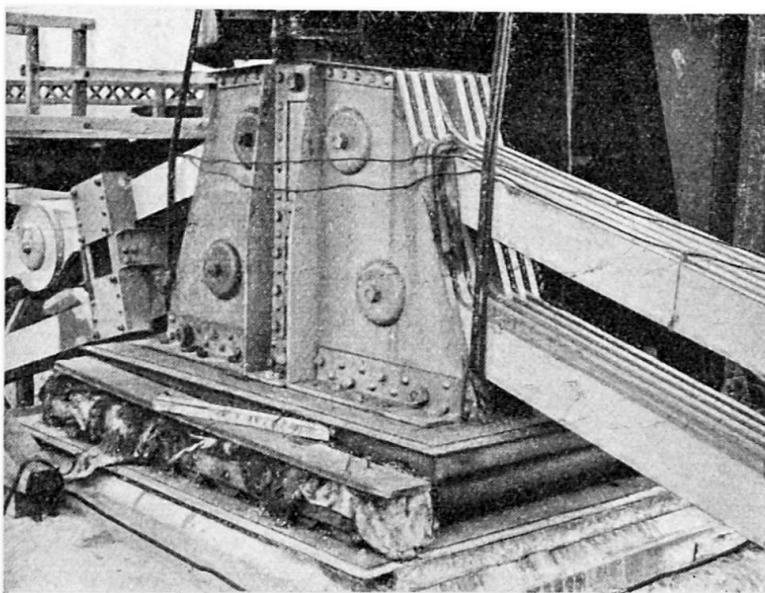
**Fig. 6.** One of the new roller bearing chain saddles in course of erection on top of the pier and before its enclosure in an oil bath. The new chains have been erected and connected upon the saddle.

Where the main chains rest upon the piers roller bearings permit of horizontal movement and the ten steel rollers each ten inches in diameter and seven feet long in each of the four main bearings are submerged in an enclosing oil bath from which air is totally excluded so as to prevent water from condensing inside the bath.

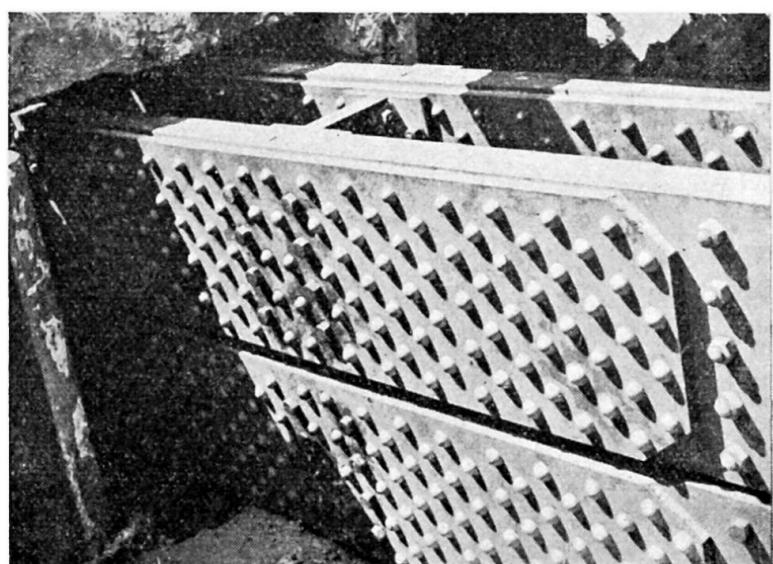
**Fig. 7.** Steel plate extension of the new eyebar chains which were designed to slide down the anchorage tunnels and to be concreted in solid instead of painted and left exposed as were the underground eyebar extensions in the old structure.
