**Rubrik:** Vc: Corrosion of reinforcing steels and resulting damage

# Korrosion von Bewehrungsstählen und daraus folgende Schäden

Corrosion of Reinforcing Steels and Resulting Damage Corrosion des armatures et détériorations en résultant

# Galvanized Steel Reinforcement in Concrete

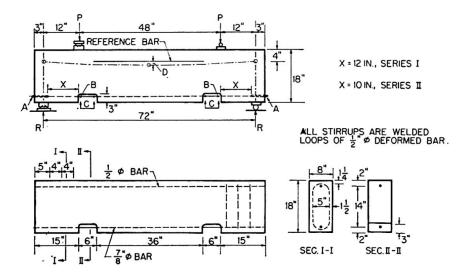
Fig. 1. Bond Specimen Details.

Specimens cast erect — main  $^{7}/8'' \varnothing$  steel bar in bottom. Specimens cast inverted — main  $^{7}/8'' \varnothing$  steel bar in top.

- A Dial gage to measure slip at free end of bar.
- B Dial gage to measure slip at loaded end of bar.
- C Extensometer with 5 in. gage length to measure strain.
- D Deflection at midspan measured with respect to reference bar.

The effect of galvanizing on bond of steel reinforcement was studied in beam specimens generally conforming to the ACI Standard 208-58 of ACI Committee 208 (now 408) on Bond. Two series of tests were conducted: one, on unrusted bars — as received (Series I), with galvanized bars prepared using steel mill procedures and controls; and another on unrusted and lightly rusted 1) bars (Series II), approximating the more usual field conditions and using shop galvanized bars. In both series ungalvanized (hereafter called black), galvanized, plain and deformed steel bars of intermediate grade (yield stress about 40 ksi) were used. The zinc coating was approximately 3 oz. per sq. ft. of bar surface for both series. The beams were  $6\frac{1}{2}$  ft. long, 8 by 18 inches in cross section, reinforced in tension with a single bar, Fig. 1. The concrete in both series was made with type I Portland cement, had a cement factor about  $5\frac{1}{2}$  sacks per cu. yard and concrete strength averaging 4.2 ksi. The length of embedment in the first series was 12 in. at each end, and this was reduced to 10 inches in the second series. Beams in the first series were tested at approximately 28 days, and at approximately 20 days in the second series.

In Series I, with unrusted bars, 24 beams were tested, 12 of these were cast "erect" with reinforcing bars in the bottom of the beams and 12 were cast "inverted" with reinforcing bars in the top of the beam. In Series II 16 beams were tested, all cast "inverted" to obtain a more critical bond condition; of these 8 beams were cast with rusted bars and 8 with bars having normal, as received, surface condition. The procedure for rusting the bars was as follows:

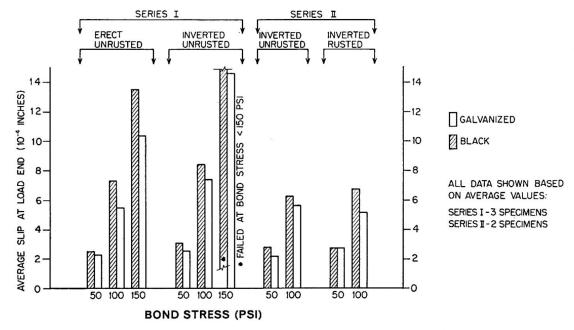
Fig. 2. Bond Performance of Plain Bars.

Figs. 2 and 3 show the amount of slip at loaded end between the reinforcing bars and the concrete at different levels of bond stress. Average bond stresses were calculated assuming uniform distribution along the embedded length of the bar, and values of slip represent averages taken for both ends of similar beam specimens. Note the change in scale for the slip of plain and deformed bars.

- a) Plain galvanized bars, unrusted, cast erect (i. e. bars in bottom of beam), indicated significantly better bond performance than similar black bars.
- b) Deformed galvanized bars, unrusted, cast inverted (i. e. bars in top of beam), indicated *somewhat better* bond performance than similar black bars.
- c) All other galvanized bars in the two test series had equal or slightly better bond performance than similar black bars.

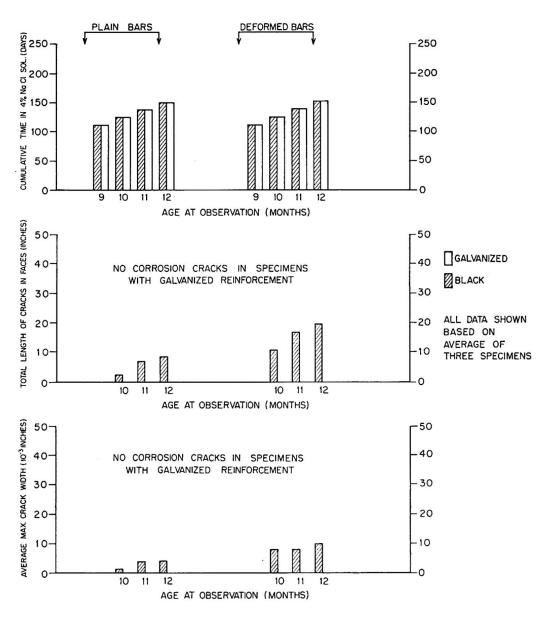
Fig. 5. Corrosion Performance Under Alternating Immersion in Salt Solution.

time in salt solution, total length of longitudinal cracks in the prism faces, and maximum crack widths are shown in Fig. 5. The values shown are averages of the observed values for the 3 specimens. For this exposure, based on 12 months observations, corrosion cracks were not observed on specimens with galvanized reinforcement.

- a) Specimens in laboratory air have been observed for a period of about 12 months, without any evidence of corrosion (cracking) in prisms with either black or galvanized reinforcement.
- b) Specimens in salt solution (alternating immersion and drying) with black steel reinforcement have shown some cracking at approximately 9 months. Companion specimens in the same environment with galvanized reinforcement show no signs of cracking at the age of 12 months. Cumulative

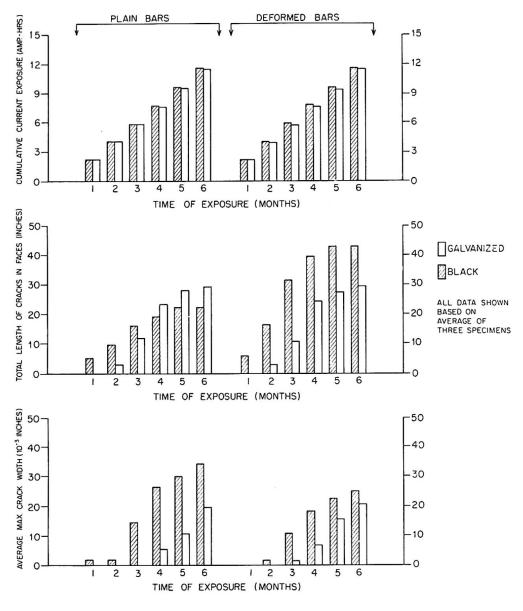
Fig. 6. Corrosion Performance Under Sustained Direct Current.

c) Specimens with impressed current with black steel reinforcement have shown some cracking at the age of 1 month. Companion specimens in the same environment with galvanized reinforcement have shown similar cracking at the age of 2 months. Cumulative current exposure in ampere-hours, total length of cracks in the prism faces, and maximum crack widths are shown in Fig. 6. The values shown are averages of the observed values for the 3 specimens. For this exposure galvanizing plain bars reduced crack widths but

resulted in about the same or increased crack lengths, and galvanizing deformed bars reduced both crack lengths and crack widths.

Nevertheless, under a severe exposure to sustained impressed current, the distress-free "life" of the test prism with galvanized reinforcement was double that for prisms with black reinforcement. For a severe immersion-drying cycles environment, the distress-free life of prisms with galvanized reinforcement appears to be greater than that for prisms with black reinforcement.
