Zeitschrift: IABSE congress report = Rapport du congrès AIPC = IVBH
Kongressbericht

Rubrik: Vc: Corrosion of reinforcing steels and resulting damage

Corrosion of Reinforcing Steels and Resulting Damage

Galvanized Steel Reinforcement in Concrete

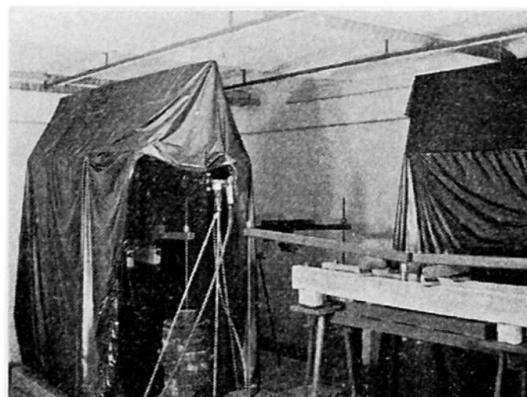
Fig. 1.

Nach 7 Monaten Erhärtung wurden die Balken gemäß Fig. 1 in Belastungsvorrichtungen eingebaut und paarweise mit Gewichten über Hebel belastet. Die Belastung wurde mit 59 bis 65 kg/mm^2 rechnungsmäßiger Stahlspannung so hoch gewählt, daß in jedem Balken einige Risse mit 0,2 bis 0,3 mm Weite entstanden sind. Insgesamt hatte die Hälfte aller Risse 0,2 bis 0,3 mm Weite und je ein Viertel kleinere bzw. größere Weiten.

Alle Prüfstände wurden zur Förderung der Korrosion zusätzlich befeuchtet, in dem unter den in Fig. 1 gezeigten Zelten ein feinst verteilter Sprühregen erzeugt wurde. Jeder Prüfstand wurde in jeder Woche 2 mal einem Sprühregen von 4 Stunden Dauer ausgesetzt. Dazwischen trockneten die Balken aus, wobei die Temperatur auf 20°C und die Luftfeuchtigkeit auf 80% konstant gehalten wurden.

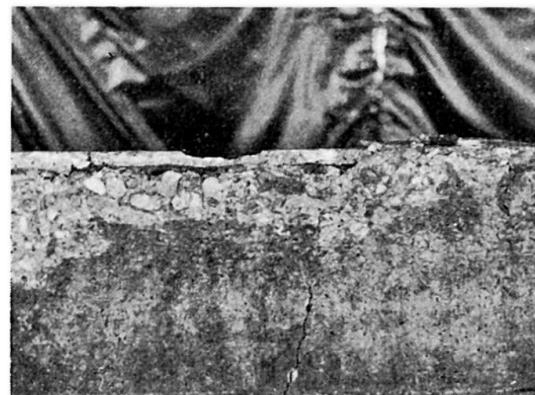
Fig. 3.

Fig. 3 zeigt einen Extremfall der Korrosion. Infolge zu geringer Deckung ist ein Längsriß über dem Stab aufgetreten und über dessen ganze Länge Korrosion. Weiters ist noch die unvermeidliche Porosität dieser dünnen Deck- schichten festzustellen, die insbesondere dann ungünstig wirken, wenn sich Sandkörner zwischen dem Stab und der Oberfläche verklemmen, wodurch das Wasser zum Stahl direkten Zutritt erhält.

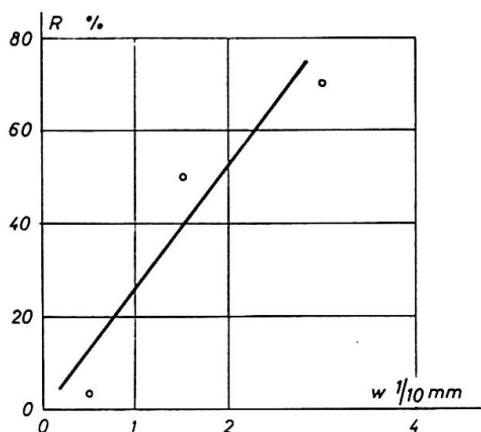
Fig. 5.

Den Zusammenhang zwischen Rißweite (w) und Korrosion (R) zeigt Fig. 5, in der wieder Gruppenmittel aufgetragen sind; die Korrosion nimmt mit steigender Rißweite zu. Wenn die Betondeckung 2 cm betrug haben Rißweiten von 0,2 bis 0,3 mm zu keiner Korrosion geführt. Bei einer Deckung von wenigen mm führten jedoch schon Rißweiten von 0,1 mm zu Korrosion.

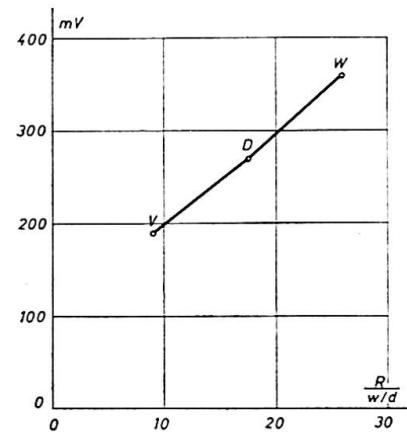
Fig. 6.

Zur Abklärung der Existenz des Pumpeffektes der Risse infolge oftmals wiederholter Belastung wurden in Fig. 6 sämtliche Risse der zusammengehörigen Balken zu einem Mittelwert zusammengefaßt. Als Abszisse ist aufgetragen ein Maß für die Rostgefahr oder Rostintensität, in dem die Länge der Verrostung (R) durch die Weite der Risse (w) und diese durch die Dicke der Betondeckung (d) dividiert wurden.

Die Balken W mit oftmals wechselnder Belastung zeigen mit dem Wert 26 eine größere Rostgefahr als die Balken D mit ständig ruhender Belastung, für die der Wert 17,5 ermittelt wurde.

In den einzelnen Belastungsvorrichtungen sind auch Balken unbelastet ausgesetzt worden, die durch eine gleich starke Vorbelastung Risse hatten. Diese Balken V haben mit dem Wert 9 die geringste Rostbildung gezeigt.

In Fig. 6 sind weiters die Endwerte der gemessenen Potentialdifferenzen (mV) angegeben als Ordinaten. Die Potentialdifferenz ist für die am stärksten durch Rost gefährdeten Balken W mit oftmals wiederholter Belastung am größten und für die unbelasteten Balken mit Rissen, die auch die geringste Verrostung zeigten, am kleinsten. Es erscheint daher möglich durch Messungen der Potentialdifferenz eine Aussage über die Rostgefahr für eine Stahlbetonkonstruktion zu treffen. Durch weitere Forschungen muß die Brauchbarkeit einer solchen zerstörungsfreien Methode abgeklärt werden.

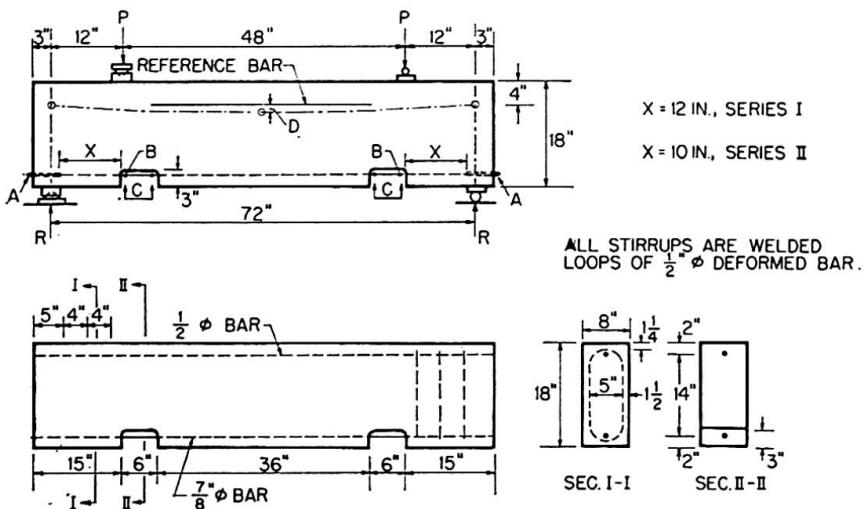
Fig. 1. Bond Specimen Details.

Specimens cast erect — main $7/8$ " \varnothing steel bar in bottom.

Specimens cast inverted — main $7/8$ " \varnothing steel bar in top.

A Dial gage to measure slip at free end of bar.

B Dial gage to measure slip at loaded end of bar.

C Extensometer with 5 in. gage length to measure strain.

D Deflection at midspan measured with respect to reference bar.

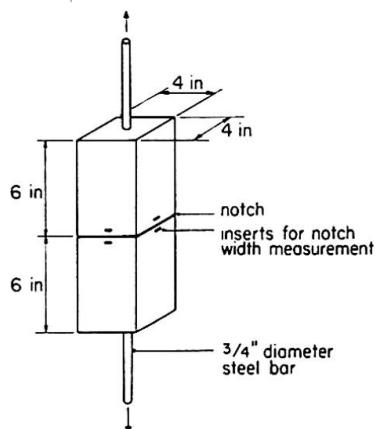
Fig. 4. Corrosion Specimen Details.

The effect of galvanizing on corrosion of steel reinforcement in concrete was studied on 4 by 4 inches square, 12 inches long, concrete prism specimens, axially reinforced with a $3/4$ inch diameter steel bar, Fig. 4. A $1/2$ inch deep notch was cut at the mid-section of the concrete prism to enforce formation of a crack at the notch when the specimen was loaded. Gauge points

insulated from the reinforcement were located above and below this notch on all four faces. The concrete was made with type II (low alkali) Portland cement, had a cement factor of 6.6 scy, and compressive strength of 6.0 ksi.

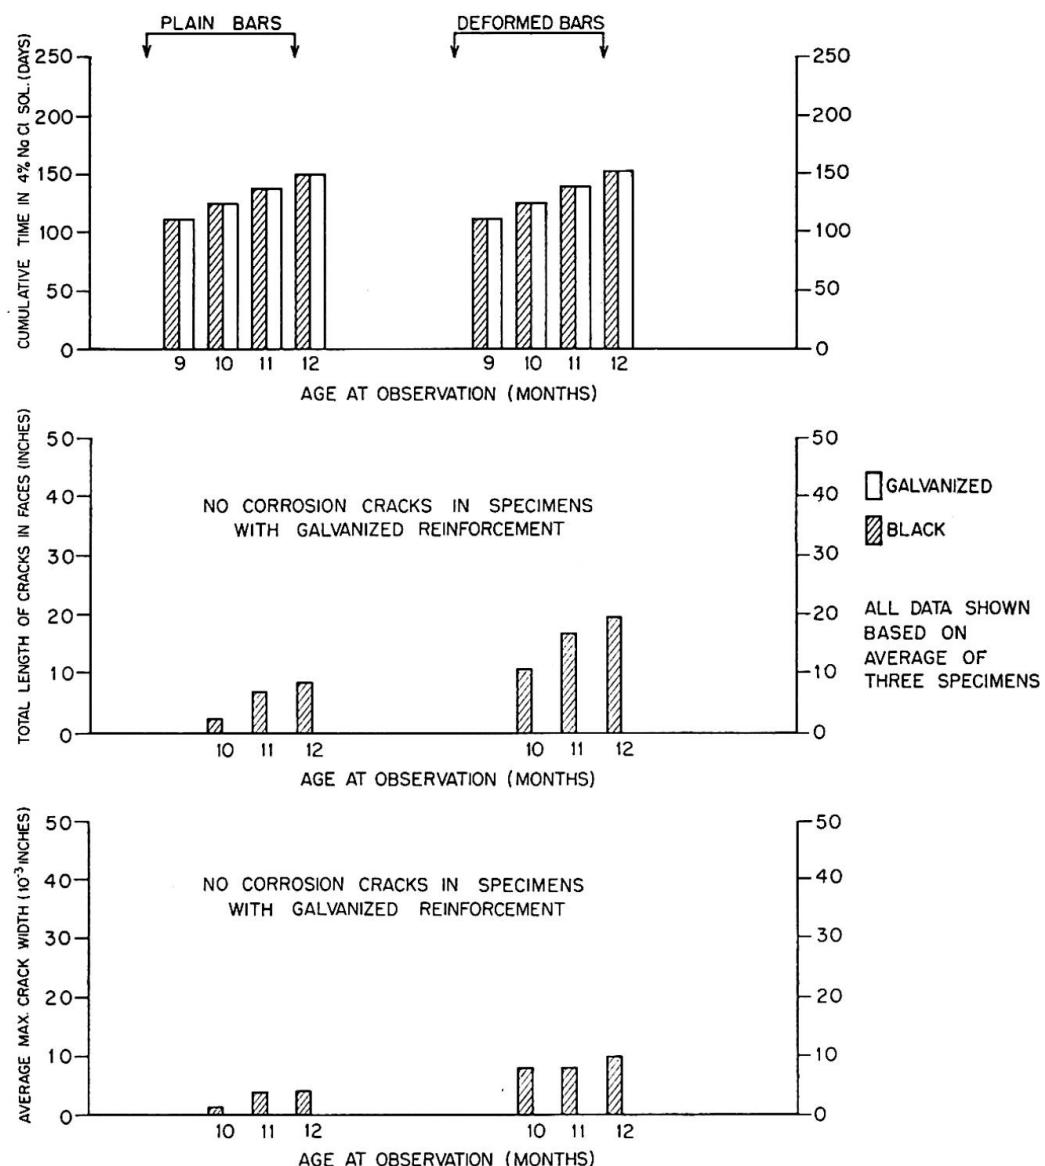
Fig. 5. Corrosion Performance Under Alternating Immersion in Salt Solution.

- Specimens in laboratory air have been observed for a period of about 12 months, without any evidence of corrosion (cracking) in prisms with either black or galvanized reinforcement.
- Specimens in salt solution (alternating immersion and drying) with black steel reinforcement have shown some cracking at approximately 9 months. Companion specimens in the same environment with galvanized reinforcement show no signs of cracking at the age of 12 months. Cumulative

time in salt solution, total length of longitudinal cracks in the prism faces, and maximum crack widths are shown in Fig. 5. The values shown are averages of the observed values for the 3 specimens. For this exposure, based on 12 months observations, corrosion cracks were not observed on specimens with galvanized reinforcement.

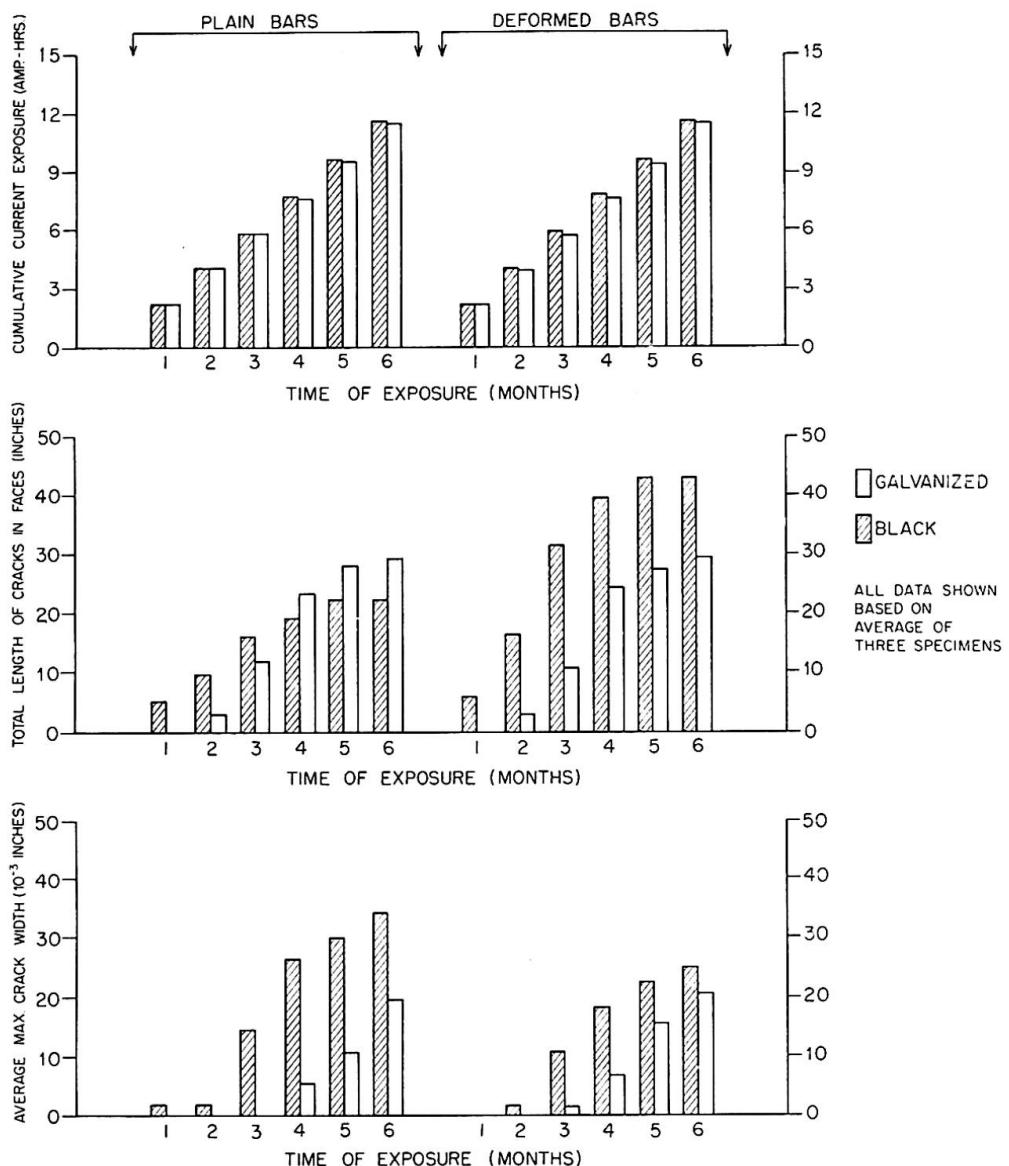
Fig. 6. Corrosion Performance Under Sustained Direct Current.

c) Specimens with impressed current with black steel reinforcement have shown some cracking at the age of 1 month. Companion specimens in the same environment with galvanized reinforcement have shown similar cracking at the age of 2 months. Cumulative current exposure in ampere-hours, total length of cracks in the prism faces, and maximum crack widths are shown in Fig. 6. The values shown are averages of the observed values for the 3 specimens. For this exposure galvanizing plain bars reduced crack widths but

resulted in about the same or increased crack lengths, and galvanizing deformed bars reduced both crack lengths and crack widths.

Nevertheless, under a severe exposure to sustained impressed current, the distress-free "life" of the test prism with galvanized reinforcement was double that for prisms with black reinforcement. For a severe immersion-drying cycles environment, the distress-free life of prisms with galvanized reinforcement appears to be greater than that for prisms with black reinforcement.
