## II d 4

### The Behaviour of Steel Beams Under Slow Repeated Loading

J. W. RODERICK

B. RAWLINGS

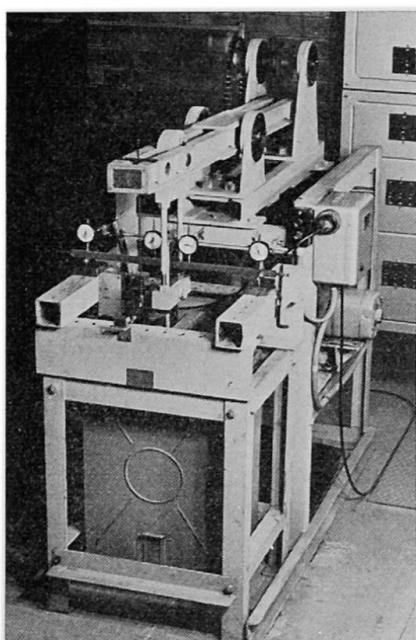
The testing machine used for loading the specimens is shown in Fig. 1. The specimen, of rectangular cross section and 20 inch (50.8 cm) simply supported span, rests on knife edges on rollers and is loaded to bend about the major axis, by dead load, applied and removed by an overhead rocking beam. The motion of this rocking beam is actuated by an eccentric which is

chain-driven from a 1000 to 1 reduction gearbox driven by a 1425 r.p.m. squirrel cage induction motor. The frame supporting the gearbox, motor and rocking beam is made independent of that supporting the specimen in order to isolate the specimen from any vibration which might develop.

An overload cutout is installed, to stop the motor in the event of any seizure of the equipment, and limit switches set below the specimen will stop the machine if the specimen deforms to an extent in excess of a selected maximum value. Locating stops are also provided to prevent the specimen from wandering whilst the test is in progress.

Deflections of the beams were recorded by four 0.001 inch dial gauges, mounted above the specimen supports and at points 2 inches from each side of the centre of the span. For the purposes of plotting graphs, the beam deflection was taken as the mean of the inner gauge readings minus the mean of the readings of the support gauges. A cycle counter of the manual reset type was fitted to operate from the rocker beam.

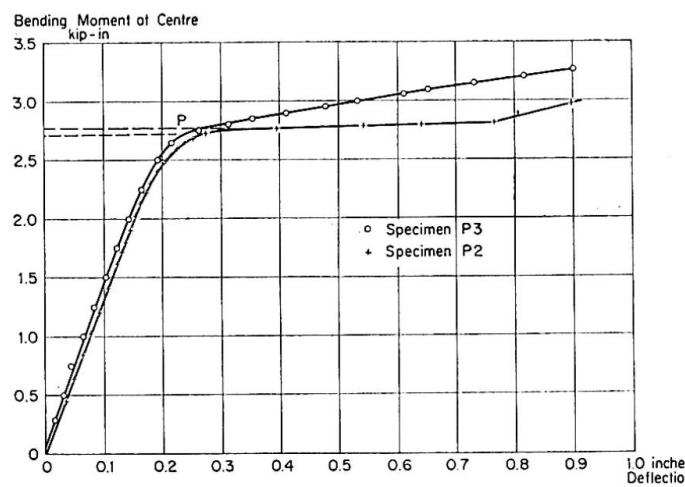
The details of the various specimens and results of static tests are summarised in Table 1. Typical curves plotted from these results are shown in Fig. 3. The value of full plastic moment accepted for the central point load tests was that corresponding to the point  $P$  (Fig. 3) at which the curve just entered the inclined region of strain-hardening behaviour. It will be seen that this value

agreed fairly closely with that obtained from a uniform flexure test on the same type of specimen.

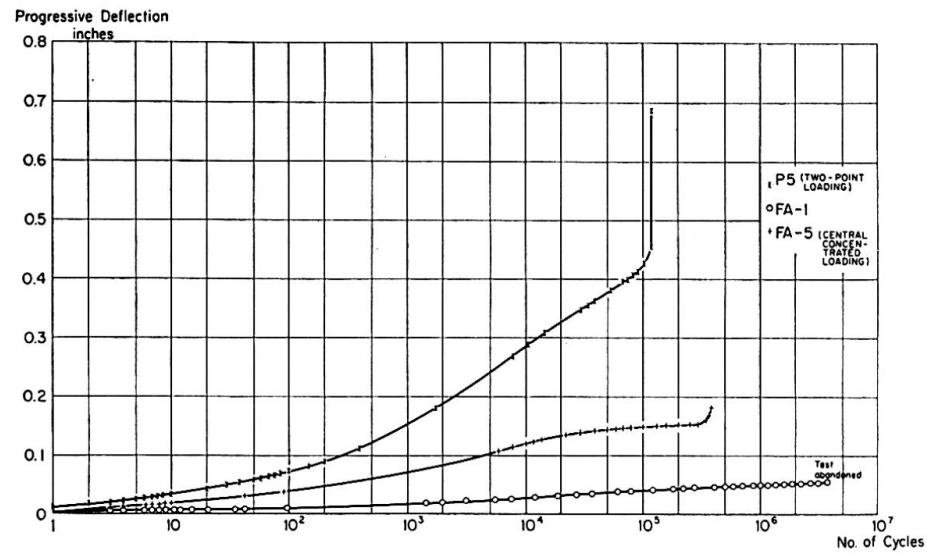
Fig. 4a.

It is convenient to represent the readings of progressive deflection against the number of cycles, as shown in Fig. 4, using a logarithmic scale as abscissa, and linear scale for ordinates. The graphs as shown are at arbitrary heights but the true initial values of deflection at the commencement of testing are given in Table 2.

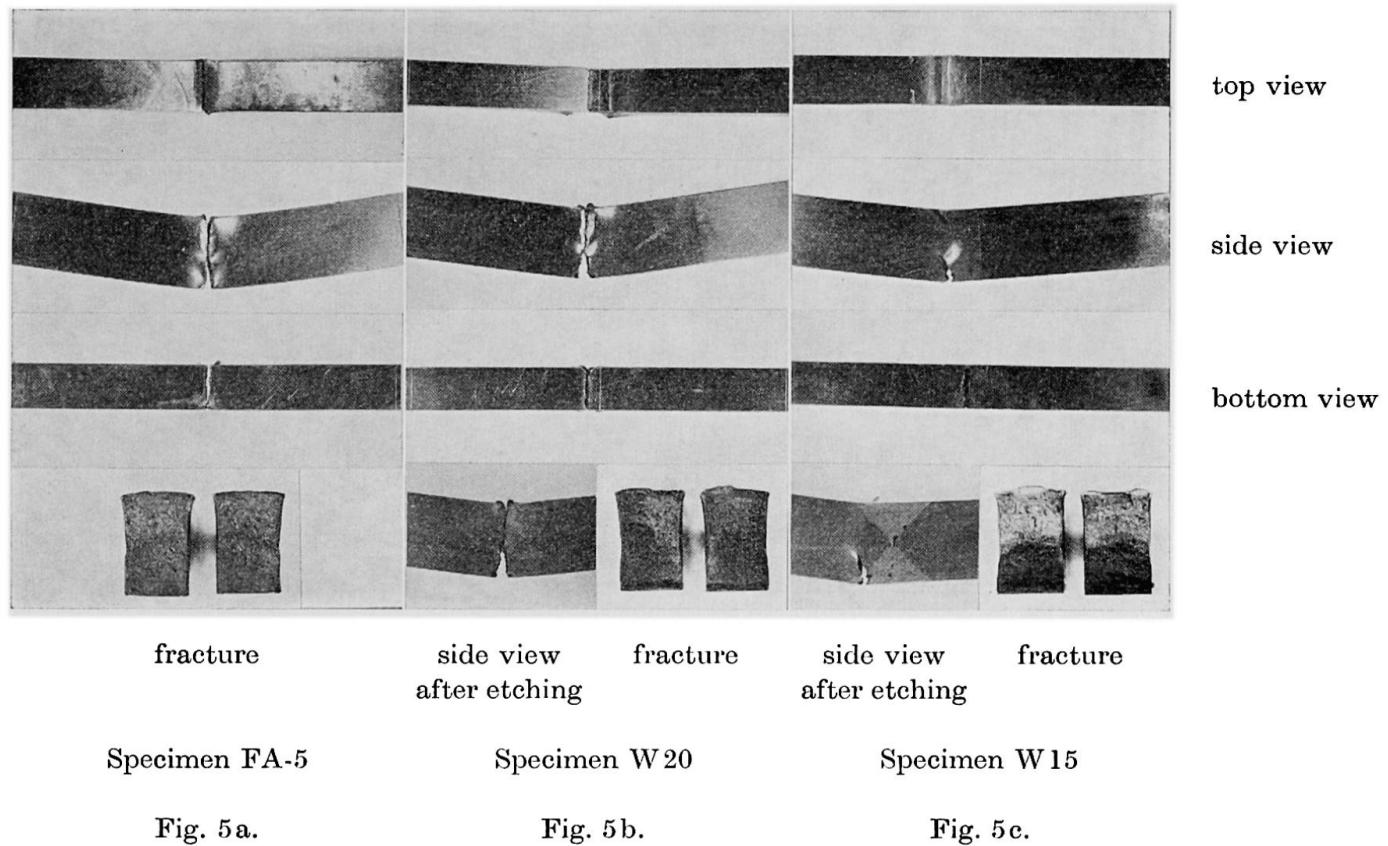
A number of photographs of specimens after testing showing elevations, top and underneath views and fracture surfaces are shown in Fig. 5. It will be evident that in all cases the region of the specimen adjacent to the fracture underwent considerable plastic deformation, and this was accompanied by lateral flow of the material, resulting in the large distortions of the cross-sections. The distorted surfaces are also clearly seen in the elevations. In a number of specimens rippling of the compression face was evident, and in others, some fine transverse cracks could be observed in the compression face when the specimen was closely examined. It will be observed from the photograph of specimen W 20 (Fig. 5b) that, even when the specimen was broken apart prior to photographing, there was some ductility of the remaining material as the two parts do not mate together precisely at the top.

Under single point loading conditions, the cracks were located at a section near the centre, but in most cases displaced approximately  $1/2$  inch away and near the extremity of the welded zone. In the case of the welded specimens subjected to two point loading, the cracks again frequently developed to one side of the centre line of the span, as is shown in Fig. 5c. (Specimen W 15.) The unwelded specimen subjected to two point loading developed a crack which originated under one of the loading points, in the tensile fibre. The crack propagated from one of the scribed lines used for marking out the

specimen prior to testing. Cracks in the specimens propagated vertically, and often appeared to emanate from a small weld defect such as an inclusion near the tensile face. It will be seen from the photographs in Fig. 5 which show elevations of typical welded specimens after etching with 10 per cent nitric acid in methylated spirit, that the cracks all originated within the welded zone, although in many cases they subsequently penetrated regions of unwelded material.

If attention is directed to the sectional views, which were taken after the specimens were broken apart in a vice, it will be observed that in some striations occurred consistent with the progressive nature of the cracking. These are particularly noticeable in the case of specimen FA-5. The fractures were crystalline in appearance, the lighter colour occurring in the region which was freshly broken.

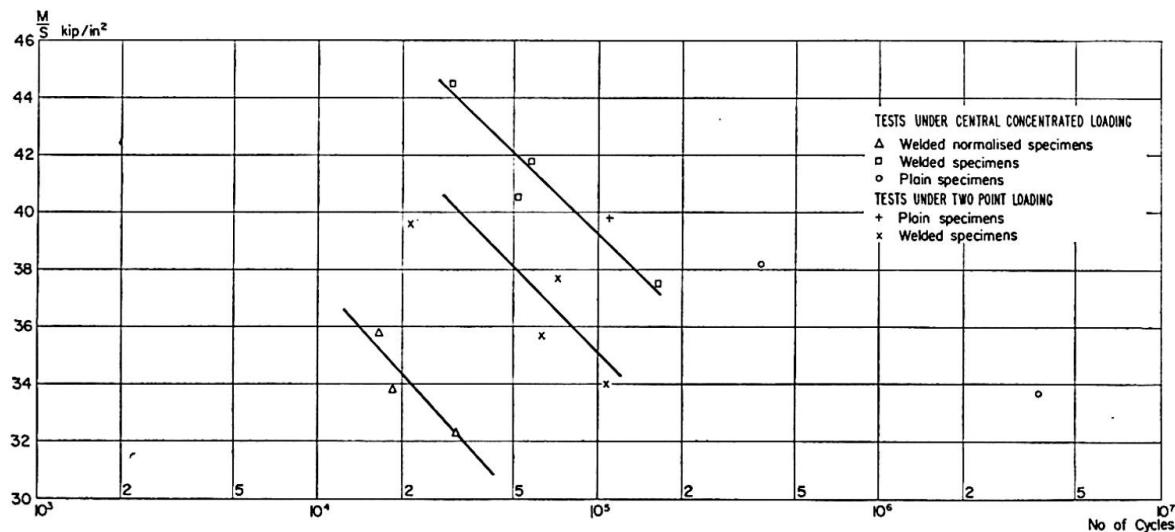
The test results are summarised in Fig. 6. Here, the number of cycles to failure are plotted on a logarithmic axis, against the applied maximum moment divided by the plastic section modulus of each specimen. These same results are plotted again in Fig. 7, the ordinate being the maximum applied moment divided by the full plastic moment of a specimen of the same dimensions, as determined from the static tests. In both figures the relationship between the logarithm of the life of a specimen, and loading, will be seen to be sensibly linear.

It will be observed that the curves for two point and central point loading specimens agree fairly closely, when allowance is made for the different values of full plastic moment of resistance. If it is assumed that the section where

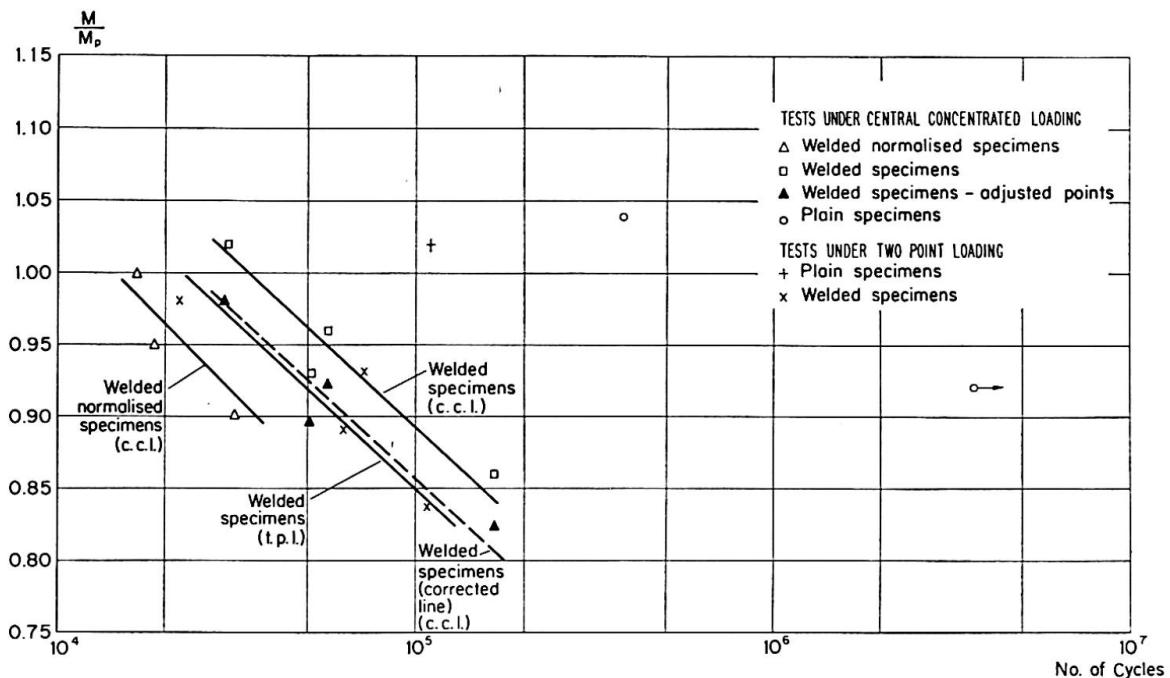
Fig. 7.

cracking occurs is at the extremity of the weld as is suggested by the photographs of the etched specimens, it will be seen that at these sections, the moment is only 96 per cent of the central moment, consequently the curve in Fig. 7, for the welded central load tests will be displaced downwards to the position shown by the broken line. The results of the central load and two-point load tests then agree very closely.
