Zeitschrift: IABSE congress report = Rapport du congrès AIPC = IVBH
Kongressbericht

Artikel: Spalling of concrete in actual fire

Spalling of Concrete in Actual Fire

Building Research Institute, Ministry of Construction

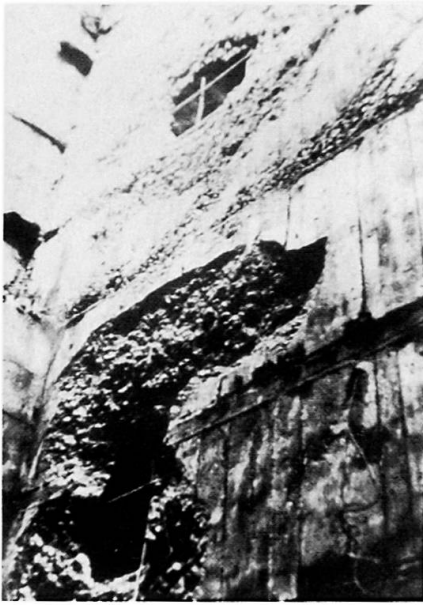
Fig.4

Spalling was so much intensive as to be explosive at the 5th story floor slab and at the bearing wall around the elevator shaft in the 3rd and 4th story. The concrete was of ordinary aggregate

and the amount of free water should have been very high because of early ages of concrete (fig. 4).

Spalling at the wall of the
elevater shaft

This example, reported by K. Kizawa and S. Ohgishi in 1967, shows a remarkable spalling in concrete during hardening. A five-story reinforced concrete shop building having 2,200m² total floor area was under construction when fire spread from the 3rd to the 5th floor, 5 days after concreting in the 4th story and floor slab of the 5th story. It was 17th day after concreting in the 3rd story.

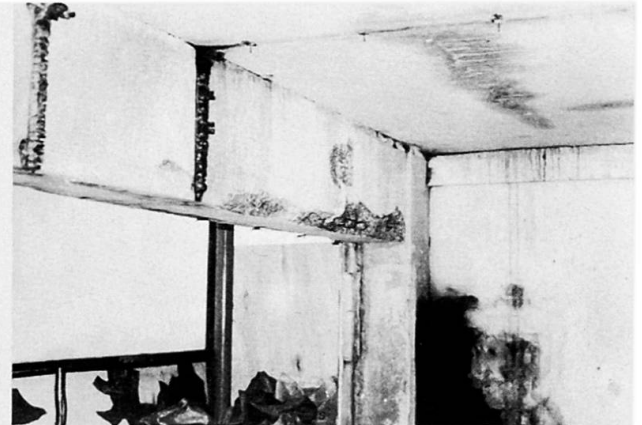
Though the damage by the gas explosion was so heavy as to destroy the walls and slabs (fig. 6), spalling was observed only at the lower corner of the beams and around the ventiration opening penetrating them (fig. 7). The cause of the slight spalling might be a fairly low content of free water in the concrete due to steam curing.

Fig.7
Spalling at the beam

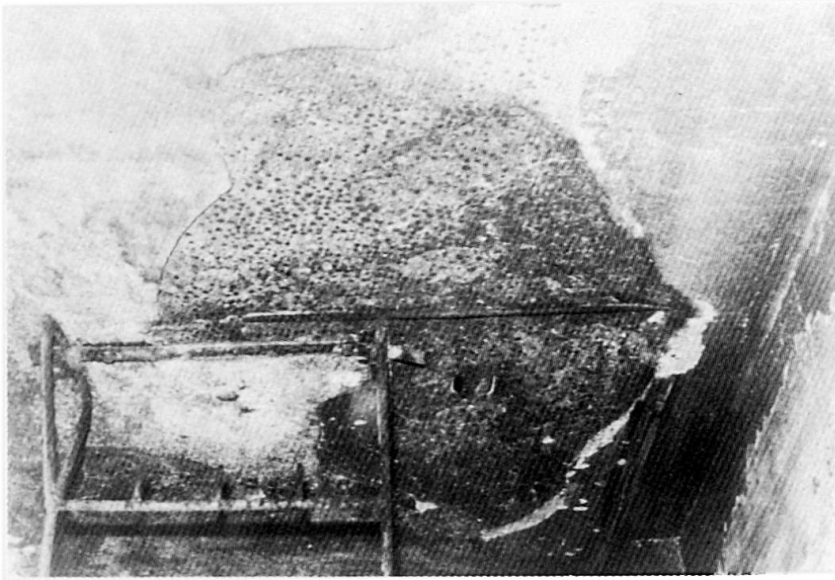
Fig.8

Spalling could scarcely be observed except at the under side of balcony slab of the upper story. The spalled part was about 80cm x 50cm, depth about 2cm, and its appearance was as same as that of test panels spalled in our experiment. This part has been attacked directly by the flame going out from the broken window, and the amount of free water in the slab should have been higher than in interior elements (fig. 8).

Spalling at the under side of balcony slab
