Zeitschrift: IABSE congress report = Rapport du congrès AIPC = IVBH
Kongressbericht

Artikel: Spalling of concrete in actual fire

Spalling of Concrete in Actual Fire

K. SHIRAYAMA

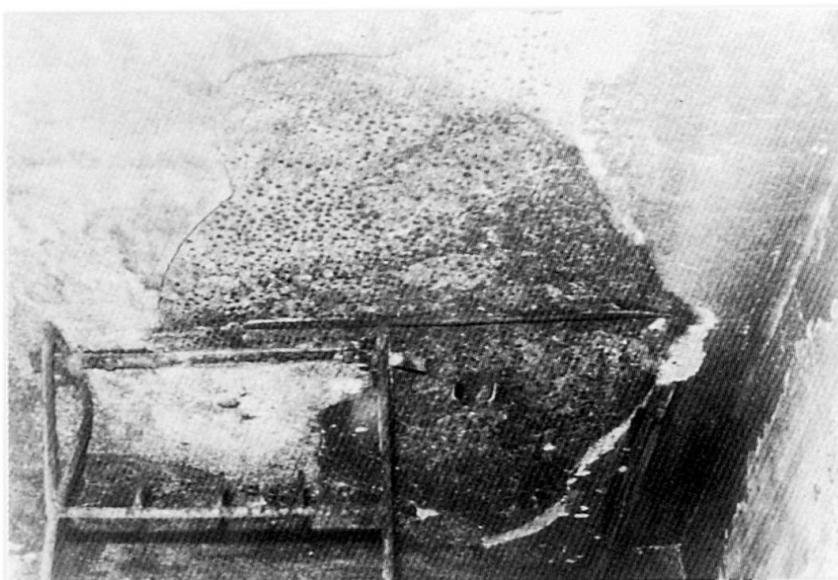
Spalling could scarcely be observed except at the under side of balcony slab of the upper story. The spalled part was about 80cm x 50cm, depth about 2cm, and its appearance was as same as that of test panels spalled in our experiment. This part has been attacked directly by the flame going out from the broken window, and the amount of free water in the slab should have been higher than in interior elements (fig. 8).

Fig.8
Spalling at the under side of balcony slab
