Zeitschrift: IABSE congress report = Rapport du congrès AIPC = IVBH
Kongressbericht

Artikel: Spalling of concrete in actual fire

Autor: Shirayama, K. / Tomosawa, F. / Kawase, K.

Spalling of Concrete in Actual Fire

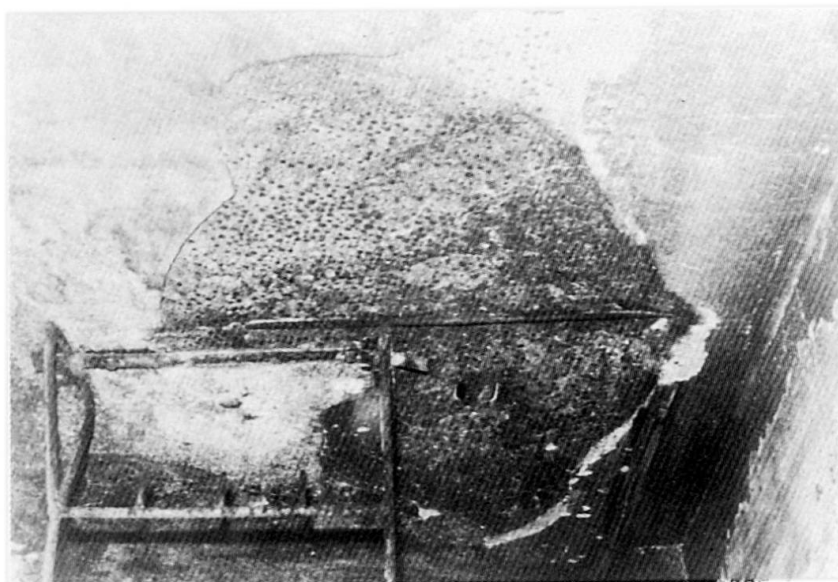
Fig.8

Spalling could scarcely be observed except at the under side of balcony slab of the upper story. The spalled part was about 80cm x 50cm, depth about 2cm, and its appearance was as same as that of test panels spalled in our experiment. This part has been attacked directly by the flame going out from the broken window, and the amount of free water in the slab should have been higher than in interior elements (fig. 8).

Spalling at the under side of balcony slab
