Rubrik: Theme Ic: Serviceability and maintenance

**The James River Bridge.
Rescue Campaign for a 7 Kilometer Crossing**

THOMAS R. KUESEL
Partner
Parsons Brinckerhoff Quade & Douglas
New York, N.Y. 10001, USA

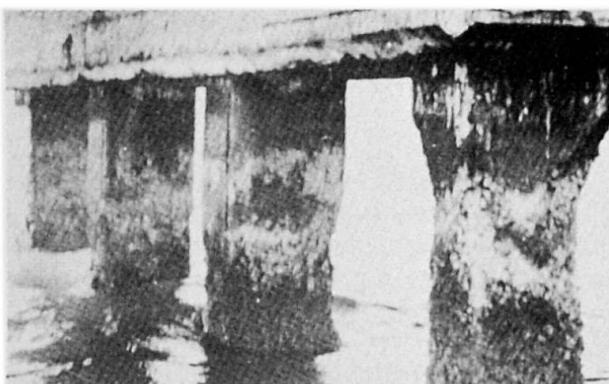
2. Necked pile caps damaged by age and salt water

By the 1960s the 6.7-m-wide roadway had become seriously obsolescent, particularly with no facilities for handling breakdowns anywhere in the 7-km bridge length. Beyond this, physical deterioration of the structure was accelerating alarmingly, primarily from exposure to a salt-laden marine environment. Figures 2 and 3 show typical conditions on the trestle spans. There was serious concern that the bridge might actually collapse, and its replacement became a priority project of the Virginia Department of Highways.

The critical deterioration of the old trestle structure was concentrated in the concrete within the tidal zone and on the undersides of the pile caps and roadway deck. In these areas salt penetration had caused extensive spalling and softening of concrete and exposure and rusting of reinforcing steel. Many of the concrete piles were necked down alarmingly (see Fig. 2). Two thousand five hundred piles were repaired (after chipping away all deteriorated concrete) by encasing them in cylindrical concrete jackets placed within gasketed water-tight cofferdam forms. Eroded concrete on the underside of the deck, and the side and bottom surfaces of the pile bent caps, which had been most exposed to salt spray, was also chipped away and repaired with pneumatically projected mortar.

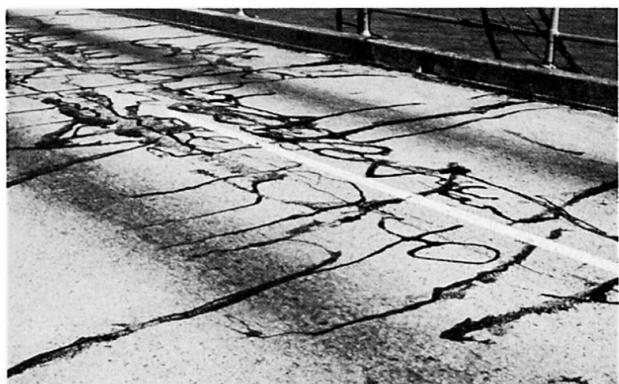
3. Deteriorated riding surface temporarily repaired with poured asphalt

Fortunately, the structural steel was in relatively good condition, and it was decided that it could be maintained for the required duration with minimal isolated reinforcement, plus maintenance painting. Systematic repairs were necessary for the concrete diaphragms joining the steel stringers at the ends of each span. Thirty percent of these diaphragms were cracked, and were reinforced with steel channels and brackets. The concrete deck surface was badly cracked, but it was decided to spend the available money on structural repair to the under-surface rather than cosmetic repair to the top surface. The cracks were, therefore, sealed with poured asphalt (see Fig. 3), and the crazy quilt patched riding surface served as a constant reminder that Phase 1 was a temporary program.

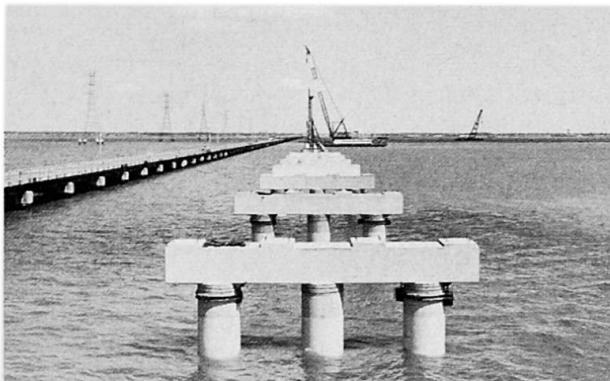
5. Newly installed piles and caps for replacement roadway

For the trestle foundations, precast, prestressed, cylindrical concrete piles were chosen. They have a diameter of 1.4 m and a wall thickness of 13 cm. Cast by a rotary centrifugal process, they have an exceptionally dense and smooth surface for resistance to salt water erosion. Over a 3-m height through the tidal zone they are further protected by an epoxy coating applied at the casting yard. The pile sections were precast in 5.2-m lengths, and joined by 16 prestressing cables to form individual piles up to 52 m long, weighing as much as 60 tons.

Three piles were connected by a precast, reinforced concrete cap to form a pile bent. The piles were filled with sand to furnish resistance against impact by small fishing vessels which abound in the area. A hollow void was left in the tops of the piles after they were cut off to a uniform elevation. The precast caps were fitted with three prongs of reinforcing steel that projected into the pile tops. After the caps were adjusted to grade and levelled, the voids were filled with concrete placed through vertical holes provided through the caps over each pile. The trestle substructure was thus established with a maximum proportion of dense, high quality concrete and a minimum of site labor and materials.

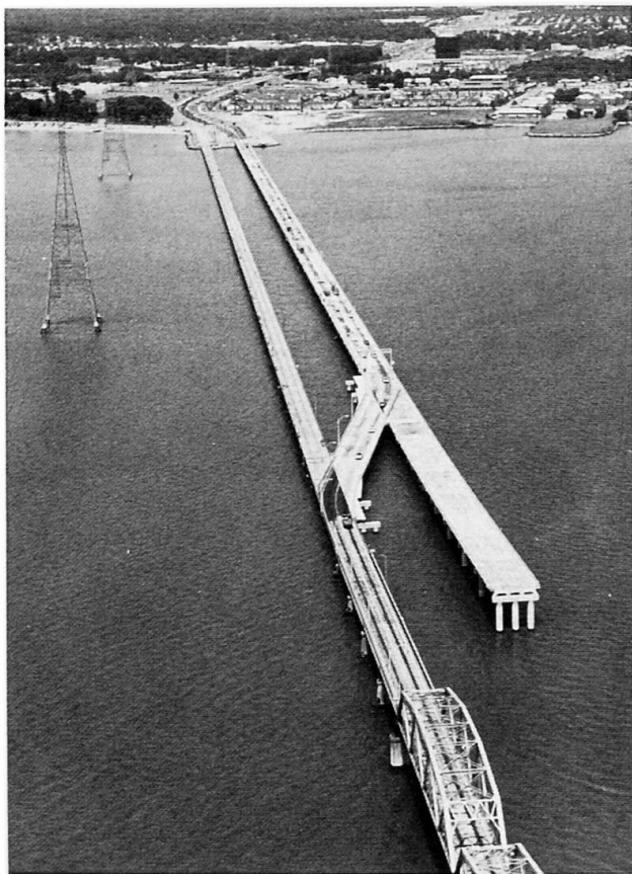
7. Old and new bridges shown during construction with crossover in operation

The 6.2-km new trestle structure was completed and joined to the old channel crossing by temporary crossover structures in September 1975, at a cost of approximately \$17 million, well within the available funds for Phase 2. This has permitted retiring the old trestle structure, and has eliminated 90 percent of the safety hazards of the crossing.
