**Artikel:** The James River Bridge: rescue campaign for a 7 kilometer crossing

**Autor:** Kuesel, Thomas R.

**The James River Bridge.  
Rescue Campaign for a 7 Kilometer Crossing**

Parsons Brinckerhoff Quade & Douglas  
New York, N.Y. 10001, USA

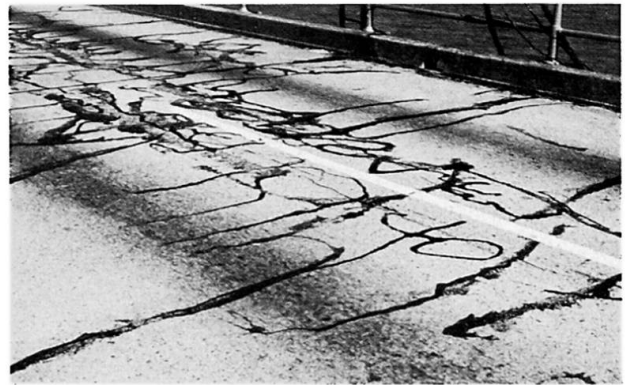
3. Deteriorated riding surface temporarily repaired with poured asphalt

By the 1960s the 6.7-m-wide roadway had become seriously obsolescent, particularly with no facilities for handling breakdowns anywhere in the 7-km bridge length. Beyond this, physical deterioration of the structure was accelerating alarmingly, primarily from exposure to a salt-laden marine environment. Figures 2 and 3 show typical conditions on the trestle spans. There was serious concern that the bridge might actually collapse, and its replacement became a priority project of the Virginia Department of Highways.

Fortunately, the structural steel was in relatively good condition, and it was decided that it could be maintained for the required duration with minimal isolated reinforcement, plus maintenance painting. Systematic repairs were necessary for the concrete diaphragms joining the steel stringers at the ends of each span. Thirty percent of these diaphragms were cracked, and were reinforced with steel channels and brackets. The concrete deck surface was badly cracked, but it was decided to spend the available money on structural repair to the under-surface rather than cosmetic repair to the top surface. The cracks were, therefore, sealed with poured asphalt (see Fig. 3), and the crazy quilt patched riding surface served as a constant reminder that Phase 1 was a temporary program.

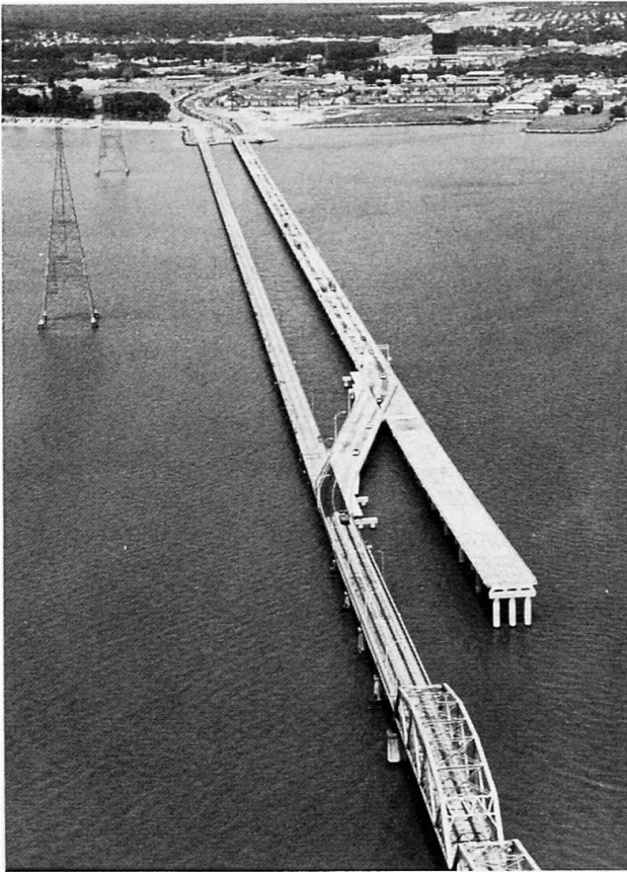
7. Old and new bridges shown during construction with crossover in operation

The 6.2-km new trestle structure was completed and joined to the old channel crossing by temporary crossover structures in September 1975, at a cost of approximately \$17 million, well within the available funds for Phase 2. This has permitted retiring the old trestle structure, and has eliminated 90 percent of the safety hazards of the crossing.
