Installing prestressing tendons in arduous conditions

**V****Installing Prestressing Tendons in Arduous Conditions**

G.R. SIDES
Ph.D. F.I.C.E.
Simonbuild Ltd.
Stockport, England

Prestressing operations require care and expertise even in the best working conditions. This article describes such activities afloat, 24 hours a day, in the winter months and in conjunction with slipforming operations during the construction of the 67 m high towers of the Cormorant 'A' oil production platform.

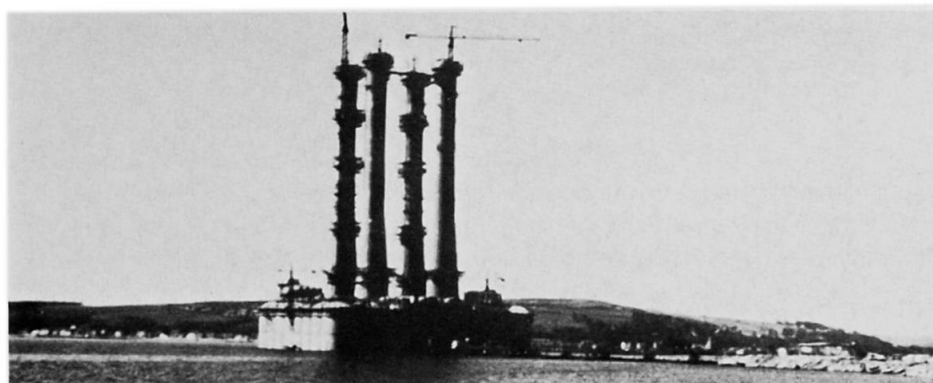
Fig. 1 The Cormorant 'A' Oil Production Platform.

The Main Contract was for the construction by Sir Robert McAlpine & Sons Ltd., and Sea Tank Company of Paris of the North Sea oil production platform Cormorant 'A' for Shell Esso, fig. 1. The Main Contract programme required that the platform was completed and delivered to suit the North Sea weather window, i. e. a limited period in the summer months. Failure to meet this "window" would mean that oil production from the Cormorant 'A' platform would be delayed by 12 months, which possibility was unthinkable.

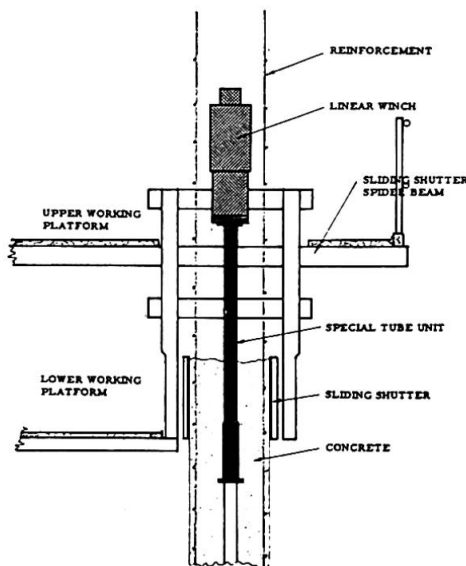
Fig. 4 Tendon lifting arrangements

The method to avoid these problems whilst allowing the installation of the prestressing tendons during the slipforming process involved fastening an "upper tube unit", fig. 4, onto the top of the ducting at each tendon installation level. This unit was 3m long and incorporated :-

- a conventional end anchor plate at the top end
- a smaller bearing plate at the bottom end to distribute the stresses applied, during the installation of the tendon, to the relatively young concrete of the tower.

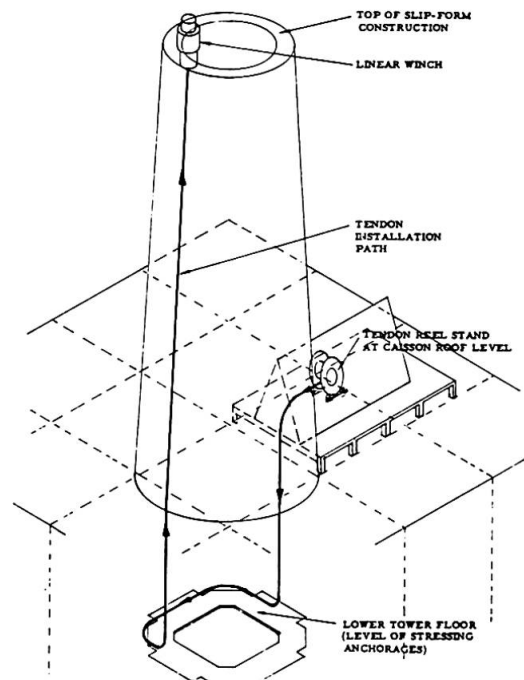
Fig. 5 Tendon installation route

The tendon was installed along a tortuous route extending from the platform deck to the slipform platform as shown in fig. 5, by fixing a lifting device (a linear winch) to the top plate when the concrete had been placed to within 0.5m of the upper plate. At this stage the lower plate was 2.5m into the concrete and was bearing on concrete which had achieved sufficient strength to withstand the loads transmitted through the tube unit from the lifting device. When the tendon had been lifted to the correct distance above the top plate of the tube unit, chocks were positioned between the tube unit upper plate and the underside of the tendon fixed anchorage. The lifting device was then removed and the slipforming proceeded, without delay, past and covering the completed fixed end anchorage, fig. 6.
