**Artikel:** Installing prestressing tendons in arduous conditions

# **Installing Prestressing Tendons in Arduous Conditions**

G.R. SIDES Ph.D. F.I.C.E. Simonbuild Ltd. Stockport, England H.R. MÜLLER dipl. Ing. ETH Stahlton AG Zürich, Switzerland

Prestressing operations require care and expertise even in the best working conditions. This article describes such activities afloat, 24 hours a day, in the winter months and in conjunction with slipforming operations during the construction of the 67 m high towers of the Cormorant 'A' oil production platform.

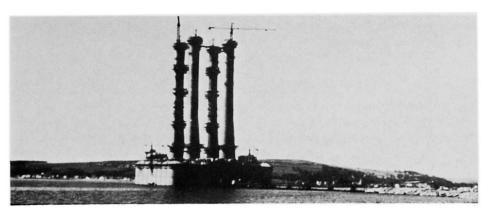
Fig. 1 The Cormorant 'A' Oil Production Platform.

The Main Contract was for the construction by Sir Robert McAlpine & Sons Ltd., and Sea Tank Company of Paris of the North Sea oil production platform Cormorant 'A' for Shell Esso, fig. 1. The Main Contract programme required that the platform was completed and delivered to suit the North Sea weather window, i.e. a limited period in the summer months. Failure to meet this "window" would mean that oil production from the Cormorant 'A' platform would be delayed by 12 months, which possibility was unthinkable.

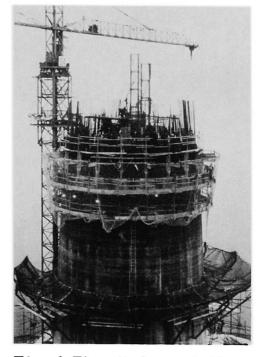
Fig. 3 The slipform platform

The load applied to the slipforming platform during tendon installation was to be kept to a minimum as increased loads would require extra lifting equipment which would cause congestion in an already limited area, fig. 3. It is also important in slipforming to avoid eccentric loads. Thus to lift tendons weighing up to 1.5 tonnes from different points around the slipforming platform would cause unacceptable slipforming conditions.

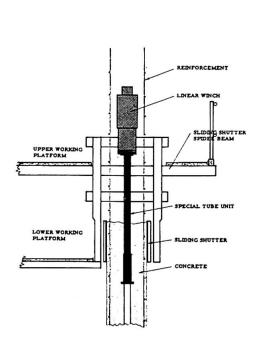
Fig. 4 Tendon lifting arrangements

The method to avoid these problems whilst allowing the installation of the prestressing tendons during the slipforming process involved fastening an "upper tube unit", fig. 4, onto the top of the ducting at each tendon installation level. This unit was 3m long and incorporated:-

- a conventional end anchor plate at the top end
- a smaller bearing plate at the bottom end to distribute the stresses applied, during the installation of the tendon, to the relatively young concrete of the tower.

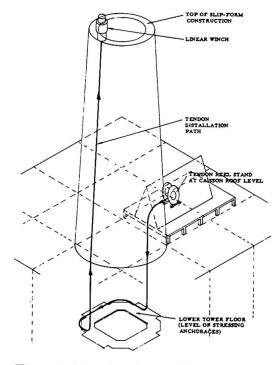
Fig. 5 Tendon installation route

The tendon was installed along a tortuous route extending from the platform deck to the slipform platform as shown in fig. 5, by fixing a lifting device (a linear winch) to the top plate when the concrete had been placed to within 0.5m of the upper plate. At this stage the lower plate was 2.5m into the concrete and was bearing on concrete which had achieved sufficient strength to withstand the loads transmitted through the tube unit from the lifting device. When the tendon had been lifted to the correct distance above the top plate of the tube unit, chocks were positioned between the tube unit upper plate and the underside of the tendon fixed anchorage. The lifting device was then removed and the slipforming proceeded, without delay, past and covering the completed fixed end anchorage, fig. 6.
