Artikel: Installing prestressing tendons in arduous conditions

Autor: Sides, G.R. / Müller, H.R.

**V****Installing Prestressing Tendons in Arduous Conditions**

Prestressing operations require care and expertise even in the best working conditions. This article describes such activities afloat, 24 hours a day, in the winter months and in conjunction with slipforming operations during the construction of the 67 m high towers of the Cormorant 'A' oil production platform.

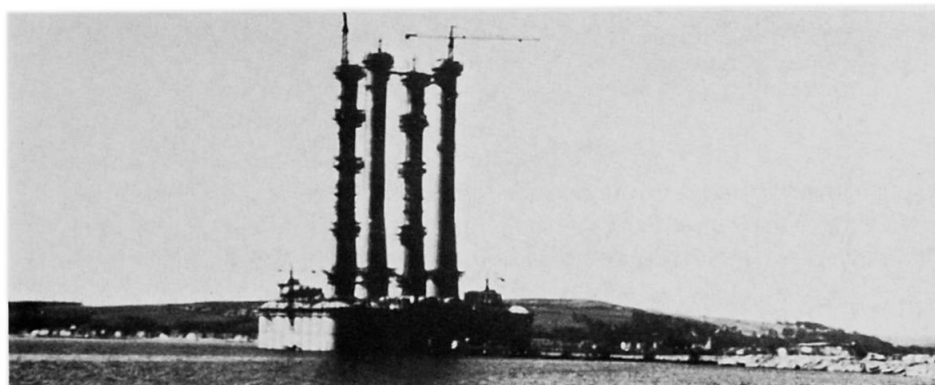
Fig. 1 The Cormorant 'A' Oil Production Platform.

The Main Contract was for the construction by Sir Robert McAlpine & Sons Ltd., and Sea Tank Company of Paris of the North Sea oil production platform Cormorant 'A' for Shell Esso, fig. 1. The Main Contract programme required that the platform was completed and delivered to suit the North Sea weather window, i.e. a limited period in the summer months. Failure to meet this "window" would mean that oil production from the Cormorant 'A' platform would be delayed by 12 months, which possibility was unthinkable.

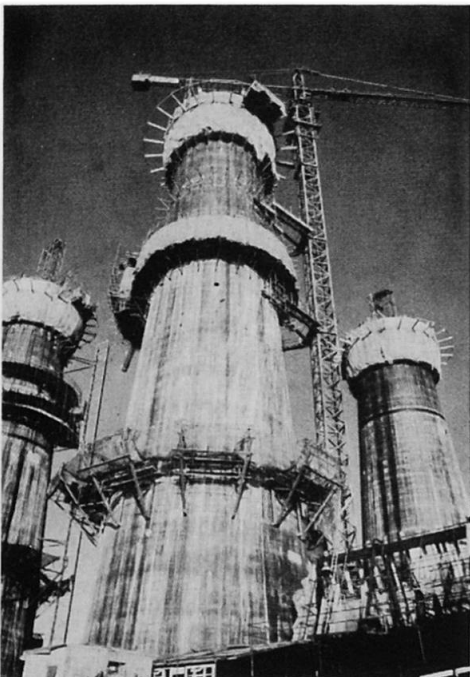
Fig. 2 Slipforming the 67m high towers.

The Sub-contract was to install the prestressing tendons in each of the four 67m high towers whilst the towers were being constructed by the slipforming process, fig. 2. These Sub-contract works were completed by BBRV Marine which is a joint venture of the BBRV Licensees in Scandinavia (A/S Strangbetong), Switzerland (Stahlton AG) and the United Kingdom (Simonbuild Ltd).

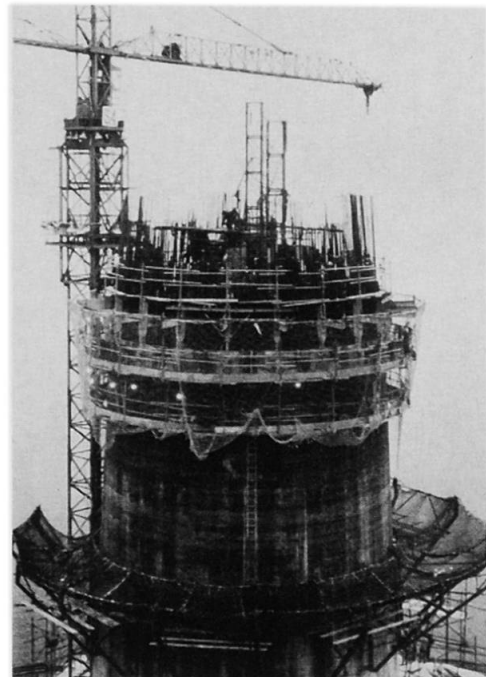
Fig. 3 The slipform platform

The load applied to the slipforming platform during tendon installation was to be kept to a minimum as increased loads would require extra lifting equipment which would cause congestion in an already limited area, fig. 3. It is also important in slipforming to avoid eccentric loads. Thus to lift tendons weighing up to 1.5 tonnes from different points around the slipforming platform would cause unacceptable slipforming conditions.

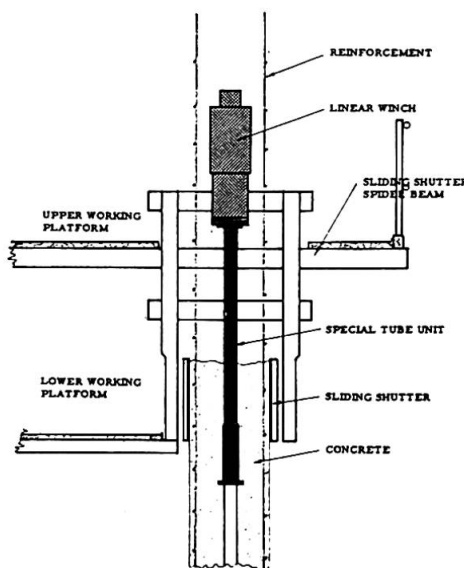
Fig. 4 Tendon lifting arrangements

The method to avoid these problems whilst allowing the installation of the prestressing tendons during the slipforming process involved fastening an "upper tube unit", fig. 4, onto the top of the ducting at each tendon installation level. This unit was 3m long and incorporated :-

- a conventional end anchor plate at the top end
- a smaller bearing plate at the bottom end to distribute the stresses applied, during the installation of the tendon, to the relatively young concrete of the tower.

The tendon was installed along a tortuous route extending from the platform deck to the slipform platform as shown in fig. 5, by fixing a lifting device (a linear winch) to the top plate when the concrete had been placed to within 0.5m of the upper plate. At this stage the lower plate was 2.5m into the concrete and was bearing on concrete which had achieved sufficient strength to withstand the loads transmitted through the tube unit from the lifting device. When the tendon had been lifted to the correct distance above the top plate of the tube unit, chocks were positioned between the tube unit upper plate and the underside of the tendon fixed anchorage. The lifting device was then removed and the slipforming proceeded, without delay, past and covering the completed fixed end anchorage, fig. 6.
