## Installing Prestressing Tendons in Arduous Conditions

**G.R. SIDES**  
Ph.D. F.I.C.E.  
Simonbuild Ltd.  
Stockport, England

**H.R. MÜLLER**  
dipl. Ing. ETH  
Stahlton AG  
Zürich, Switzerland

Prestressing operations require care and expertise even in the best working conditions. This article describes such activities afloat, 24 hours a day, in the winter months and in conjunction with slipforming operations during the construction of the 67 m high towers of the Cormorant 'A' oil production platform.

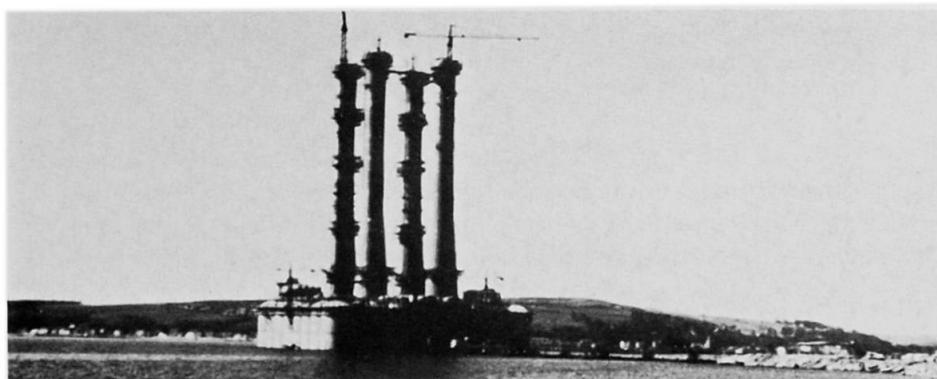
Fig. 1 The Cormorant 'A' Oil Production Platform.

The Main Contract was for the construction by Sir Robert McAlpine & Sons Ltd., and Sea Tank Company of Paris of the North Sea oil production platform Cormorant 'A' for Shell Esso, fig. 1. The Main Contract programme required that the platform was completed and delivered to suit the North Sea weather window, i.e. a limited period in the summer months. Failure to meet this "window" would mean that oil production from the Cormorant 'A' platform would be delayed by 12 months, which possibility was unthinkable.

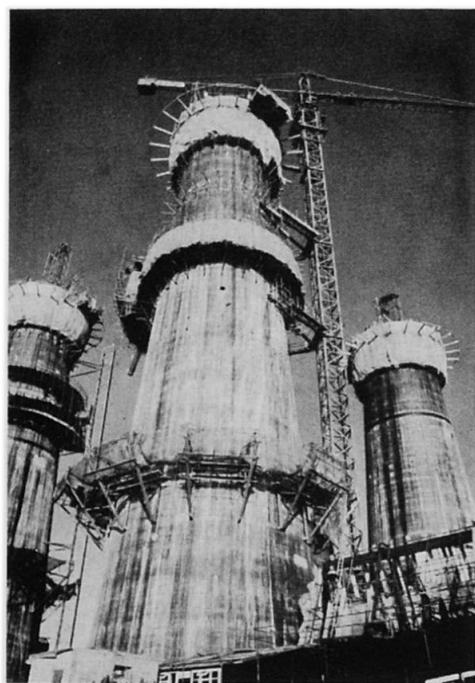
Fig. 2 Slipforming the 67m high towers.

The Sub-contract was to install the prestressing tendons in each of the four 67m high towers whilst the towers were being constructed by the slipforming process, fig. 2. These Sub-contract works were completed by BBRV Marine which is a joint venture of the BBRV Licensees in Scandinavia (A/S Strangbetong), Switzerland (Stahlton AG) and the United Kingdom (Simonbuild Ltd.).

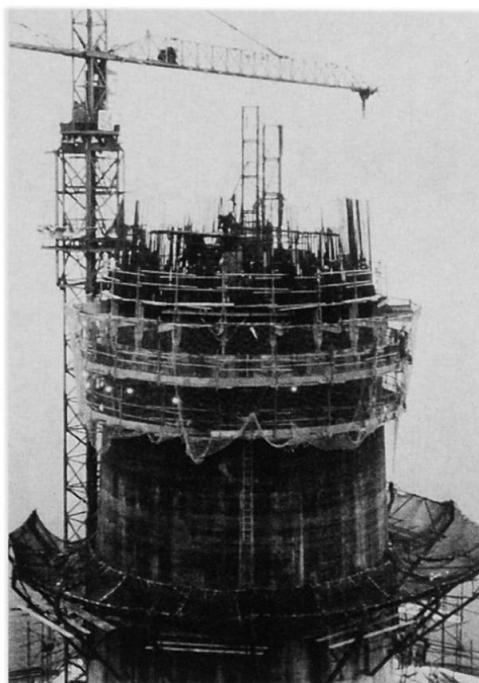
Fig. 3 The slipform platform

The load applied to the slipforming platform during tendon installation was to be kept to a minimum as increased loads would require extra lifting equipment which would cause congestion in an already limited area, fig. 3. It is also important in slipforming to avoid eccentric loads. Thus to lift tendons weighing up to 1.5 tonnes from different points around the slipforming platform would cause unacceptable slipforming conditions.

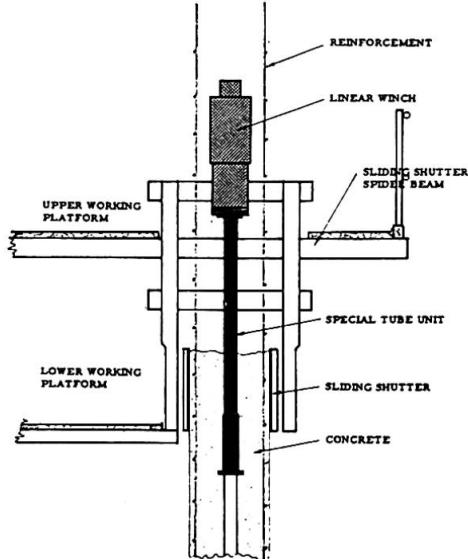
Fig. 4 Tendon lifting arrangements

The method to avoid these problems whilst allowing the installation of the prestressing tendons during the slipforming process involved fastening an "upper tube unit", fig. 4, onto the top of the ducting at each tendon installation level. This unit was 3m long and incorporated :-

- a conventional end anchor plate at the top end
- a smaller bearing plate at the bottom end to distribute the stresses applied, during the installation of the tendon, to the relatively young concrete of the tower.

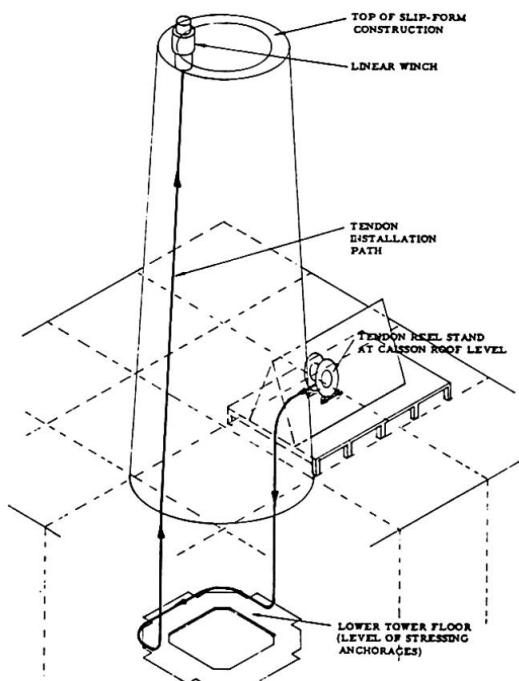
Fig. 5 Tendon installation route

The tendon was installed along a tortuous route extending from the platform deck to the slipform platform as shown in fig. 5, by fixing a lifting device (a linear winch) to the top plate when the concrete had been placed to within 0.5m of the upper plate. At this stage the lower plate was 2.5m into the concrete and was bearing on concrete which had achieved sufficient strength to withstand the loads transmitted through the tube unit from the lifting device. When the tendon had been lifted to the correct distance above the top plate of the tube unit, chocks were positioned between the tube unit upper plate and the underside of the tendon fixed anchorage. The lifting device was then removed and the slipforming proceeded, without delay, past and covering the completed fixed end anchorage, fig. 6.

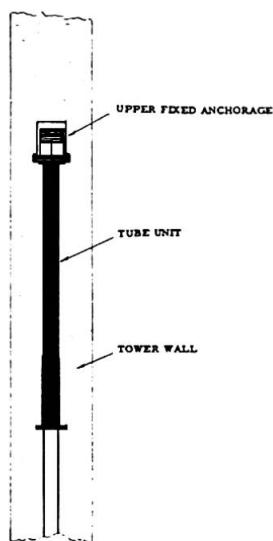
Fig. 6 Tendon fixed anchorage after passage of slipform
