Zeitschrift: IABSE congress report = Rapport du congrès AIPC = IVBH
Kongressbericht

Artikel: Nail-plates as shear connectors in composite timber and concrete
structures

Autor: Girhammar, Ulf Arne

Nail-Plates as Shear Connectors in Composite Timber and Concrete Structures

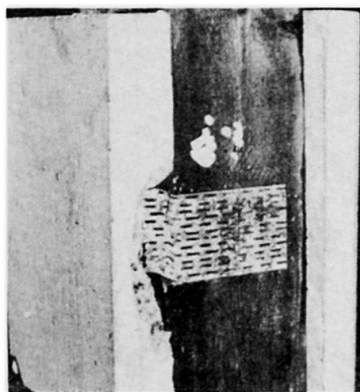
Fig. 16.5 Final failure by cracking of concrete edge for no. 5

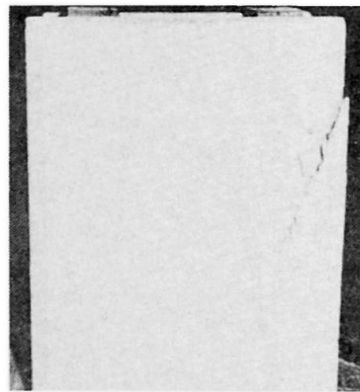
Fig. 16.6 Final failure in shear/cracking of concrete, no. 6
