Zeitschrift: IABSE congress report = Rapport du congrès AIPC = IVBH
Kongressbericht

Band: 13 (1988)

DAILY THEME C

Inspection, Assessment and Maintenance

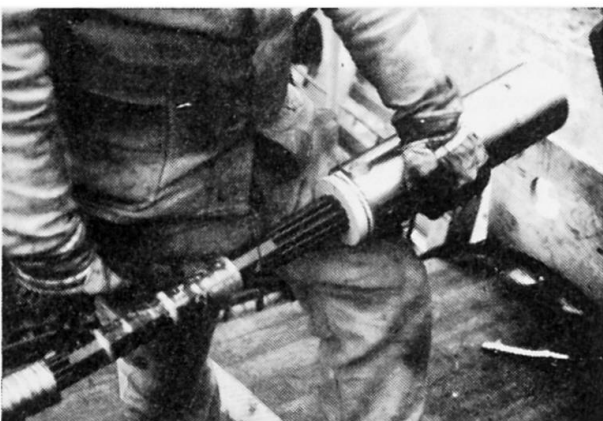
Abb. 6: HLV-Spannglied mit 19 Stäben

Die daraus hergestellten Spannglieder bestehen aus 19 Glasfaserstäben (HLV-Stäbe) mit einem Nenndurchmesser von 7,5 mm und haben eine Gebrauchslast von 660 kN (Abb. 6). Der Querschnitt eines einzelnen Glasfaserstabes enthält ca. 68 % Glasfasern und 32 % ungesättigte Polyesterharze bzw. Epoxidharze. Die Längszugfestigkeit des Werkstoffes von 1670 N/mm² ist Folge des hohen Glasfaseranteiles mit strenger unidirektionaler Orientierung (Abb. 7). Die bei der Herstellung in die einzelnen Glasfaserstäbe integrierten Lichtwellenleiter ermöglichen infolge einer besonderen Präparation den Einblick in das Spannungsdehnungsverhalten des damit vorgespannten Bauteils. Die Lichtwellenleiter wirken als Dehnungssensoren und lassen Rückschlüsse auf Veränderungen des Spannungszustandes und deren Lokalisierung zu. Durch die integrierten Sensoren werden vorgespannte Konstruktionen kontrollierbar, man kann von sogenannten "intelligenten Tragstrukturen" sprechen. Die Arbeiten hierzu werden auch über ein Forschungs- und Entwicklungsvorhaben der EG (BRITE Projekt 1353) gefördert.

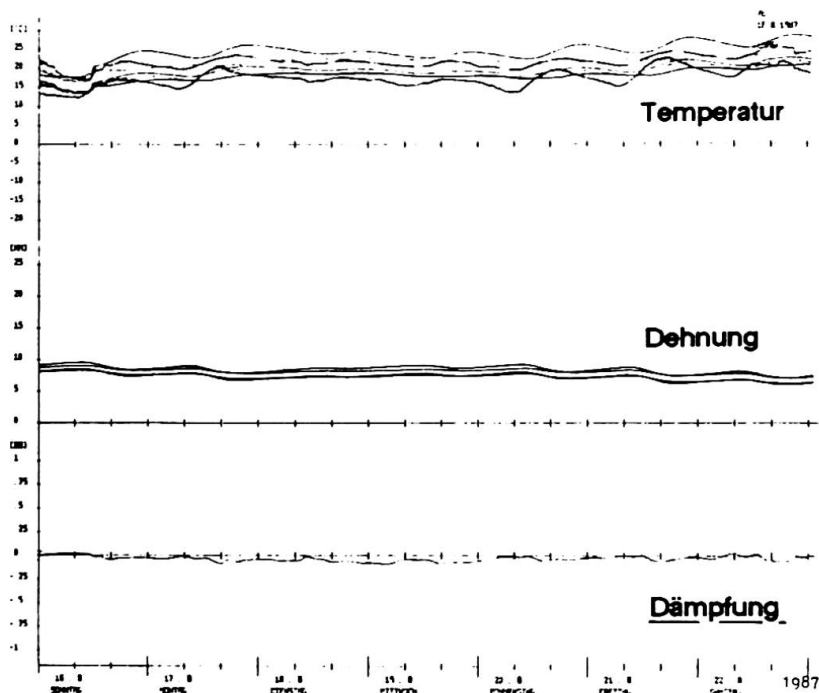
Das Ergebnis zeigt Abb. 10 als Beispiel für den Zeitraum von einer Woche im August 1987. Mit der Sensordämpfung werden hierin verglichen die im Brückeninneren laufend gemessenen Temperaturen sowie die an den Brückenköpfen gemessenen Dehnungen der Brücke. Aus den Aufzeichnungen wird erkennbar, daß sich der Temperaturgang auf die Dehnung der Brücke und damit auf den Dämpfungs-

verlauf des Sensors auswirkt. Das heißt, daß der LWL-Dehnungs-Sensor die Dehnung der Brücke ordnungsgemäß wiedergibt. Der Dämpfungsverlauf läßt dabei keine Unstetigkeiten erkennen. Das ist ein Hinweis dafür, daß im Beobachtungszeitraum praktisch keine Risse im Beton entstanden sein können. Diese Feststellung gilt für den gesamten bisherigen Beobachtungszeitraum von mehr als einem Jahr. Die Sensor-überwachung an der Brücke Ulenbergstrasse, Düsseldorf, bestätigt somit ein unter den genannten Gesichtspunkten bewertetes völlig normales Verhalten dieses Bauwerkes.

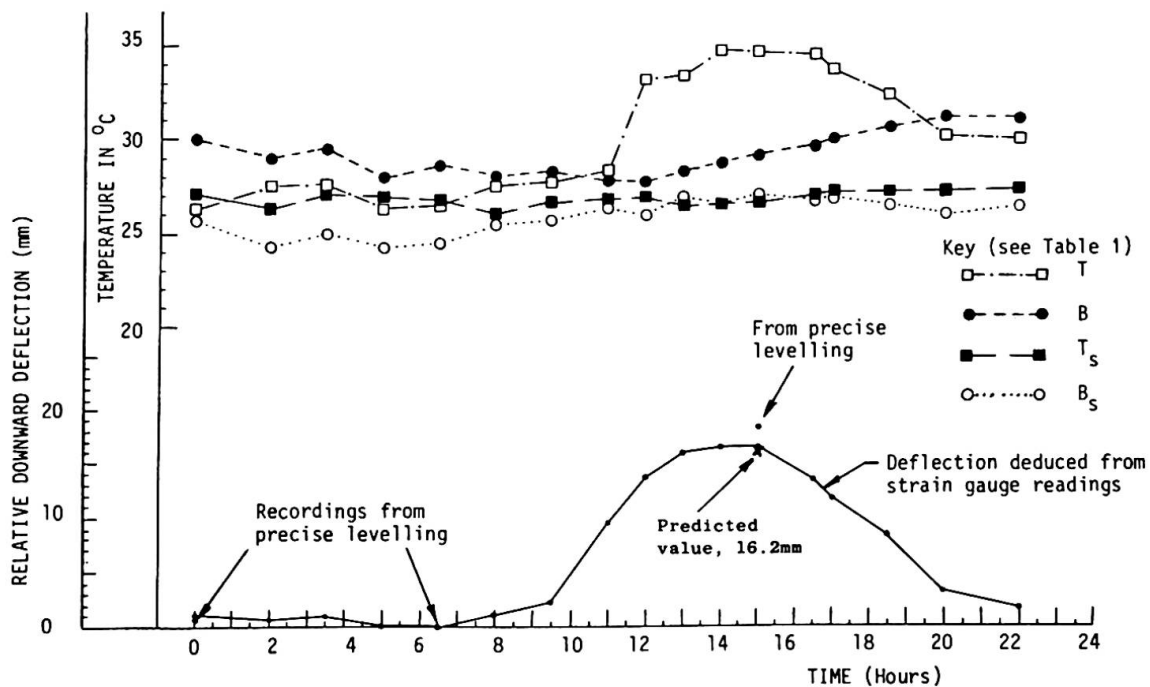
FIGURE 1. Temperature and cantilever tip deflection records during 24hr period on 11/11/84

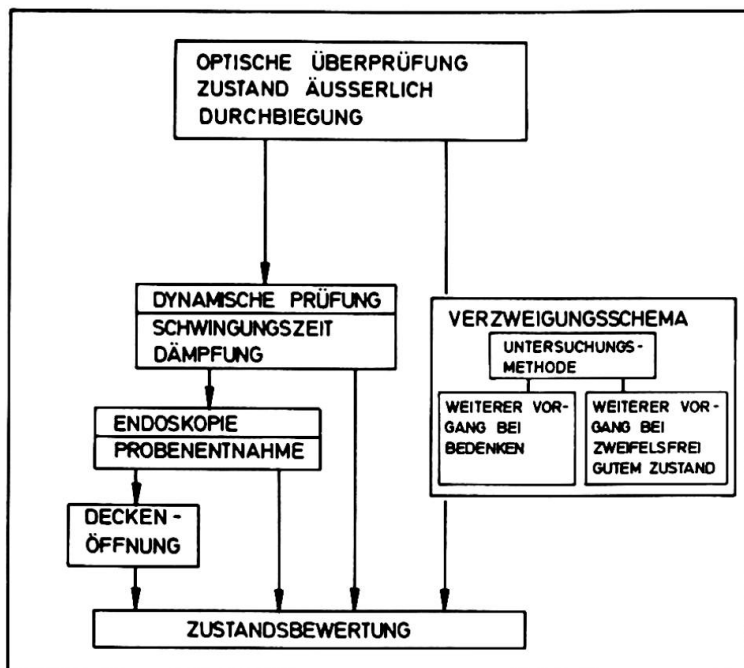
Fig.7 Ablaufschema für die Untersuchung von hölzernen Deckentragwerken

Aufgrund der zuvor skizzierten Untersuchungsmethoden wurde ein einfaches Ablaufschema für die Untersuchung hölzerner Deckenkonstruktionen entwickelt, das eine rasche Entscheidung über den Deckenzustand bei möglichst geringen Eingriffen in die Konstruktionen (besonders wichtig bei bewohnten Objekten) und bei niedrigem Kostenaufwand erlaubt.

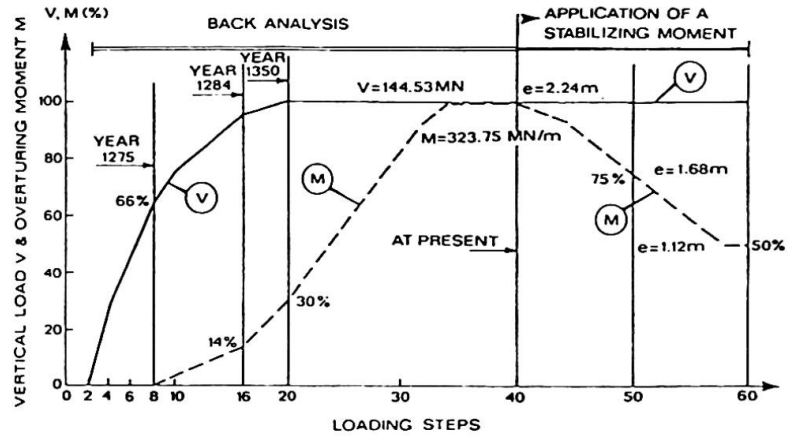
Fig. 8 Loading history of Pisa Tower

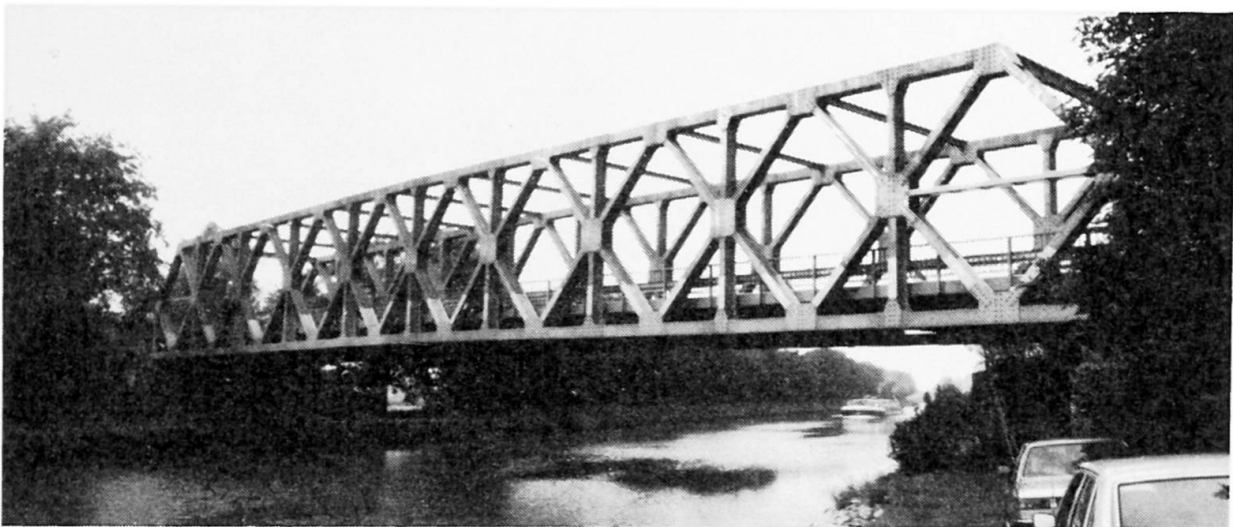
Fig. 1 Untersuchte genietete Fachwerk-Straßenbrücke
