## Dynamic Response and Subsequent Retrofit of a Tied-Arch Bridge

### SUMMARY

Two tied-arch spans across the Ohio River are experiencing excessive vertical dynamic displacement under normal traffic. The distortion, in addition to being intolerable due to public reaction, has resulted in fatigue cracking of the welded-floorbeam webs. The problem was studied through a combination of field studies and finite element modelling. These investigations suggest that the distortion problem can be solved through the addition of a longitudinal stiffening truss near the roadway level, and bolted connections spanning existing web gaps.

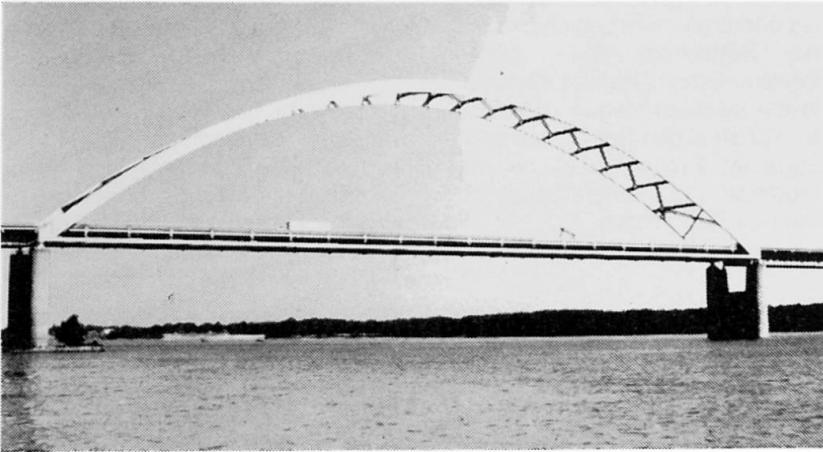
Figure 1 - View of 223 m tied-arch span.
