Stability of a stone arch bridge against flood pressure and its preservation

Zeitschrift: **IABSE congress report = Rapport du congrès AIPC = IVBH
Kongressbericht**

Band (Jahr): **13 (1988)**

Stability of a Stone Arch Bridge against Flood Pressure and its Preservation

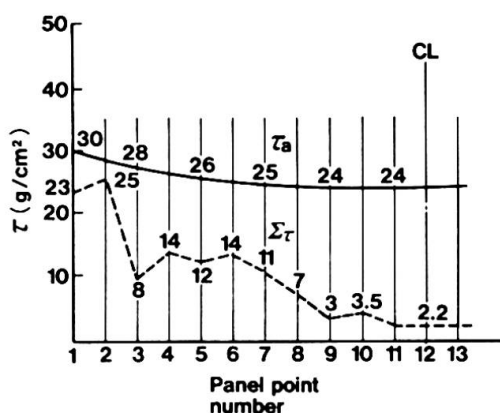
Fig. 3 Results of stability calculation with experimental values

Bridge stability against shearing stress τ_1 generated by torque τ_2 due to the in-plane arch action and the shearing stress τ_3 due to the out-of-plane arch action, can be maintained by frictional stress due to the arch thrust.

The allowable shearing stress due to the friction is denoted by τ_a .

When the resultant stress of τ_1 , τ_2 , and τ_3 becomes larger than τ_a the stability of sealing material between arch stones is lost so that they may start rotating or slipping, and finally the bridge will collapse. Fig.3 shows the calculated results, proving that the stability was maintained in the model arch.
