Zeitschrift: IABSE congress report = Rapport du congrès AIPC = IVBH
Kongressbericht

Band: 13 (1988)

Rubrik: II. Management and techniques of renovation

Management and Techniques of Renovation

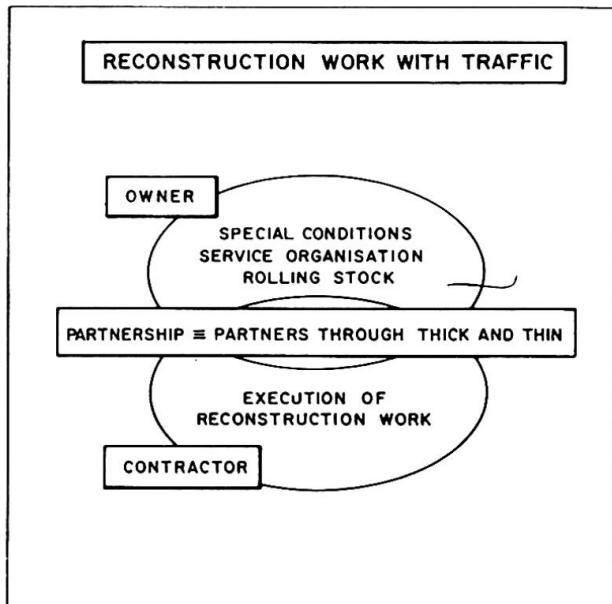
fig. 4

On the other hand, if the work must be carried out while partial or full rail services are kept running, the problems become extremely complex (see fig. 4). Rehabilitation under traffic conditions necessitates close cooperation between the owner and the contractor for the period of the reconstruction work. They share a common task through thick and thin.

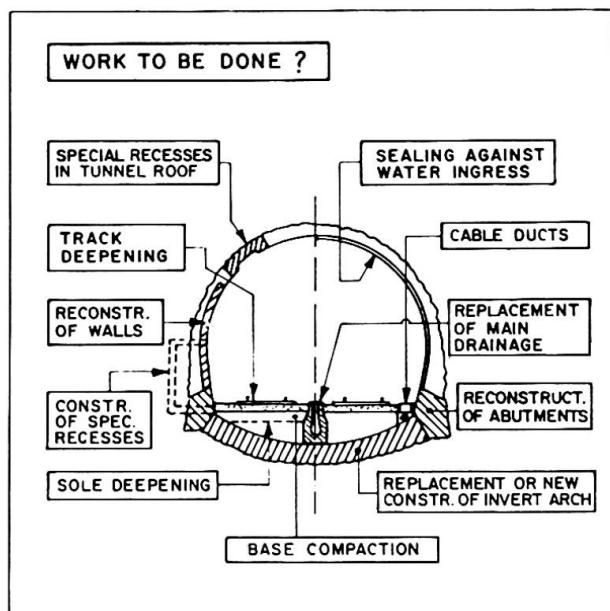
fig. 8

MAIN POINTS IN THE EXECUTION		EXCAVATION	FOUND. LAYER	ROOF BOLTS/MESH	SHOTCRETE	FORMW./REINF./CONCRETE	PREF. ELEMENTS
SOLE ADJUSTMENT	•	•					
ABUTMENT	•		(•)	(•)	•		
INVERT ARCH	•					•	
RECESSES IN WALL	•		•	•	•		
RECESSES IN ROOF	•		•	•			
ROOF SEALING				•	•		
DRAINAGE	•				•	•	
DUCTS	•				•	•	
WALL RECONSTR.	•		(•)	(•)	•		
PROFIL ADJUSTMENTS	•		(•)	(•)

We now turn the question of what kinds of technical problems face the contractor and how he should go about the construction work. Depending on the condition and age of the tunnel widely varying rehabilitation work has to be carried out (see fig. 8,9). The geology and groundwater conditions are important contributory factors in relation to the nature and extent of the damage.

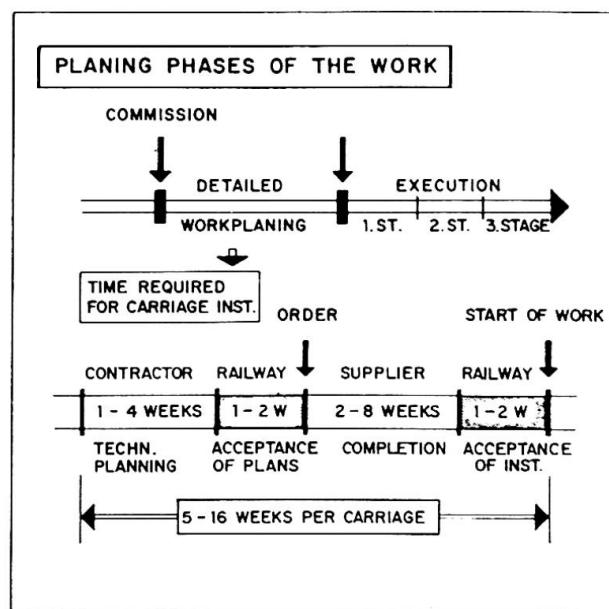
fig. 10

Consequently sufficient time must be allowed between the awarding of the contract and the start of construction (see fig. 10). Further, it must be taken into account that all equipment and installations mounted on rolling stock have to be approved by special railway departments and have to be removed afterwards.

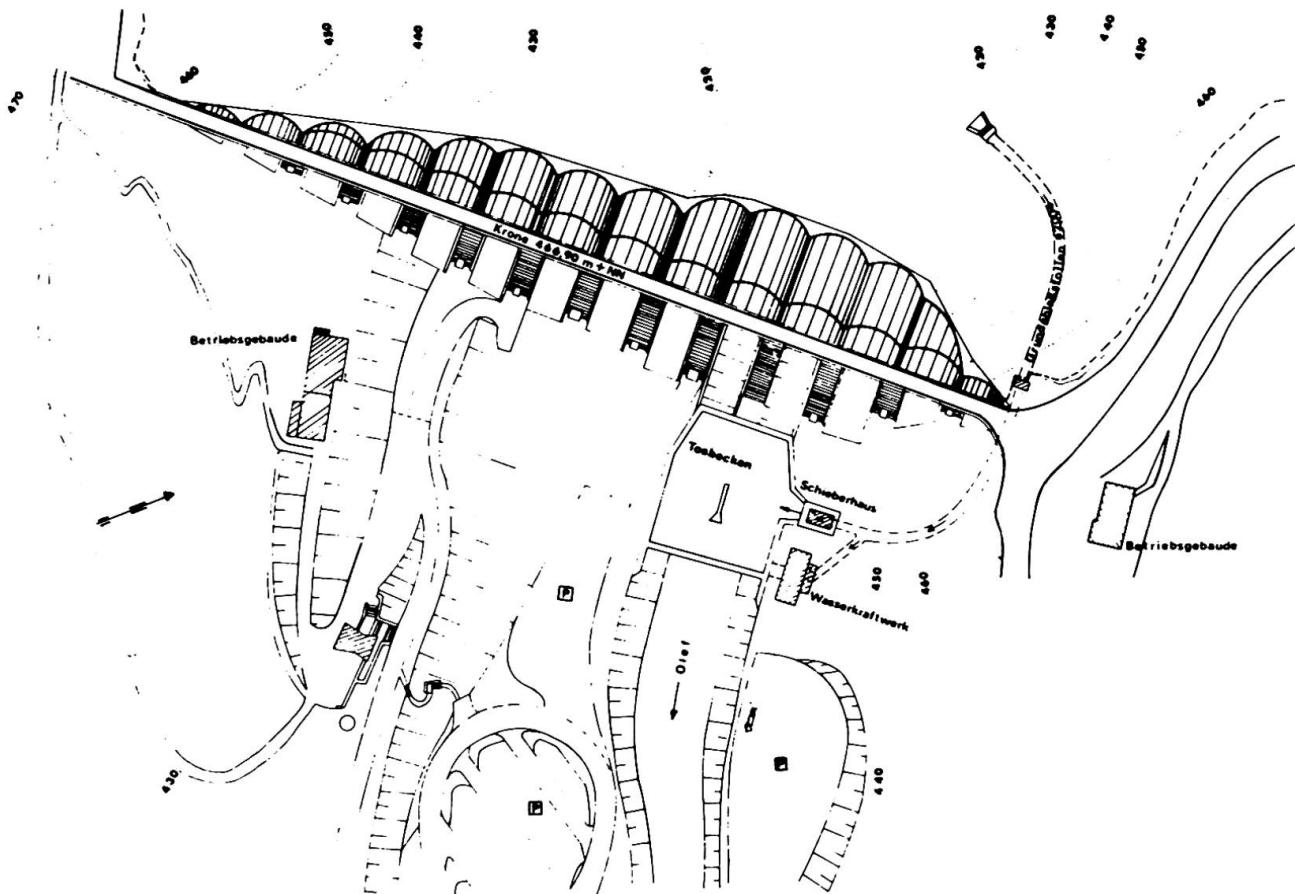
Fig. 1 Lageplan

In den Jahren 1955 - 59 wurde bei Hellenthal in der Nordeifel die Olefstaumauer errichtet. Sie besteht aus 14 Hohlpfeilern, die als eigenständige Tragglieder mit jeweils 2 cm breiten, abgedichteten Fugen konzipiert sind. Die Gesamtlänge der Staumauer beträgt 282 m, die Kronenbreite 5,70 m und die größte Höhe ca. 59 m über der Gründungssohle. Der Stauinhalt von 20 hm³ dient vornehmlich der Trink- und Brauchwasserversorgung, aber auch dem Hochwasserschutz, der Niedrigwasseraufhöhung und der Energieerzeugung (Fig. 1).

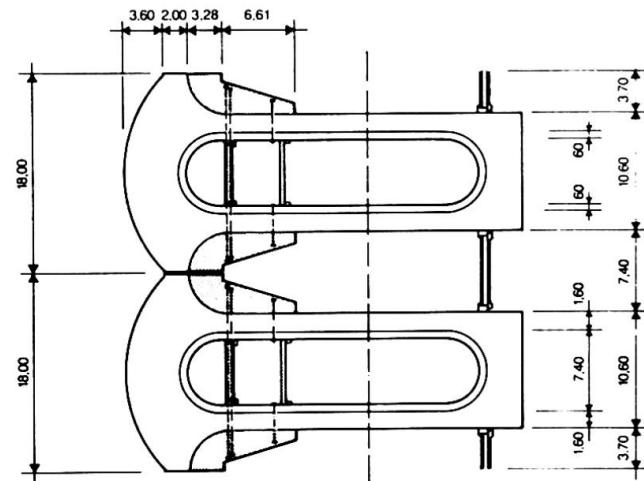
Fig. 3 Horizontalschnitt im unteren Ertüchtigungsbereich.

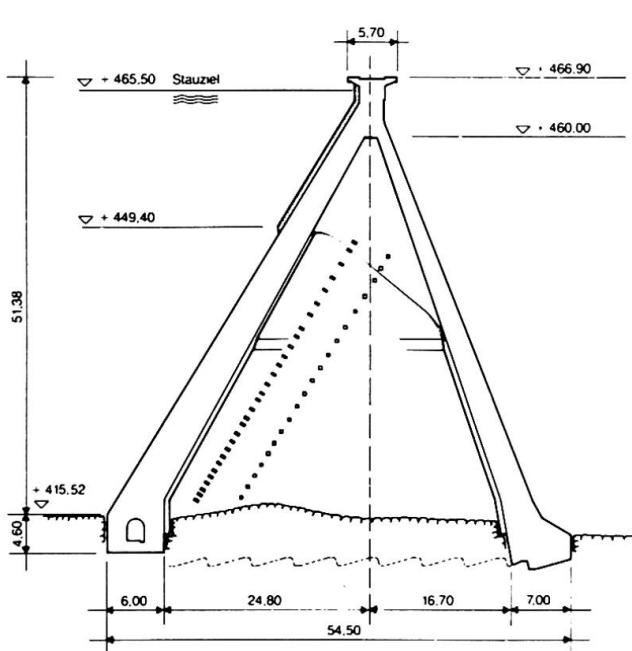
Fig. 4 Querschnitt durch die Hohlzelle mit den Zug- und Druckbalken.

Die luftseitige Kragarmunterstützung erreichte beim höchsten Pfeiler etwa 2/3 der Gesamthöhe (ca. 40 m). Sie besteht aus den beiden symmetrischen Abstützbalken von rechts und von links (Fig. 3). Damit die äußere (außermittige) Last aus den Kragarmen an die Pfeilerscheiben abgegeben werden kann, mußten Zug- und Druckglieder im Pfeilerhohlraum angeordnet werden (Fig. 4 und 5), um Biegespannungen in den alten Pfeilerscheiben auszuschließen.

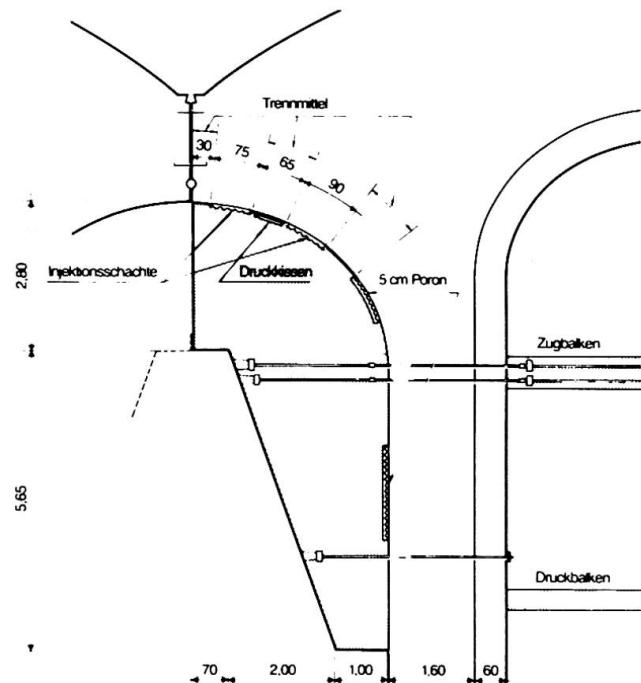
Fig. 5 Abstützbalken und Verankerungen auf der Luftseite.

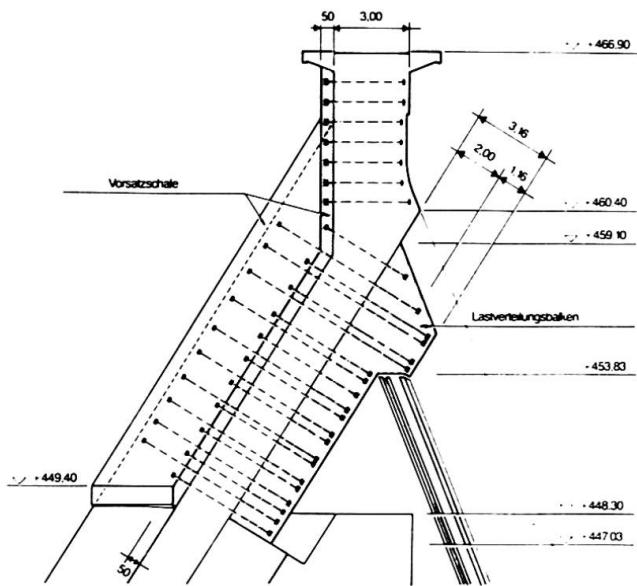
Fig. 6 Obere Verstärkungen.

Die wasserseitige Ertüchtigungskonstruktion besteht aus einer 50 cm dicken, schlaff bewehrten Stahlbetonschale mit Verankerung im Altbeton (Fig. 6 und 7). Hierfür war auf der Luftseite hinter den Kragarmen ein Lastverteilungsbalken erforderlich. Zur Herstellung des Haftverbundes wurde der Altbeton gesandstrahlt und bereits bei einer Betonfestigkeit von 12 N/mm^2 eine Teilverspannung aufgebracht. Die Bewehrung des Vorsatzbetons hat die Risse auf 0,1 mm

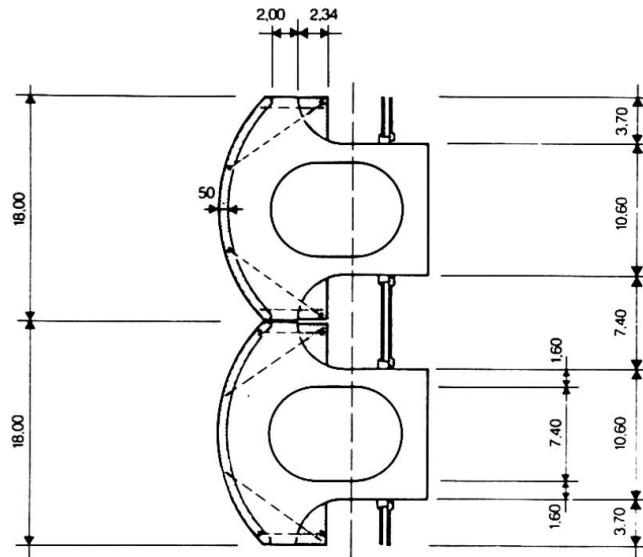
Fig. 7 Horizontalschnitt im oberen Erstüchtigungsbereich.

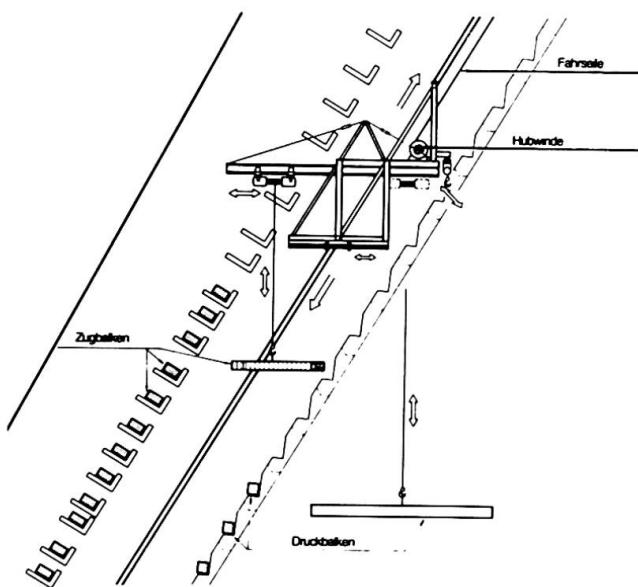
Fig. 8 Montagebühne in den Pfeilerhohlräumen.

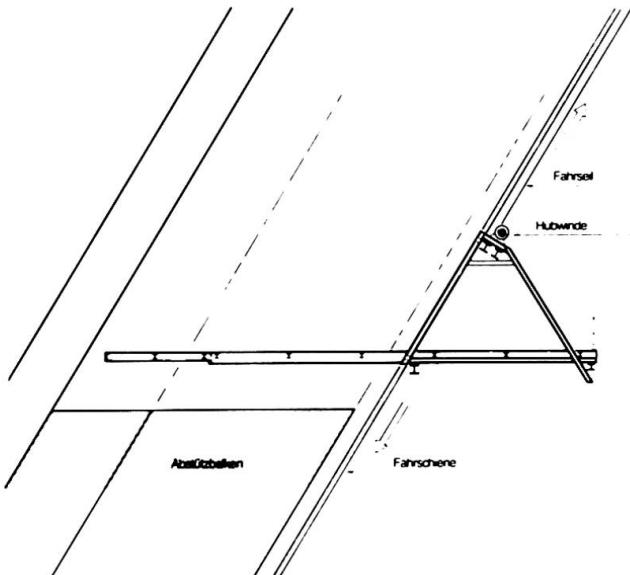
Fig. 9 Arbeitsbühne und Schalungsträger im Pfeilerzwischenraum.

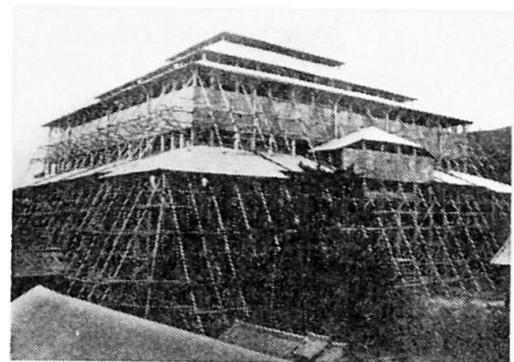
Fig. 2, Traditional SUYANE with logs

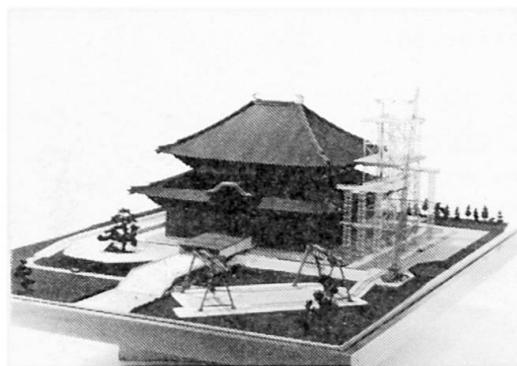
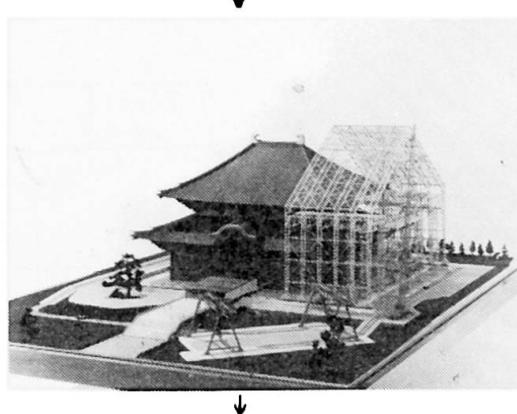
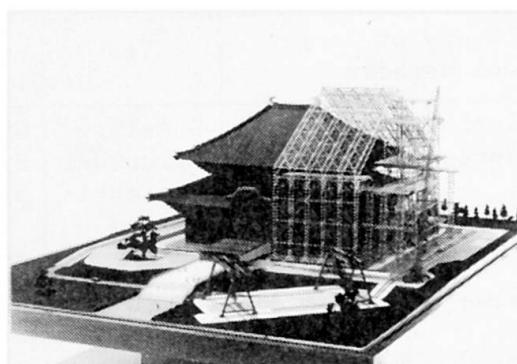
Fig. 5, SUYANE fabricate beside the temple was to moved over the building by rollers

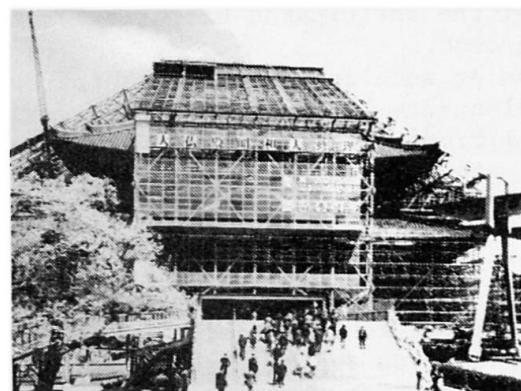
Fig. 6, Todaiji temple SUYANE
Under construction

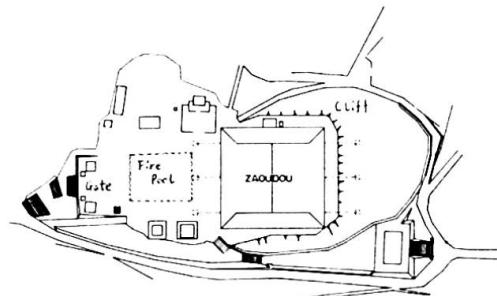
Fig. 8, Kimpusanji temple, Zaodo Layout

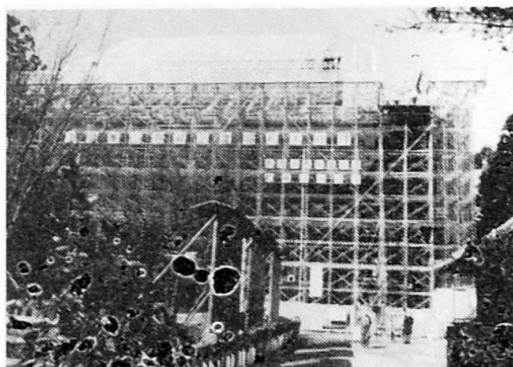
Fig.10, Kimpusanji temple, Zaodo SUYANE Under construction

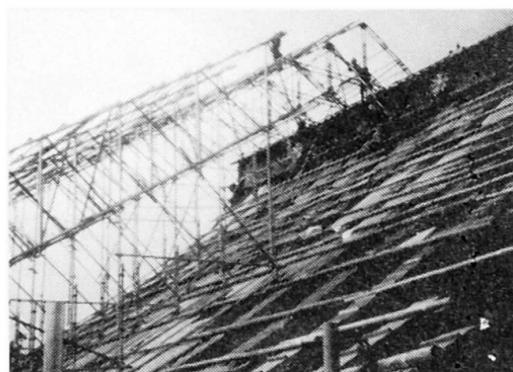
Fig.11, Kimpusanji temple, Zaodo Manual removal of roof

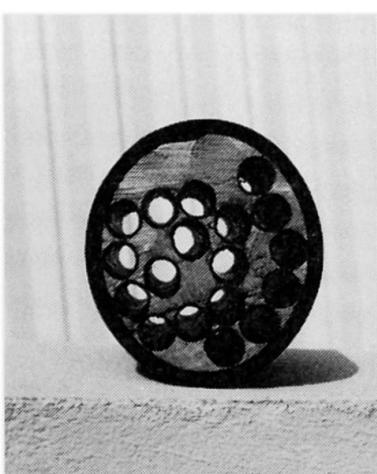
Fig. 1 Section droite d'un câble avec toron gainé graissé (toron enlevé)

Pour que les torons se trouvent dans des conditions d'enrobage analogues à celles pour lesquelles le produit a été créé, FREYSSINET a introduit l'injection avant mise en tension du groupe de torons gainés graissés/cirés enfilés préalablement dans une gaine en polyéthylène continue (Fig. 1).

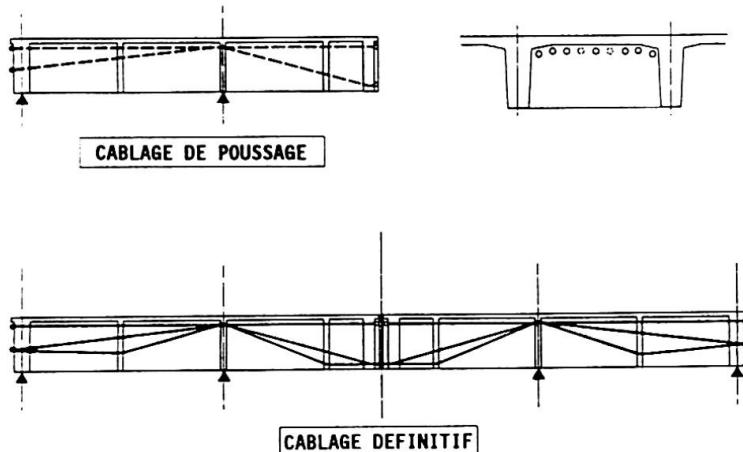
Fig. 3 Schémas de câblage

ouvrages se présente sous 3 formes : (Fig. 3)

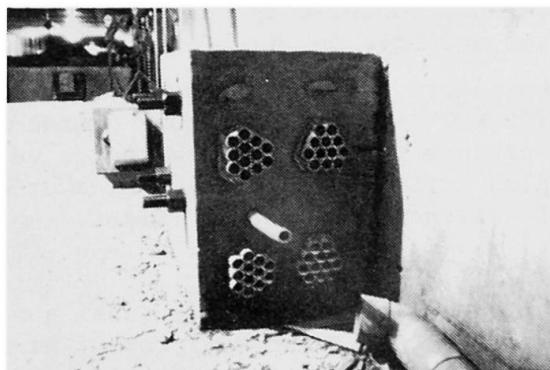
Fig. 4 Déviateur

- précontrainte extérieure d'assemblage des demi-poutres caisson en câble 12T15. Cette précontrainte est réalisée par torons gainés graissés regroupés dans une gaine injectée préalablement à la mise en tension. La gaine est supportée par un monotoron de 15 mm tendu, fonctionnant en funiculaire. Le câble court (35 m) est préfabriqué à l'extérieur de l'ouvrage et enfilé par traction au treuil. La gaine est injectée au coulis de ciment et la mise en tension est faite ensuite toron par toron lorsque le coulis atteint 15 MPa (24 h).

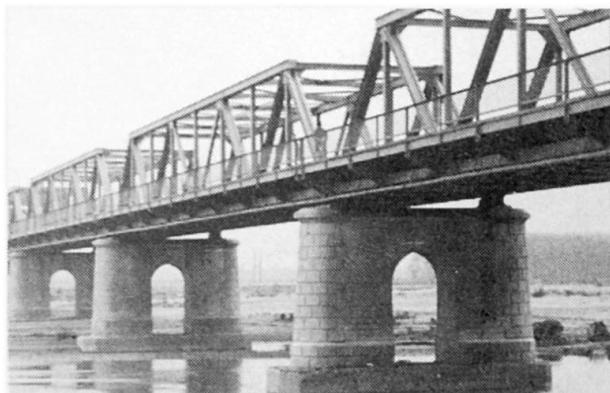
Fig.1. Vieux pont sur le Buzău

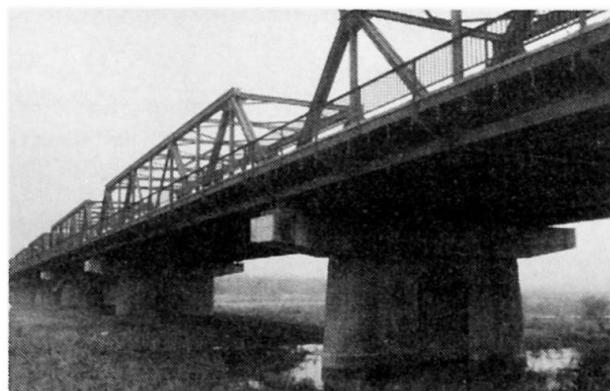
Fig.2. Nouveau pont sur le Buzău

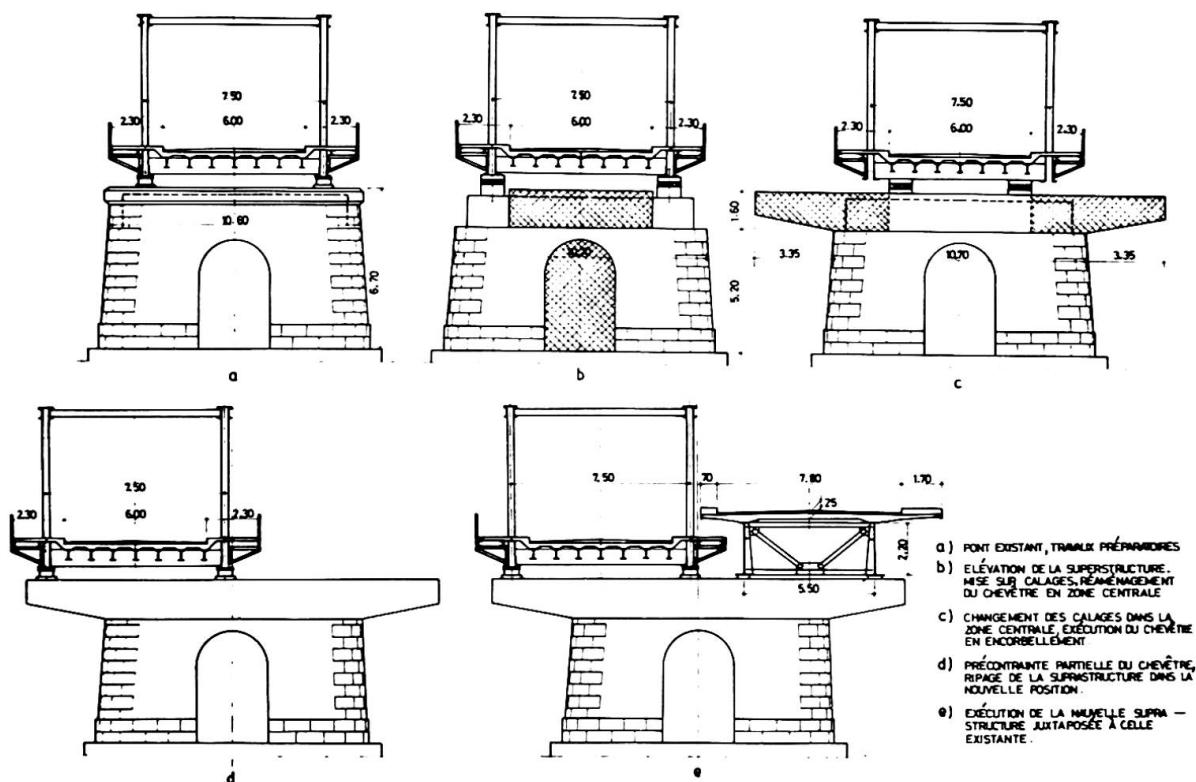
Fig.3.Phases principales d'exécution

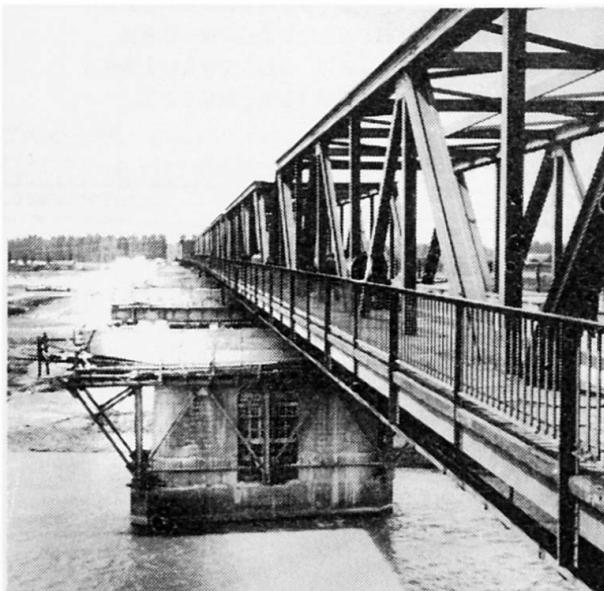
Fig.4.Nouvelle position du pont désafecté et aménagé à cette occasion en pont routier. C'est ainsi que sur les infrastructures existantes on a doublé la capacité de trafic du pont.

La superstructure existante, Fig.4, ripée dans la nouvelle

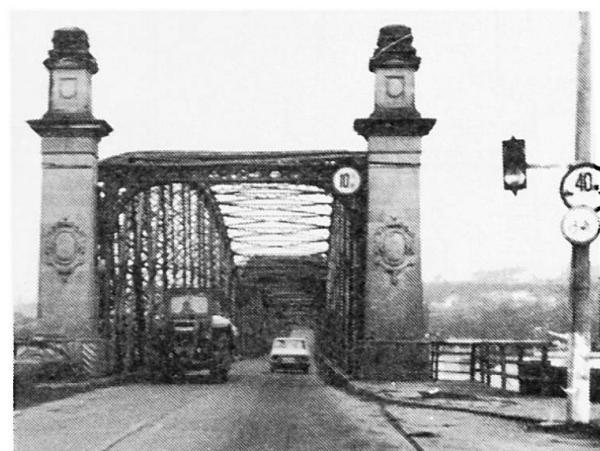
Fig. 5. Vieux pont à Slatina

2. Le pont sur l'Olt à Slatina sur la route nationale 65 Pitești-Craiova (E 70), construit en 1888, à cinq portées, 80,00 m de largeur chacune, poutres à treillis à voie basse et fondations sur caissons à air comprimé, partiellement reconstruit en 1932, lorsqu'on a refait trois portées détruites pendant la guerre. La largeur de la chaussée de 6,5 m représentait un facteur d'embarras de la circulation, ce qui a imposé des travaux de rénovation. Fig.5. Parmi les variantes étudiées on a adopté la solution

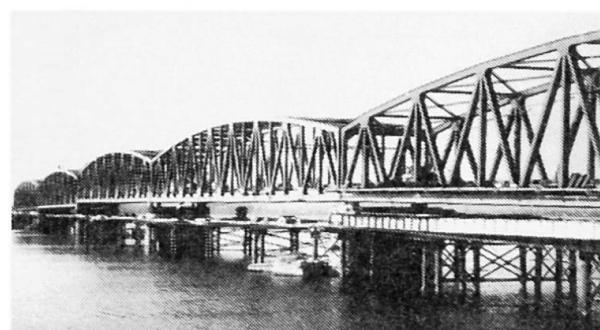
Fig. 6. Phases d'exécution

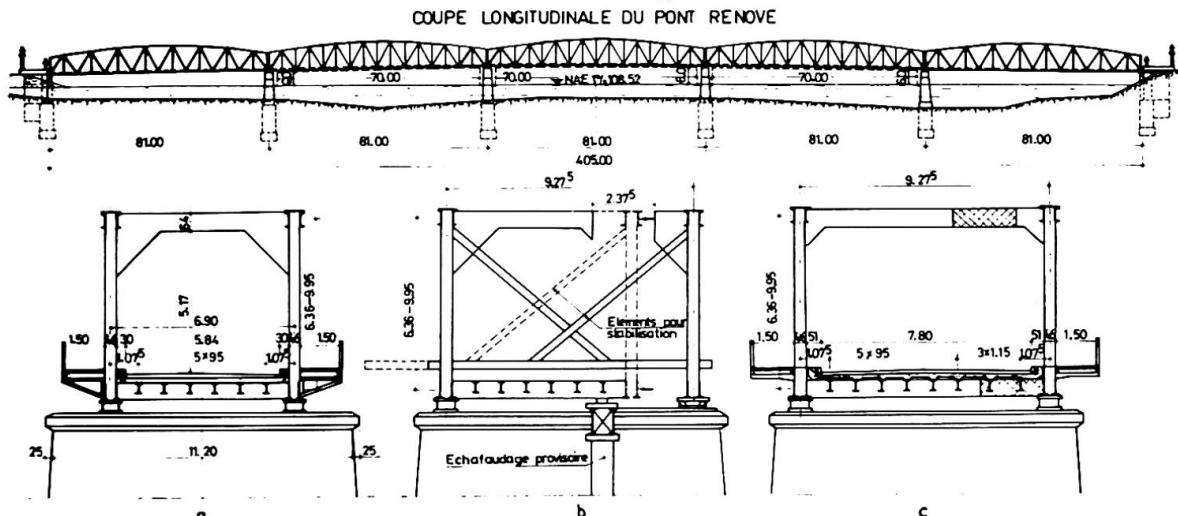
Fig. 7. Etapes d'élargissement de la vieille superstructure bien que des entretoises inférieures et supérieures, le ripage des poutres éliminées ainsi et stabilisées dans la nouvelle position, Fig. 8, l'introduction de quelques éléments de liaison pour refaire la structure en ensemble. On a aussi augmenté les sections avec des éléments assemblés par rivetage, aux diagonales de bout, au long de 60 m aux semelles inférieures et de 50 m aux semelles supérieures. Après avoir fini les travaux à la structure métallique, on a exécuté le plateelage en béton armé en interaction avec les entretoises et les longerons. Les superstructures nouvelles, qui gardent, en général, la forme de celles existantes, ont été montées

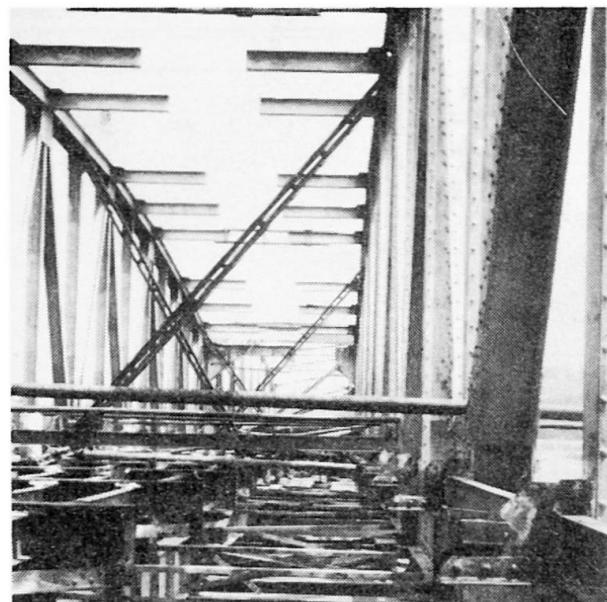
Fig.8.Déplacement des poutres
carottés.Pendant l'exécution la circulation a été déviée sur les routes existantes sur les aménagements hydroénergétiques de la zone.

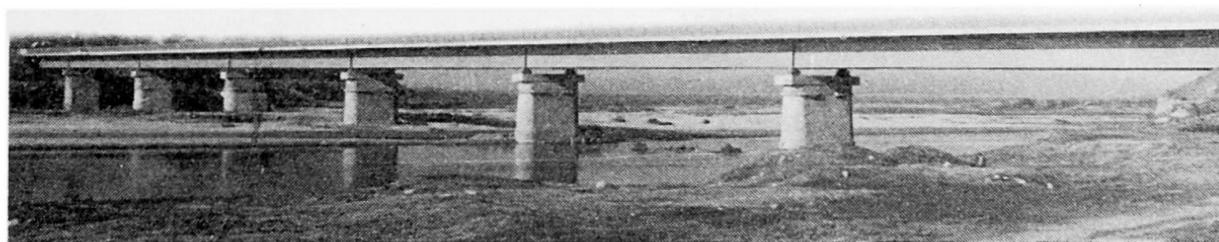
Fig.8.Pont rénové en 1976 sur l'Olt à Stoenesti
superstructure par une poutre continue métallique à plaque avec des éléments préfabriqués en béton armé à interaction en 1976.
Fig.9.L'aménagement pour la navigation de l'Olt a imposé l'exécution de quelques ouvrages à cause des changements du régime hydraulique de la rivière. Pour correspondre aux nouvelles conditions qui imposaient la construction d'un pont à hauteur libre et longueur beaucoup supérieures à celles du pont existant, on a choisi parmi les variantes étudiées la solution comprenant: le maintien de l'emplacement, l'élévation de la superstructure du pont à hauteurs variables entre 1 m et 8,80 m, le prolongement du pont par trois portées à 60 m et l'aménagement et consolidation adéquates des infrastructures. Fig.10.L'élévation de la superstructure existante a été réalisée en étapes successives à presses hydroliques et calages en béton de chaque appui (les infrastructures 4-11) Fig.11.L'élévation étant variable de 1 m à la culée rive gauche, à 8,8 m pile 4, les opérations ont dû être poursuivies et synchronisées d'une manière permanente. A l'étape de

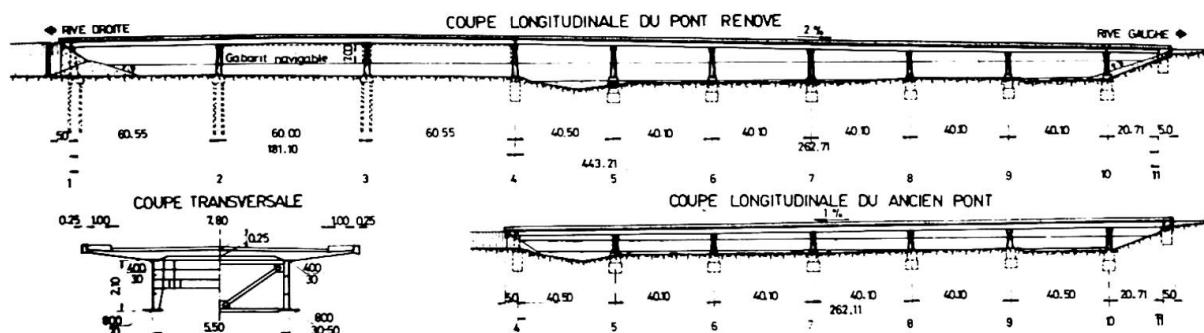
Fig.10. Disposition générale

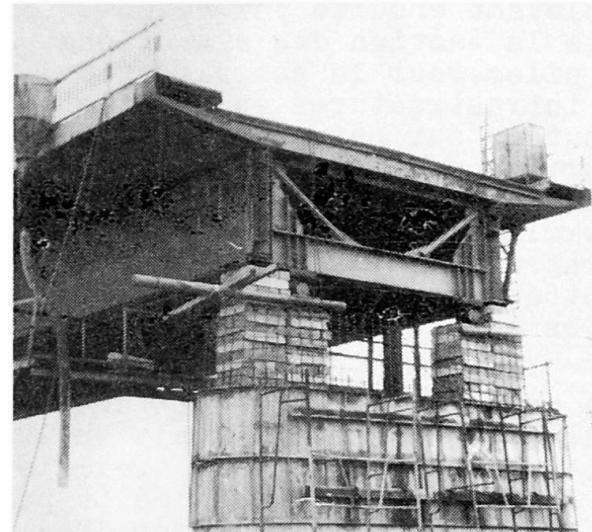
Fig.11. Elévement du vieux pont

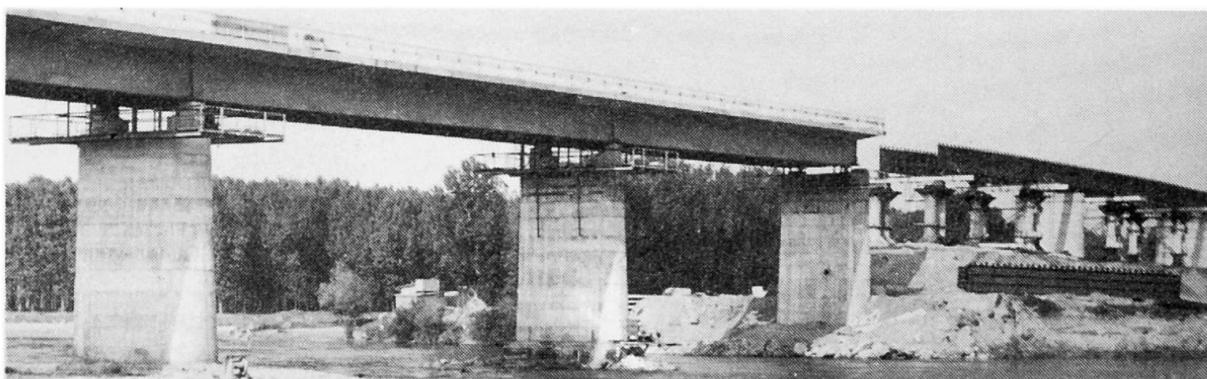
Fig.12. Pont à Stoenesti - phases d'exécution

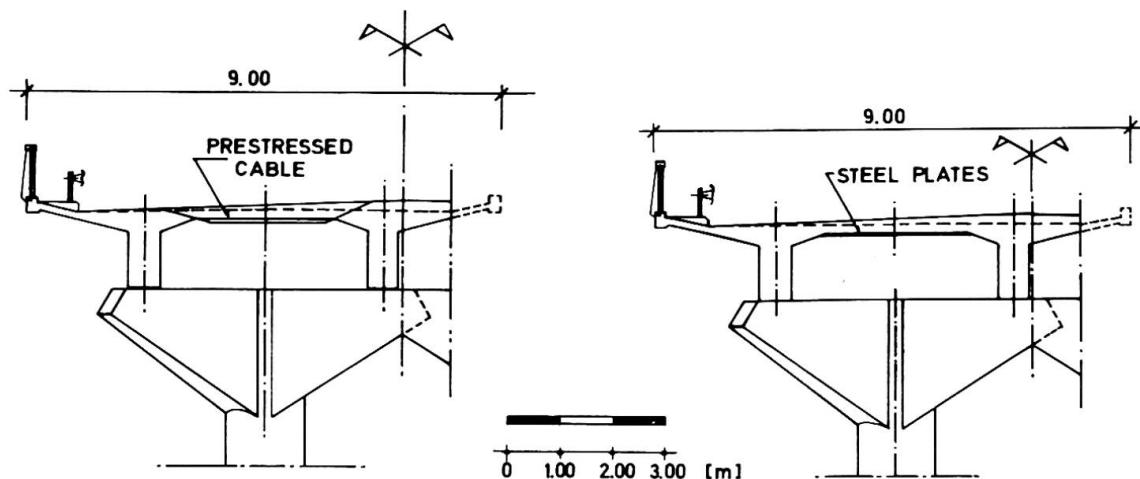
1st Solution (Road axis changes):
DYWIDAG 20F strand cables spaced 0.50 m in the longitudinal direction anchored at the top of the slab. The anchorages are to be sealed with epoxy mortar.

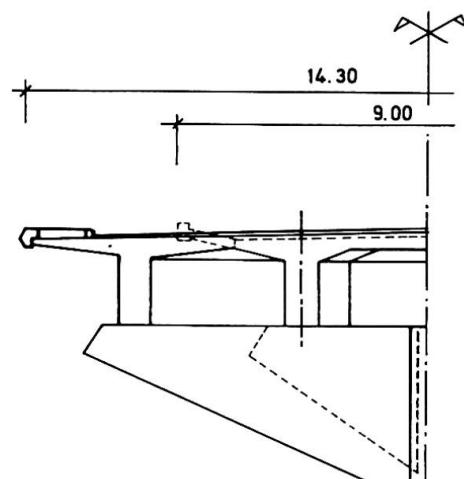
Final Solution (Road axis constant):
thickening of existing slab and introduction of additional ordinary steel reinforcement over the longitudinal beams.

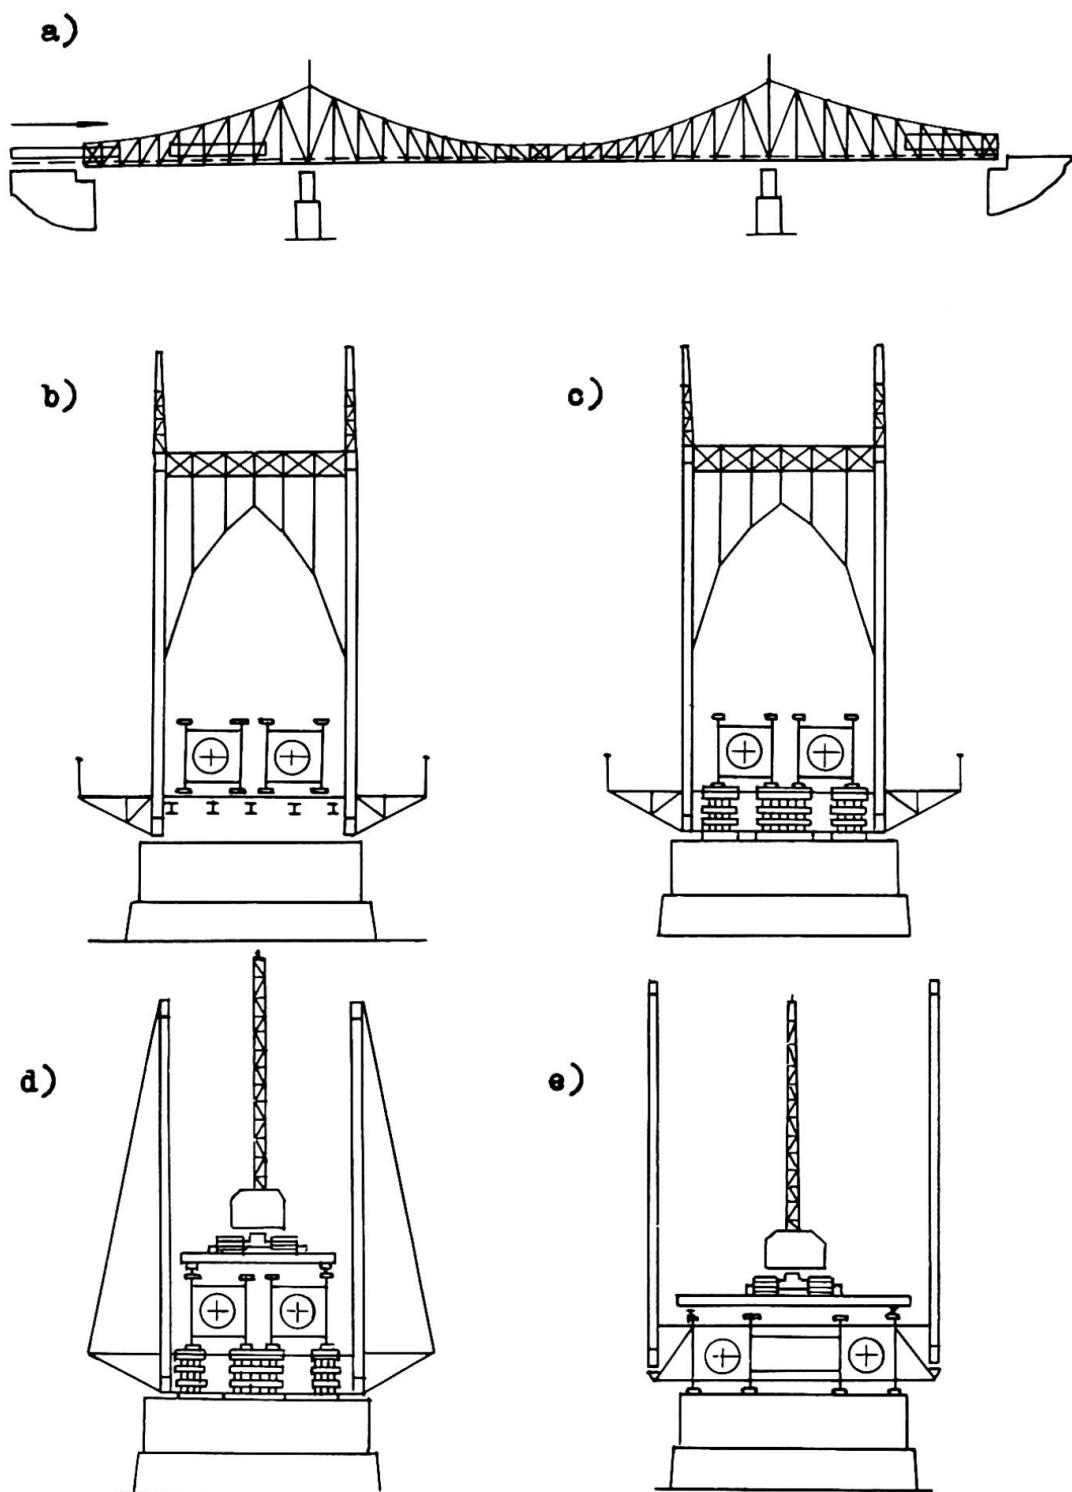
Fig. I The method of reconstruction of the metal superstructure of the Volga River Bridge in Kalinin: a, b- moving on blocks of the new superstructure; c- lowering of the moved on blocks onto the cades disposed on the permanent supports; d- cutting of lattice trusses into blocks and dismounting them; e- moving apart the blocks of the new superstructure and erection of lattice truss assemblies along the front of the new superstructure and their engaging.

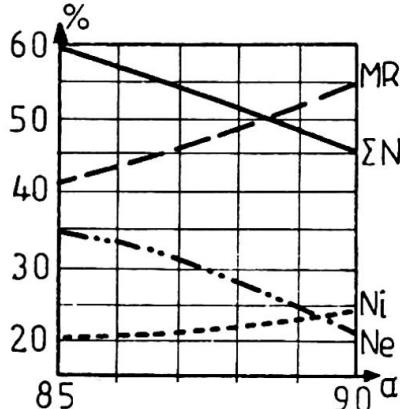
Bild 1 Tendenzen im Wohnungsbau der DDR

In den letzten Jahren verlagern sich diese Bauaufgaben mehr und mehr in die Innenstädte. Wie Bild 1 zeigt, dominieren künftig

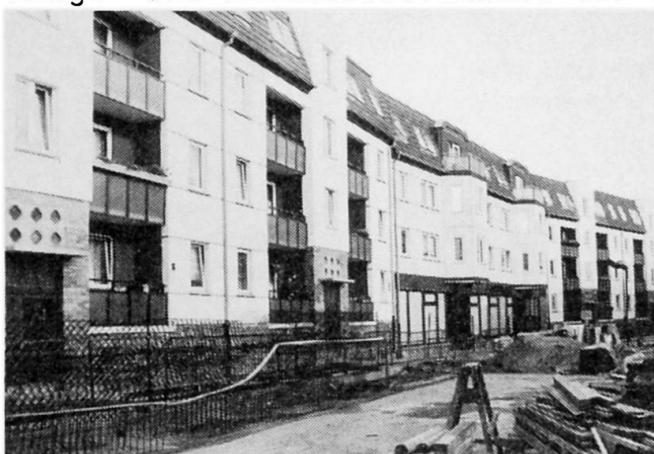
Bild 2 Plattenbau, innerstädtisch

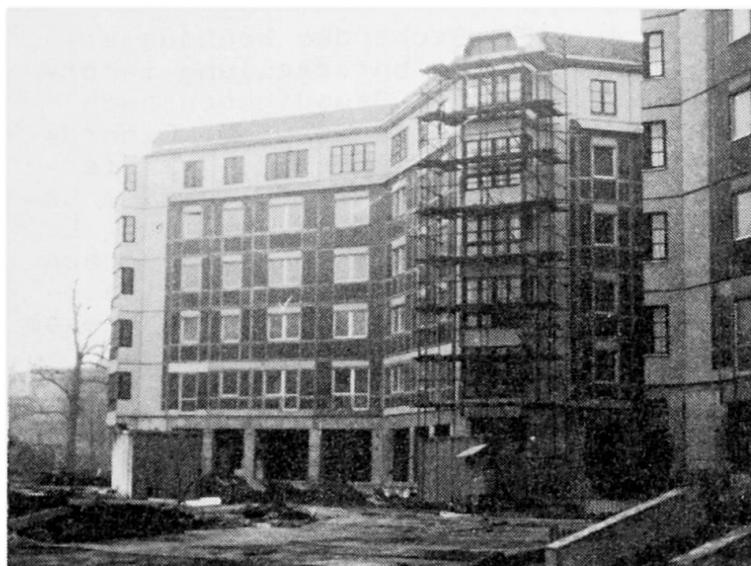
Bild 3 Unterlagerung eines Wohngebäudes in Plattenbauweise durch ein monolithisches Erdgeschoß

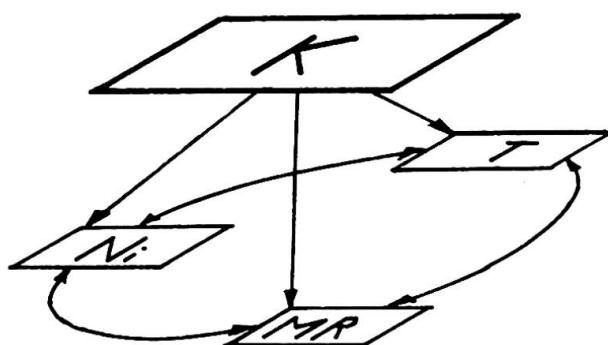
Bild 4 Ebenen der bautechnologischen Planung

Das Bauen auf innerstädtischen Komplexstandorten (K) ist durch die räumliche und zeitliche Verflechtung von Prozessen des kommunalen Tiefbaus (T), des Neubaus (Ni) und der Modernisierung/Rekonstruktion (MR) gekennzeichnet. Die einheitliche Planung und Steuerung des Gesamtprozesses und die objektspezifische bautechnologische Planung und Steuerung der Prozesse T, Ni, MR, die durch unterschiedliche Baukombinate realisiert werden, erfordern die bautechnologische Bearbeitung in zwei Ebenen unterschiedlicher Genauigkeit und Zeithorizonte (Bild 4).

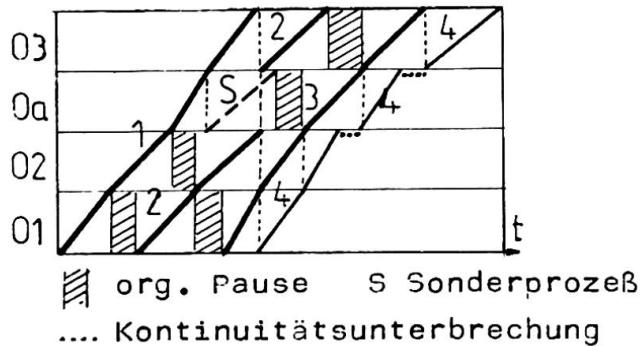
Bild 6 Unrhythmische Taktstraße mit technologisch unterschiedlichen Objekten
(0a qual. u. quant.abweichend)

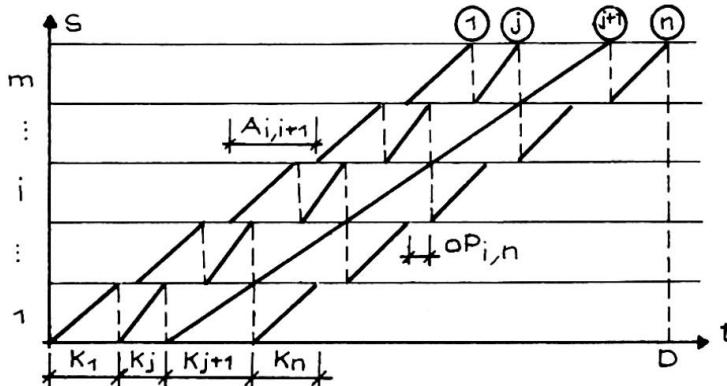
Bild 7 Prinzip der kontinuierlichen Objektfertstellung

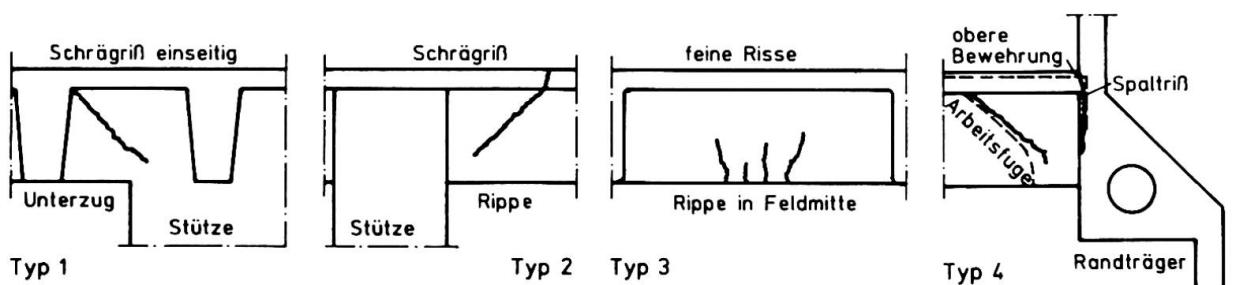
Bild 2: Typische Rißbilder der Rippendecke

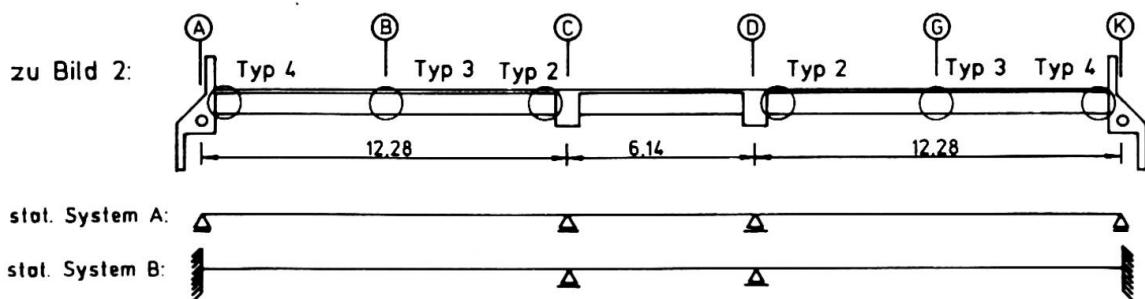
Bild 3: Deckenquerschnitt und statisches System

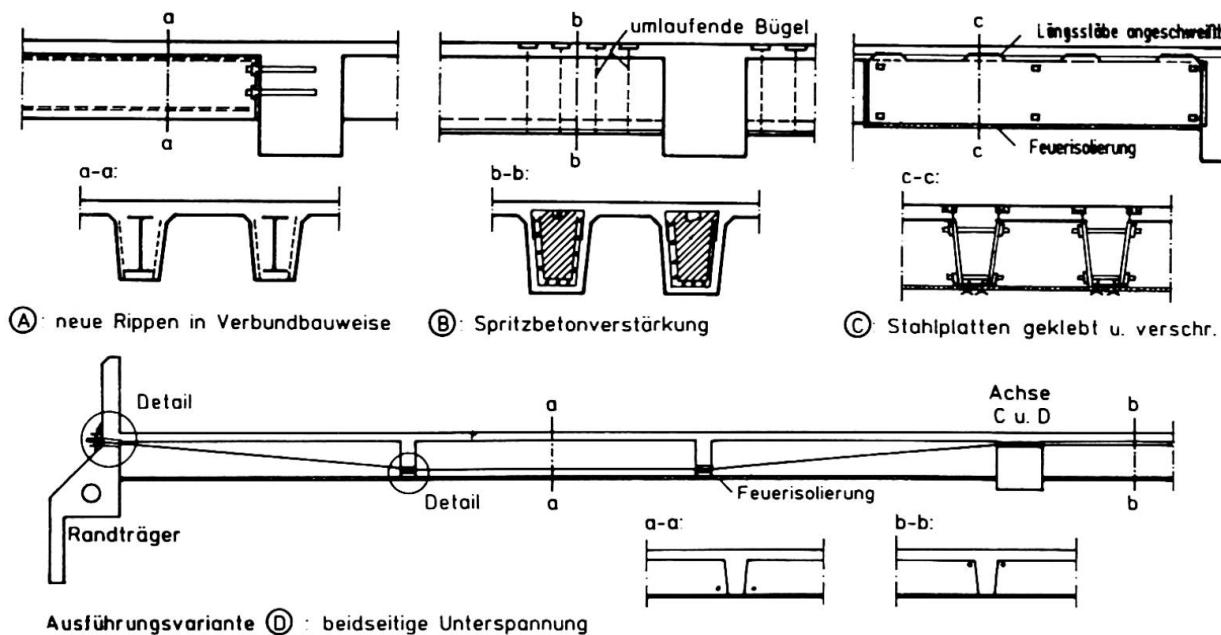
Bild 4: Varianten für die Rippenverstärkung

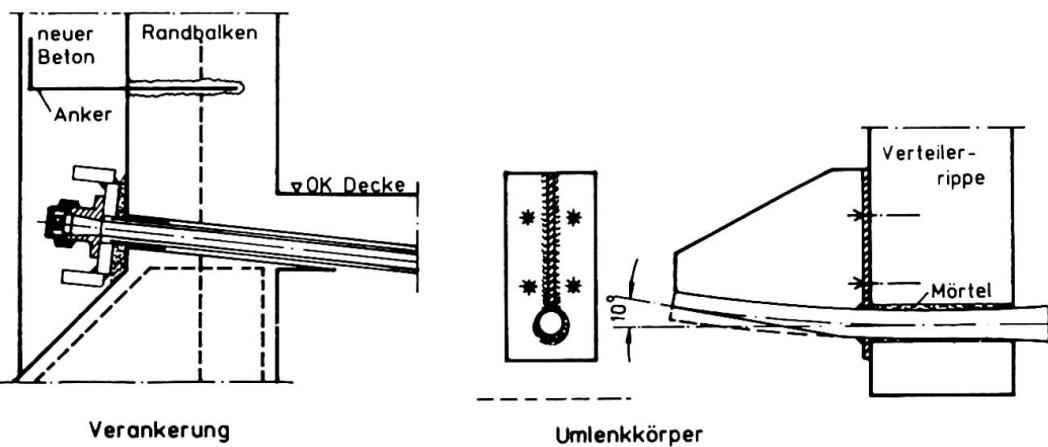
Bild 6: Details der Unterspannung nach Variante D

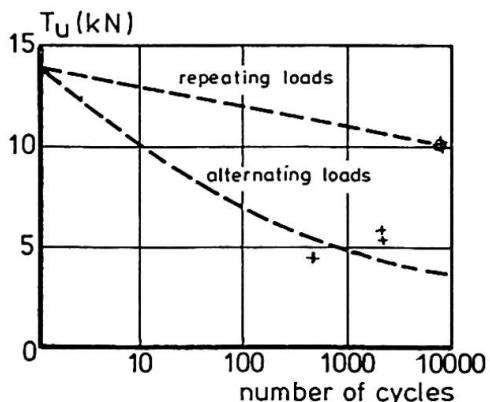
Fig. 5 Ultimate shear force vs. number of cycles

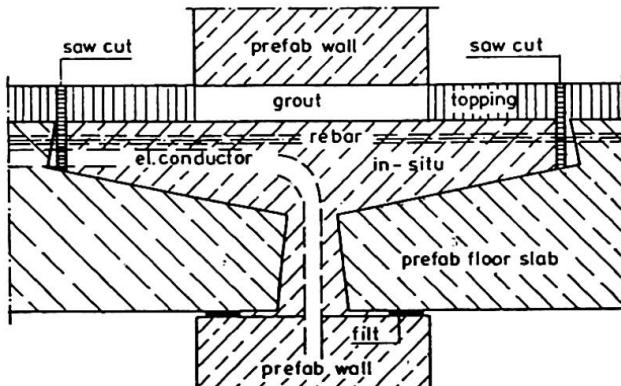
Fig. 7 shows the essential detail of the panel system. Two slabs rest on filter on the wall, the space in-between is filled by concrete. Rebars protrude from the slabs joining each other. For demounting, the

Fig. 7 Wall to floor joint of the Delta BMB system

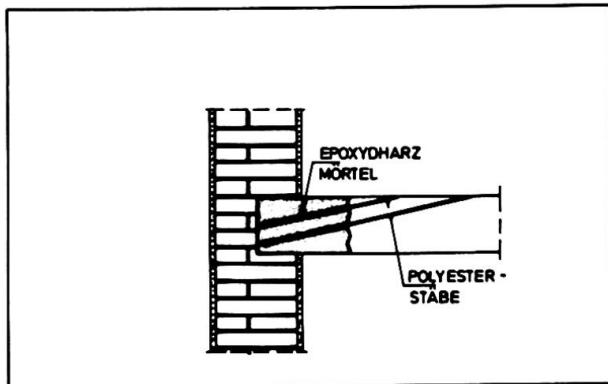
Fig.2 Ersatz des Tramkopfes durch polyesterarmierten Epoxydharzmörtel

Sanierungsmaßnahmen mit konservierender Wirkung betreffen vor allem die besonders für feuchtigkeitsbedingte Schäden anfälligen Auflager der Deckenbalken (Träme). Aus der Bedingung der durchgehenden Bewohnbarkeit des Gebäudes ergibt sich die Forderung, daß derartige Maßnahmen weitgehend von der Deckenober- oder -unterseite aus durchgeführt werden können. Da der befallene Tramkopf in der Regel entfernt und ersetzt werden muß, stehen die in Fig.2 und Fig.3 skizzierten Möglichkeiten offen.

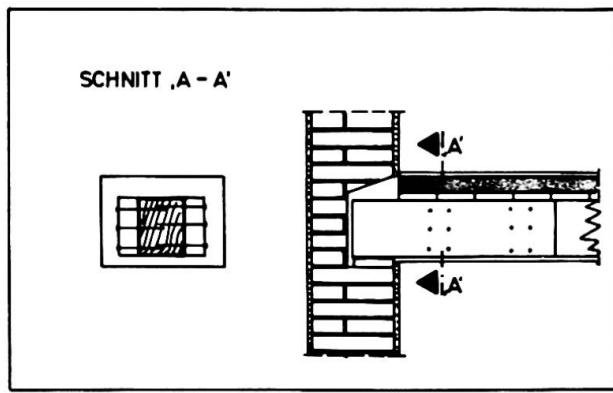
Fig.3 Ersatz durch seitlich befestigte Laschen

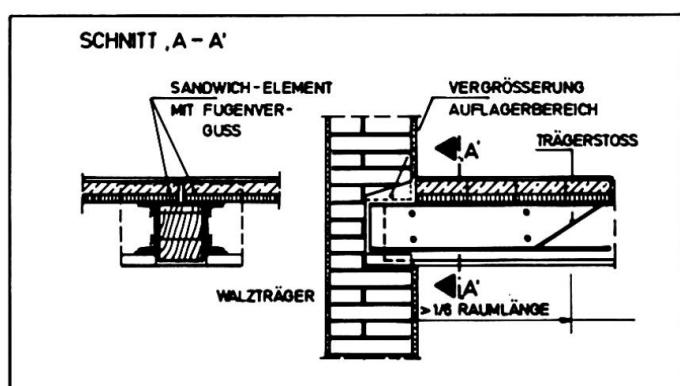
Fig.4 Einziehen von Verstärkungsträgern in Tramdecken

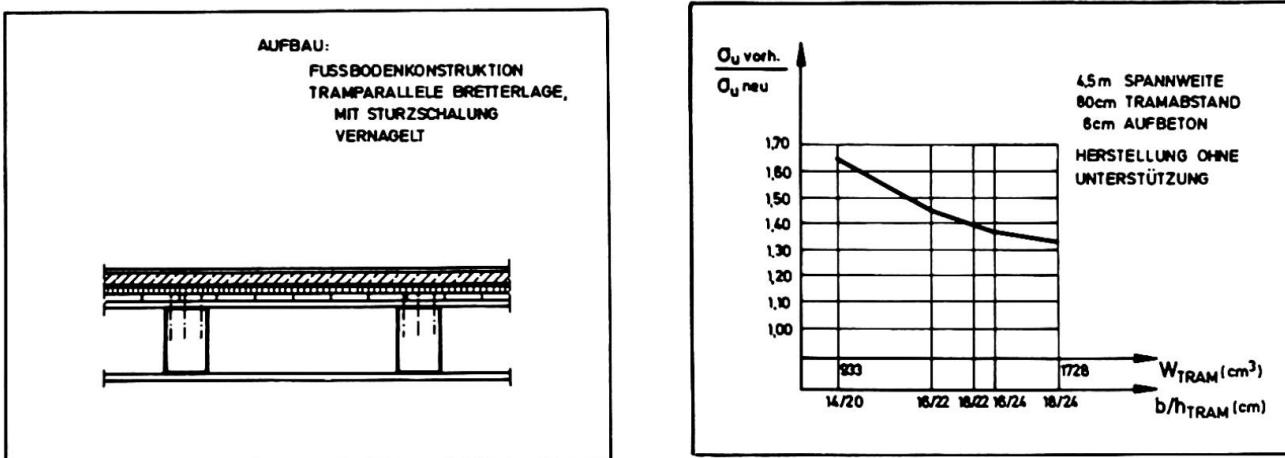
Fig.8 Aufbau einer Holz-Beton-Verbunddecke (Schema)
