# Theme VIa: Safety and stability of elements and structures

## **Constructions en béton préfabriqué**

### **Precast Structures**

**Safety and Stability of Elements and Structures**

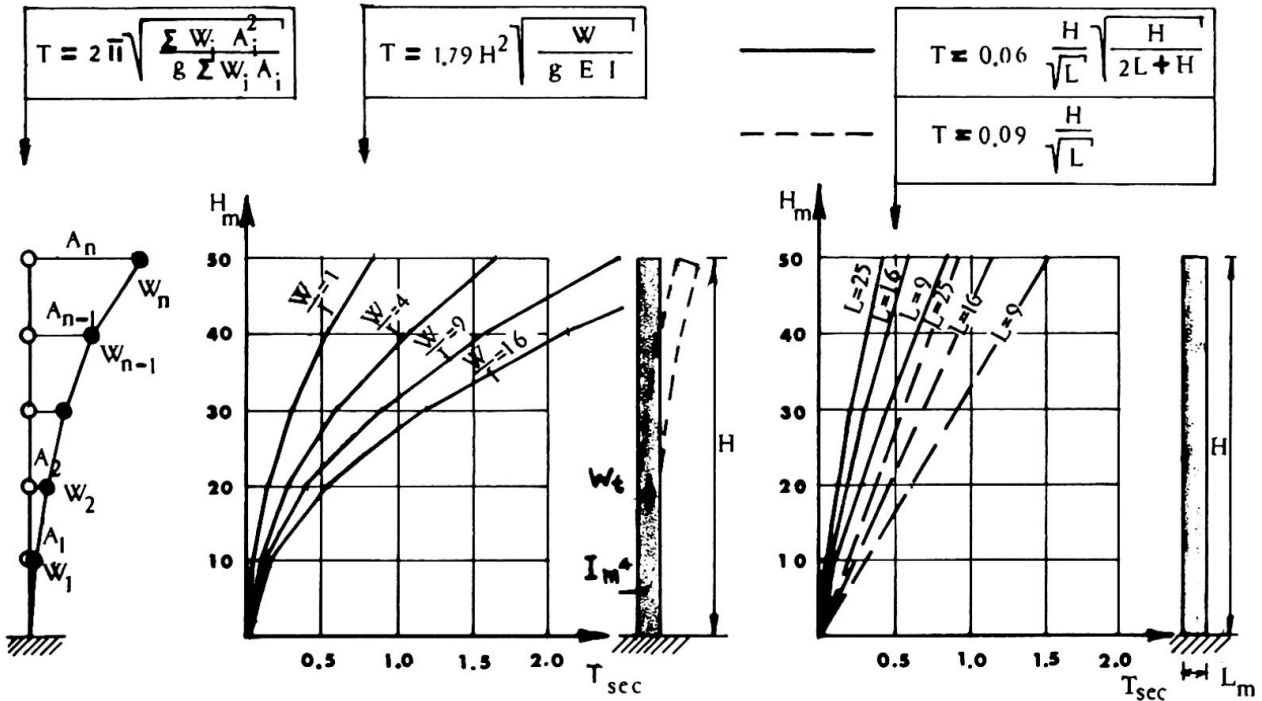
Figure (1)

Figure (2)  
Uniform load calculation

Figure (3)  
Comparison between  
code formulas

Figure (3) shows that the evaluation according to formula (4) gives a lower period than formula (5), the lateral forces therefore being greater in precast panel constructions than in reinforced skeleton.

(See Figure No. 1 ).

(See Figure No. 3 ).

A comparison was prepared between period formulas (4) and (5) and is obtained in Figure (3) for constructions of a different width  $L_x$ , beside uniform load calculation Figure (2).

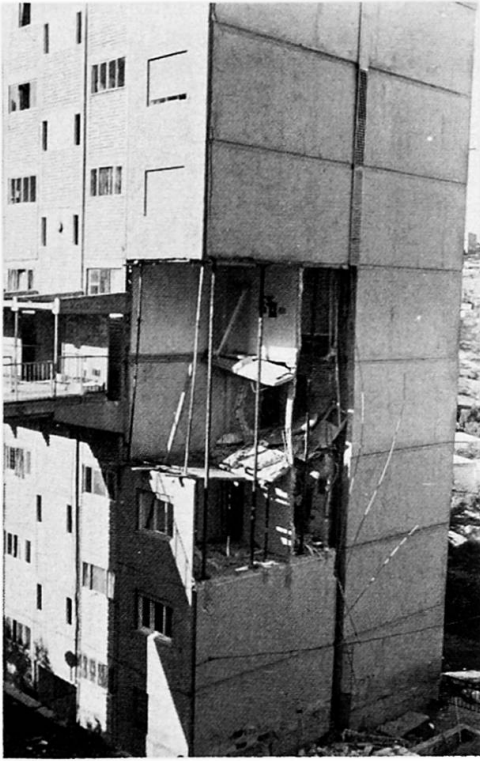
In picture No. 4, are seen the results of a hot water boiler explosion, on the 4th floor of an 8 storey building in Jerusalem in July 1975. The building consists of precast facades and ceilings, and gables cast in situ.

Figure (4)  
Results of boiler explosion  
in Jerusalem

stresses the importance of the horizontal and vertical belts cast between the precast parts, for the stability of the construction in the case of such failures. "Ronan Point building was not properly braced as was the one in Algiers or as the CEB/CIB Recommendations require". (Reference [4] ).

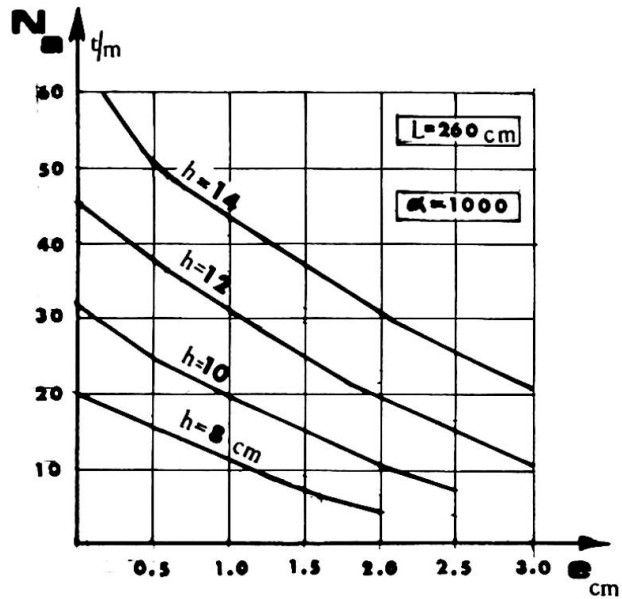
Figure (6)  
Allowed load on walls as function of eccentricity for height of L = 260cm. and  $\alpha = 1000$

$N_u$  - The load carrying capacity of the wall taking into consideration buckling.

$$N_u = \varphi N = \varphi \left( \frac{e^*}{h} ; \bar{\lambda} \right) \times \sigma_b \times A_b \tag{6}$$

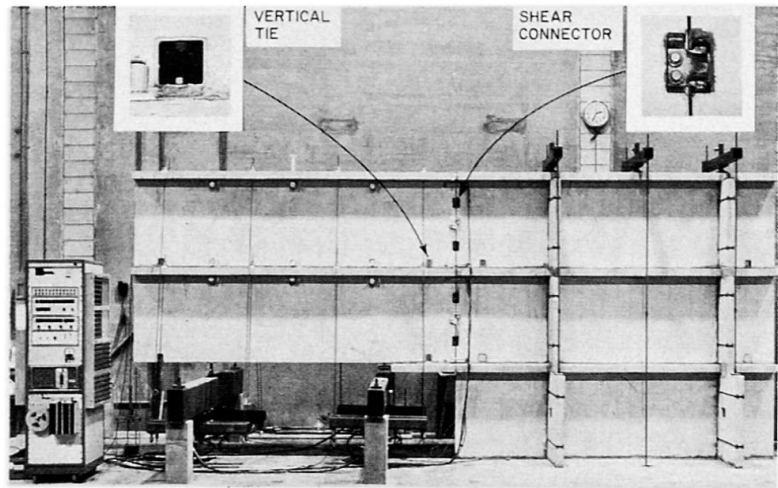
Wall panels were 3-in. (76 mm) thick, 36-in. (914 mm) high and 11-ft. 3-in. (3.4 m) long. Two shear connectors were used at the vertical joint between panels at each story. Hollow core slabs spanning between wall panels were represented in the test structure by short stub sections. The floor stub elements were 3-in. (76 mm) thick to represent 8-in. (203 mm) thick slabs in the prototype structure. Spaces between the ends of the slabs were provided by a 1-in. (25 mm) wide slot through the length of the element.

Fig. 1 - Two Story Cantilever

Construction and testing started with a 2-story cantilever as shown in Fig. 1.

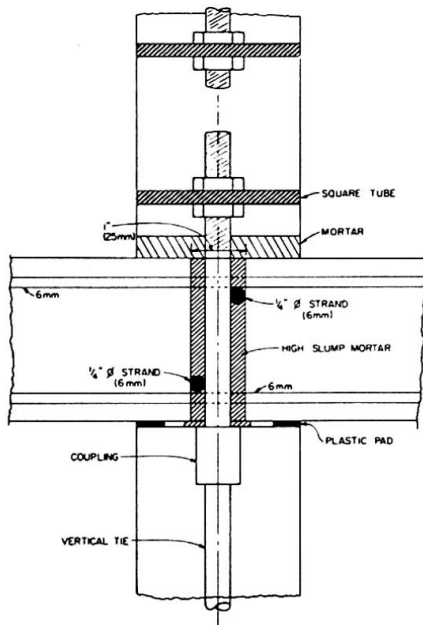
Fig. 2 - Joint Details

In Fig. 2, a detail of the joint at a vertical tie shows the horizontal tie consisting of 1/4-in. (6.4 mm) strand. This tie was placed in the slot between ends of the floor stubs and was continuous the length of the specimen. A fluid mortar was placed in the joint shown in Fig. 2.

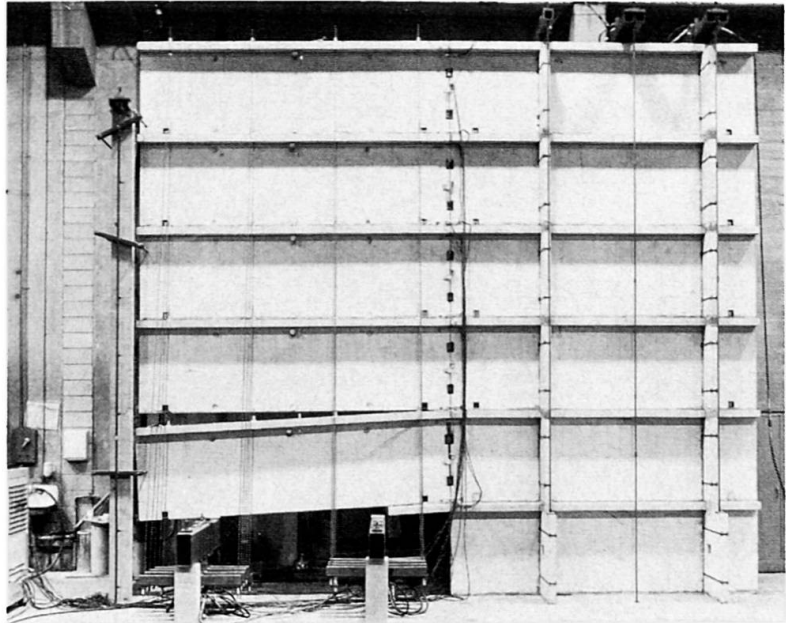
After dead load plus one-third of design live load had been applied, the complete 5-story cantilever structure was loaded to destruction. As load was increased, the vertical ties connecting the bottom panel to the structure fractured, as shown in Fig. 3. Continued loading produced additional tie fractures until only the top panel remained. Further application of load resulted in slip between the panel and the floor above.

Fig. 3 - Test Structure After Fracture of Vertical Tie at Floor Level 2

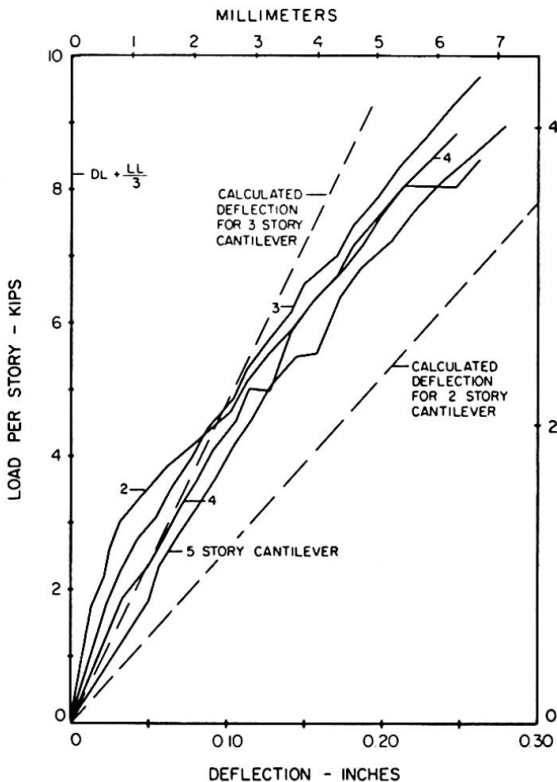
Measured story load versus deflection relationships for each service load test are shown in Fig. 4. The test load of 8.2 kips (36.4 kN) per story is marked on the load axis.

Fig. 4 - Measured Deflections at Low Loads

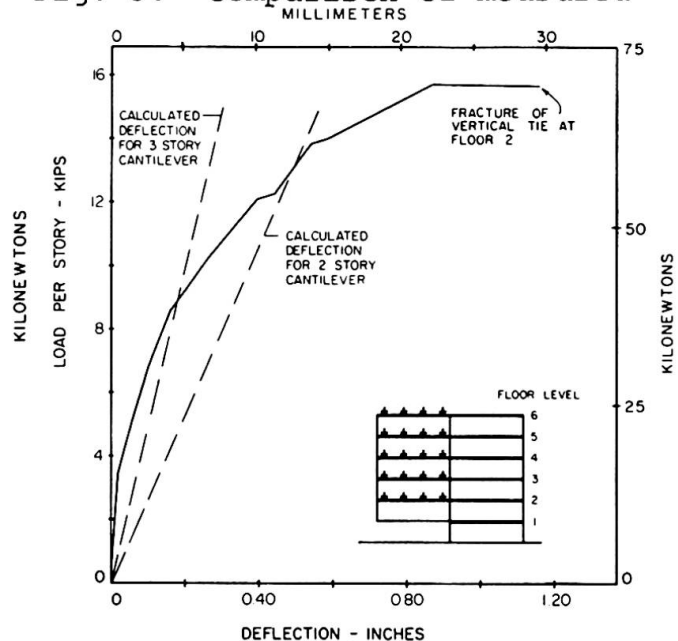
Measured deflections of the 5-story cantilever as it was loaded to destruction are shown in Fig. 5. Comparison of measured

Fig. 5 - Deflection Measured During Test to Destruction

deflections with those calculated suggests that the upper two stories did not act compositely at higher loads.

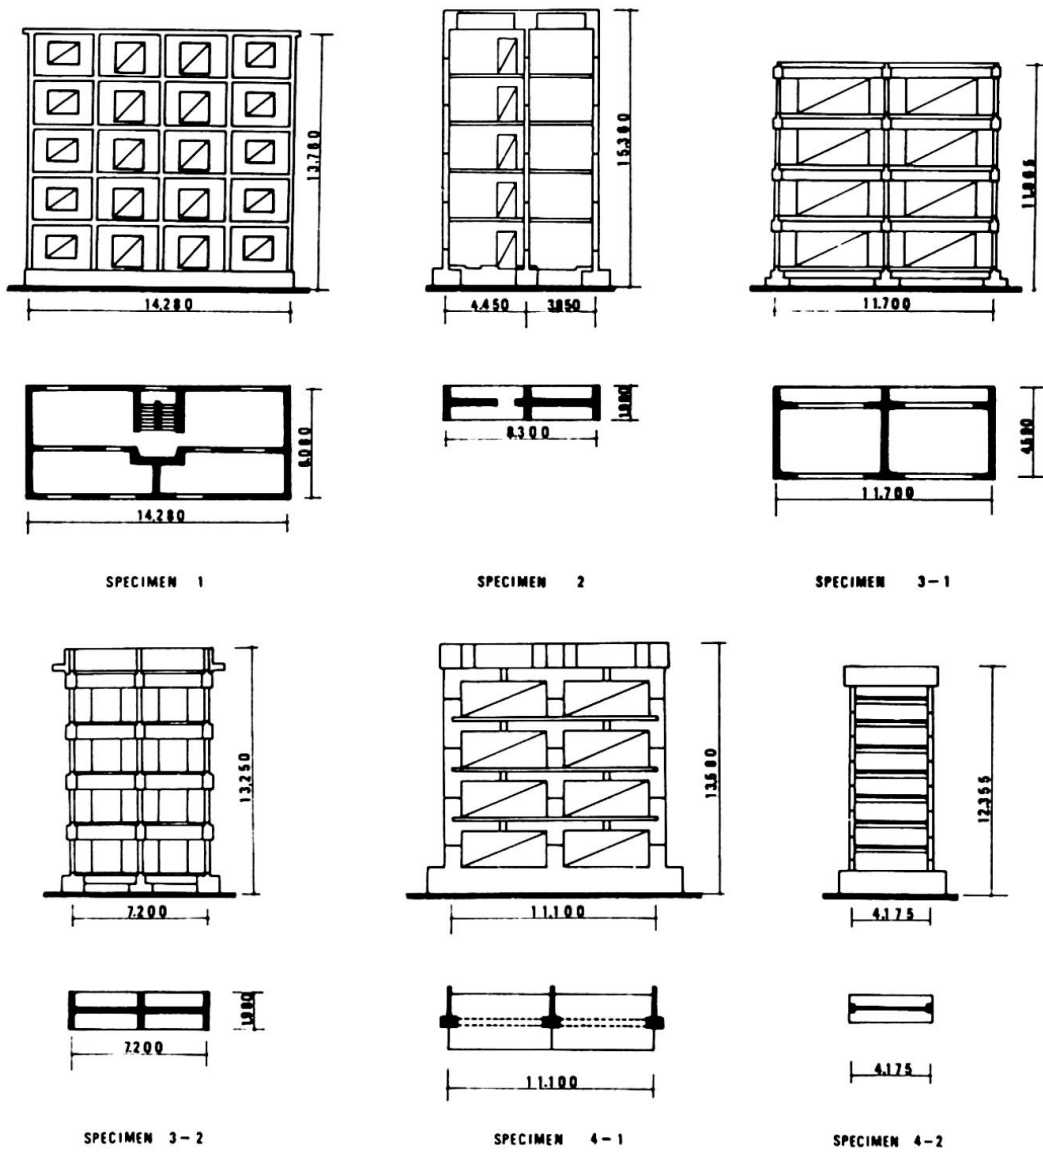
Fig. 7 Outline of Test Specimen

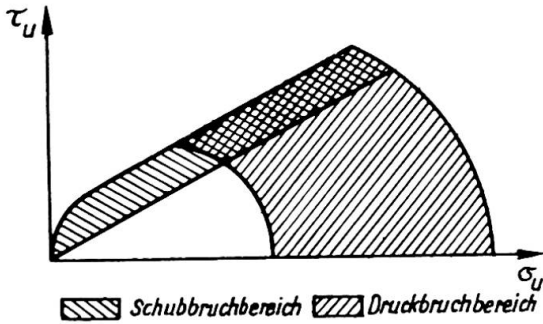
Ein Spektrum von  $\tau - \sigma$ -Beziehungen für den gesamten Schub- und Druckbruchbereich ist aus Bild 2 zu ersehen. Im Schubbruchbereich entspricht die untere Begrenzungsgerade der Charakteristik einer Fuge mit glatten Rändern, die obere Begrenzungskurve der einer verzahnten Fuge.

Bild 2: Spektrum von  $\tau - \sigma$  - Beziehungen

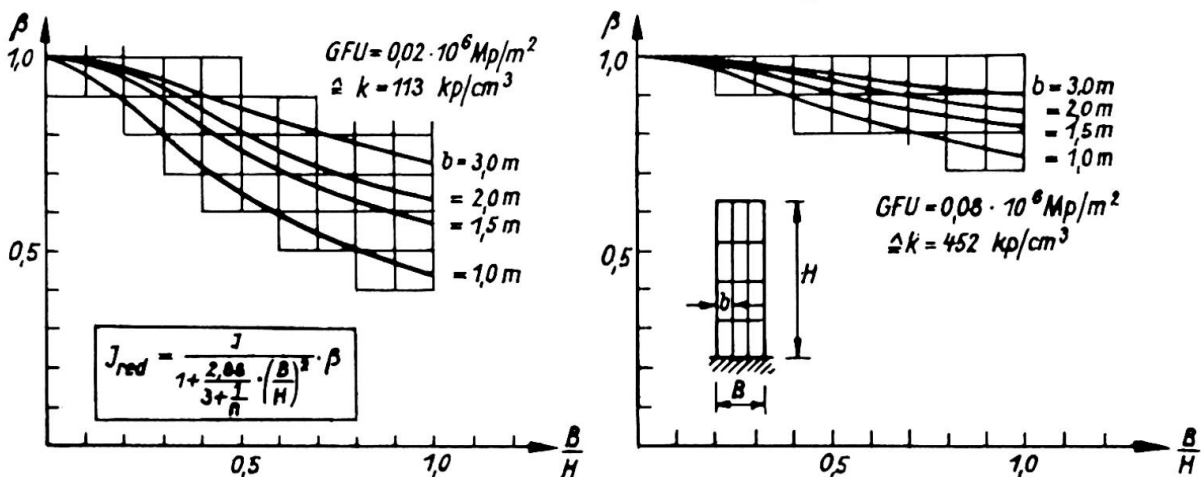
Unter der Annahme, daß alle Horizontalfugen überdrückt sind, und ihre Schubverformung vernachlässigt werden kann, ergeben sich die in Bild 4 [8] dargestellten Abminderungsfaktoren für die Trägheitsmomente der Wand bei Berücksichtigung der Schubverformung der Vertikalfugen. Diese reduzierten Trägheitsmomente sind bei der Verteilung der Horizontalkräfte anzusetzen. In [9] sind darüberhinaus Kriterien angegeben, bei deren Erfüllung der Nachweis der Horizontalkräfte von Großtafelbauten vernachlässigt werden kann.

Bild 4: Abminderungsfaktor  $\beta$  für das Trägheitsmoment der Wand

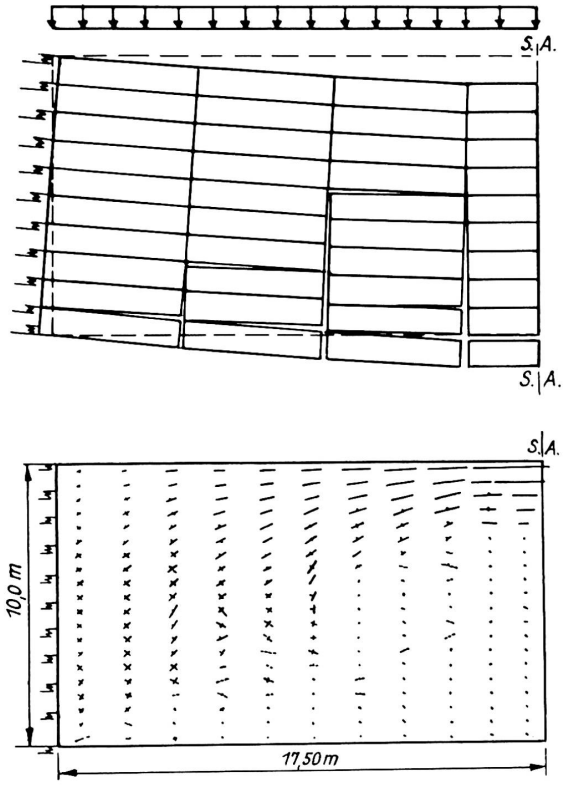
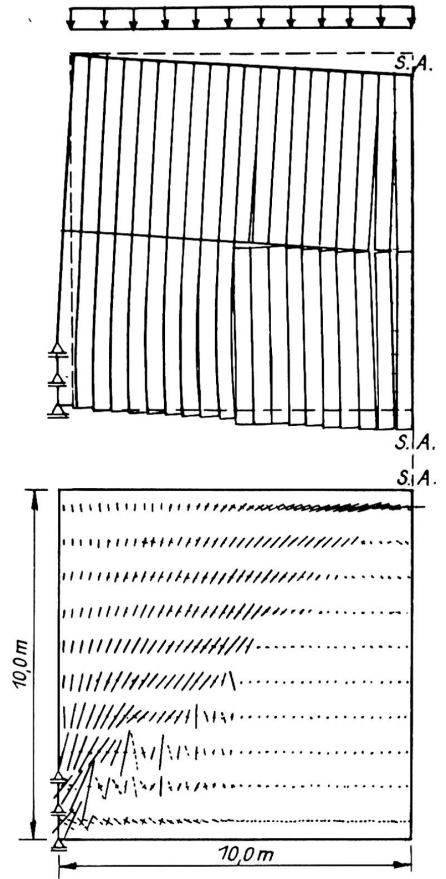
Bild 5: Verformungs- und Hauptspannungsbilder von Fertigteil-Deckenscheiben

Zum Studium des Tragverhaltens von Deckenscheiben wurden zahlreiche numerische Untersuchungen durchgeführt, in denen die rechnerische Bruchlast der Scheiben ermittelt wurde. Die Lasten wurden dabei stufenweise aufgebracht und iterativ die zugehörigen Steifigkeiten der Fugenfedern und des Verbundes zwischen Stahl und Beton bestimmt. Die wesentlichsten Parameter für das Tragverhalten sind: die Fugenausbildung (Fugenrandprofilierung → Schubtragfähigkeit), die Lagerungsbedingungen der Scheibe (eine konzentrierte Lagerung am unteren Rand der Scheibe ergibt günstigere Schubübertragung in Auflagernähe und eine größere Druckzone in Scheibenmitte, eine über die Scheibenhöhe verteilte Lagerung führt zu kleinerer Druckzone und kann zu ungünstigeren Verhältnissen bezüglich der Schubübertragung in Auflagernähe führen). Schließlich ist die Querkraftübertragung in Scheiben, bei denen die Plattenspannungsrichtung senkrecht zur Stützrichtung der Scheibe verläuft, ungünstiger als bei Plattenspannungsrichtung parallel zur Stützrichtung der Scheibe. Rechenergebnisse sowie ein Bemessungsvorschlag sind in [6] und [10] angegeben. Die aus der Rißbildung entstehende Spannungsumlagerung ist exemplarisch in Bild 5 dargestellt.

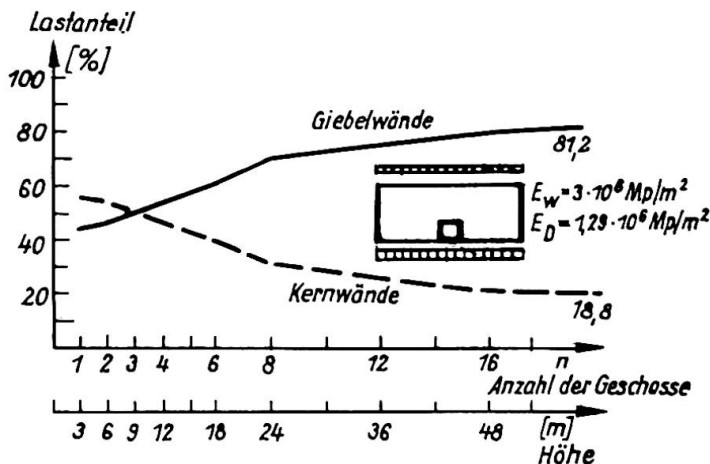
Bild 6: Verteilung der Horizontalkräfte bei Annahme von  $E_D \neq \infty$

Die Steifigkeit der Deckenscheiben aus Fertigteilen ist geringer als die von Ortbetonscheiben. Wird von der Annahme starrer Deckenscheiben bei der Verteilung der Horizontalkräfte auf die aussteifenden Wände abgegangen, was bei Fertigteilenscheiben oft zu berücksichtigen ist, so ergeben sich vor allem in den unteren Geschossen wesentliche Abweichungen gegenüber den Ergebnissen mit starren Scheiben.

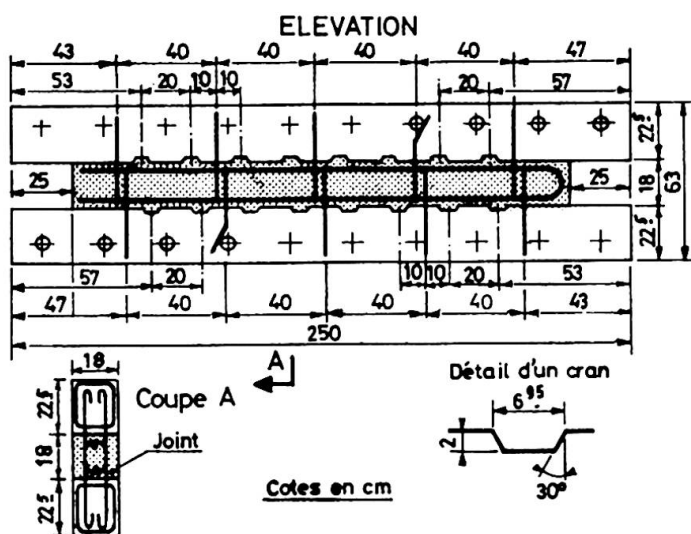
Les assemblages de 18 par 18 cm de dimension transversale et 200 cm de long, étaient d'un type connu, utilisé pour la fonction verticale de panneaux préfabriqués, ayant déjà fait l'objet d'essais statiques (figure 1). Chacun comportait deux bordures, crantées, d'où dépassaient des aciers en attente, en forme de boucles. L'assemblage était coulé une dizaine de jours, après les bordures, avec un béton de résistance inférieure à celle du béton des bordures.

Fig. 1 - Modèle essayé

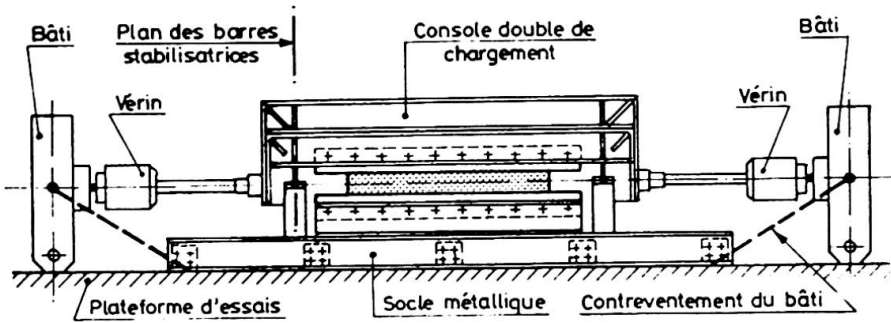
Fig. 2 - Montage d'essai

Chaque assemblage était soumis alternativement à des forces exercées suivant son axe dans une direction puis dans l'autre (figure 2). Un essai statique a été exécuté pour chaque série, à titre de référence sur un corps d'épreuve semblable et a donné une valeur de référence. Avant tout essai, chaque assemblage est fissuré aux plans de reprise par extension transversale par des vérins pour éviter un collage.

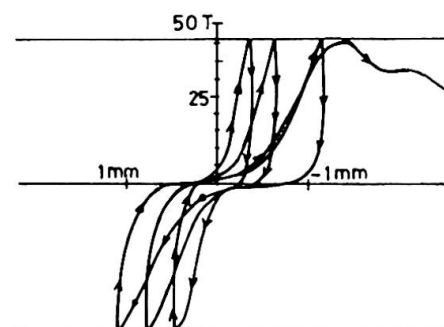
b - par forces alternées, égales et opposées, en appliquant au corps d'épreuve une force  $K T_u$ , et en notant le nombre  $N$  de cycles d'alternances que la pièce pouvait supporter avant rupture. La boucle d'hystérésis se déplace progressivement jusqu'à rupture. Les résultats ont été les suivants : pour des corps d'épreuve âgés de 32 à 45 jours (résistance du béton de l'assemblage d'environ 16 N/mm<sup>2</sup>) essayés en 1972, on a :

Fig. 4 - Cycles d'hystérésis à variation de charge imposée

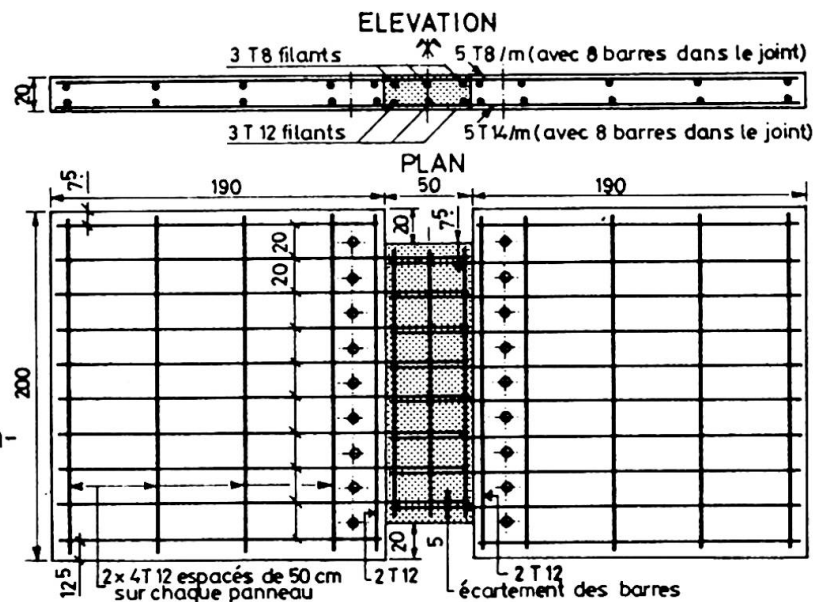
Chaque modèle est constitué de deux panneaux en béton armé préfabriqués, qui comportent des aciers en attente droits, et de l'assemblage en béton armé qui est coulé horizontalement. (figure 3).

Fig. 5 - Corps d'épreuve soumis à flexion et cisaillement

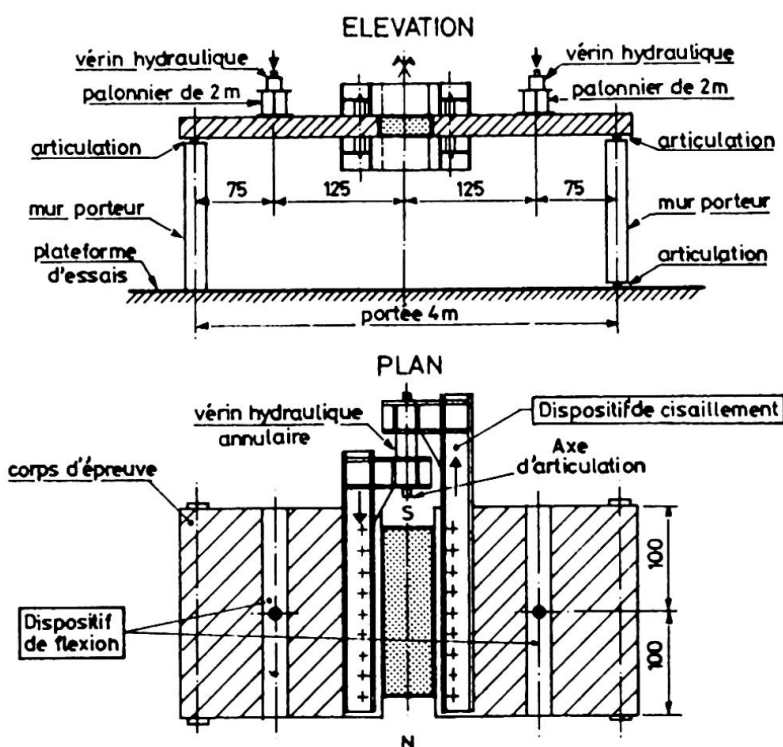
Fig. 6 - Montage d'essai
