## **Nail-Plates as Shear Connectors in Composite Timber and Concrete Structures**

### **Ulf Arne GIRHAMMAR**

### **SUMMARY**

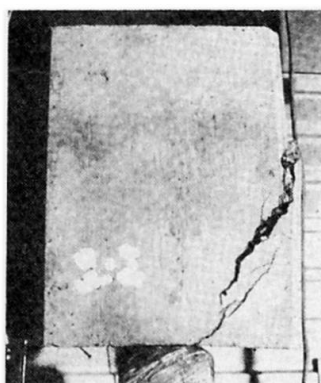
Fig. 14 Final failure by a) cracking the end of the concrete plate and b) cracking of the concrete edge for the standard design

The experimental load-slip curves for the standard design of the shear connections are given in fig. 8. In all tests, the nail-plates were excessively deformed in shear. In the tests 1-3, some of the nail-plates were partially sheared off when the final failure by cracking of the end or corner of the concrete plate occurred, see fig. 14a. The final failure in the tests 4-5 was reached by cracking of the concrete edge, fig. 14b, but there were no nail-plate shear failures. The cracking of the concrete plate started, in both cases, at the upper edge of the nail-plates and continued through the nail-plates in the downwards direction.

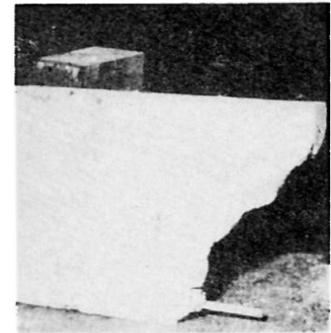
**Fig. 16.1&2** Final failure in shear for no. 1&2 **Fig. 16.3** Final failure by cracking of concrete for no. 3 **Fig. 16.4** Final failure by cracking of concrete for no. 4

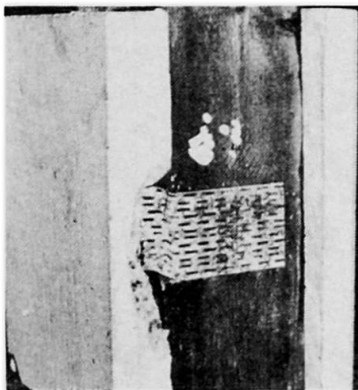
**Fig. 16.5** Final failure by cracking of concrete edge for no. 5 **Fig. 16.6** Final failure in shear/cracking of concrete, no. 6 **Fig. 17** Idealized load-slip curves (mean values)
