**Zeitschrift:** IABSE congress report = Rapport du congrès AIPC = IVBH  
Kongressbericht

**Artikel:** Preservation of newly built and historical buildings

**Autor:** Croci, Giorgio

## **Preservation of Newly Built and Historical Buildings**

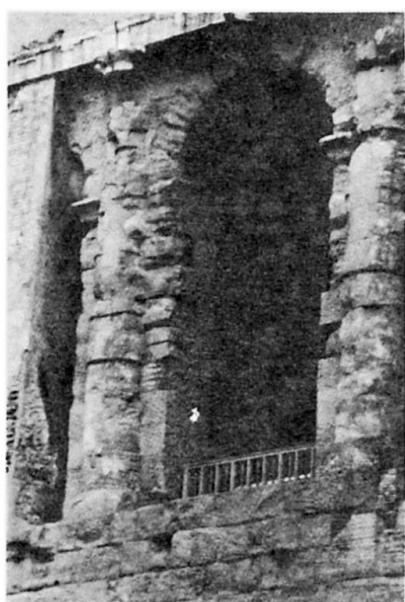
Pic.2: Alterations and deteriorations of Palazzo Senatorio

The first point to examine in the preservation of a structure is the analysis of the deterioration of the materials. This deterioration in the oldest buildings is linked not only to the chemical and physical phenomena, but also to the countless alterations, that, as in the case of Palazzo Senatorio in Capidoglio, Rome, (fig. 1) have occurred during the centuries (fig. 2), sometime stressed by incorrect reinforcements (fig. 3).

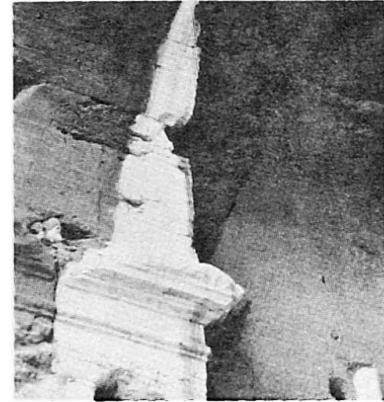
Pic.10,11: Displacements and discontinuities in the structure of Colosseum

Consequences of this outward movement are relative displacement of the blocks (fig. 10) and discontinuity between the outer elliptical structure and the radial masonry (fig. 11).

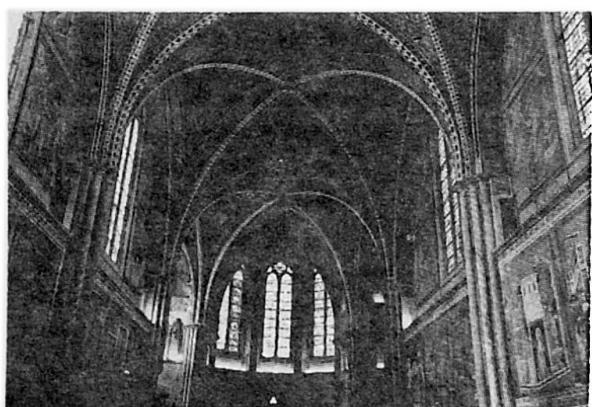
Pic.16: Damages in the Giotto frescos Pic.17: Mathematical models of Basilica of St. Francis in Assisi

The earthquake has been also the main cause of damages in the Basilica of S. Francis of Assisi (fig. 15). Many signs are visible, the cracks in the central columns of the large windows and the damages that in the centuries have effected Giotto frescos (fig. 16).

The mathematical model shows the general stress distribution (fig. 17). In the wall that supports the Giotto frescos we can see in further detail the tensile stresses in the inner surface, and the compression stress in the outer surface, corresponding to bending moments; these stresses change sign many times during the sinusoidal seismic action, causing the cracks that we have observed. In order to reduce these effects, a steel trussed beam will be placed over the internal cornice (fig. 18, 19). This beam is connected to the masonry by oleodynamic dampers in a position to allow thermal deformations, but to react rigidly under the effect of dynamic impulse due to the seismic action.

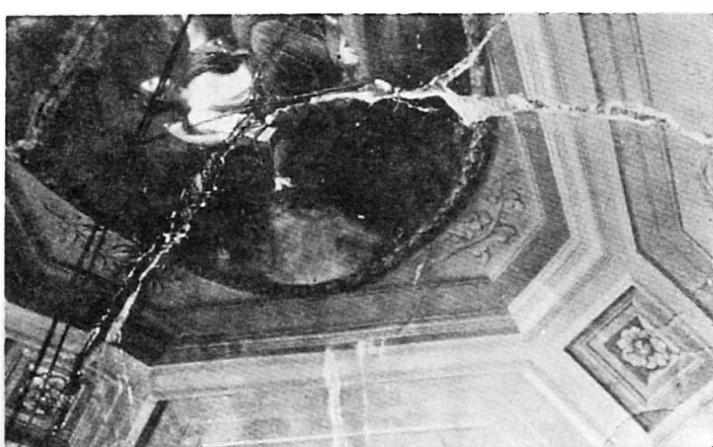
Pic.21: Cracks in the vaults of Ducal Palace of Modena

Soil deformations represent a further group of phenomena that often effect old buildings. The solution is not only in improving the bearing capacity of the foundations (underpinning, ...) or in strengthening the building as a whole. It is often better to use different solutions: in the Ducal Palace of Modena (fig. 20), where important cracks due to soil rettlements effect the walls, floors and vaults (fig. 21), we have proposed to make joints (fig. 22), to allow differential settlements to occur without inducing significant stresses in parts of the Palace.

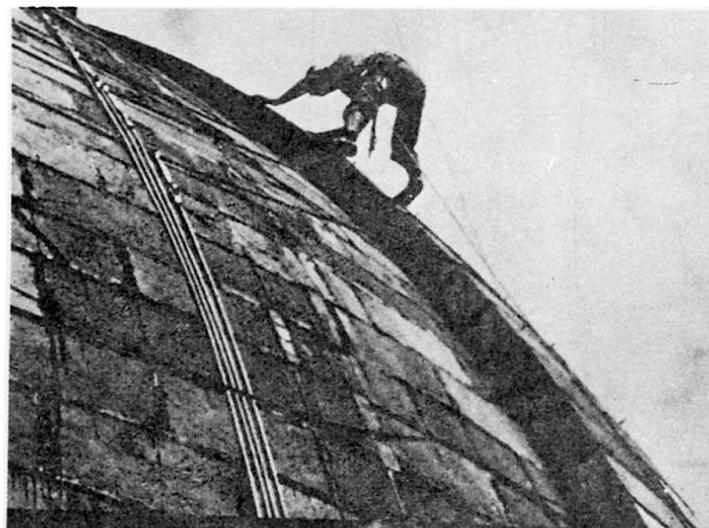
Pic.33: The operations to place the cables

The stainless steel cables have been put in place by "escaladores" (fig. 33) and the phase of pretensioning has been monitored (fig. 34).
