Artikel: Rehabilitation of transit authority structures in New York

Autor: Nagaraja, Mysore L. / Khan, Raza A.

Rehabilitation of Transit Authority Structures in New York

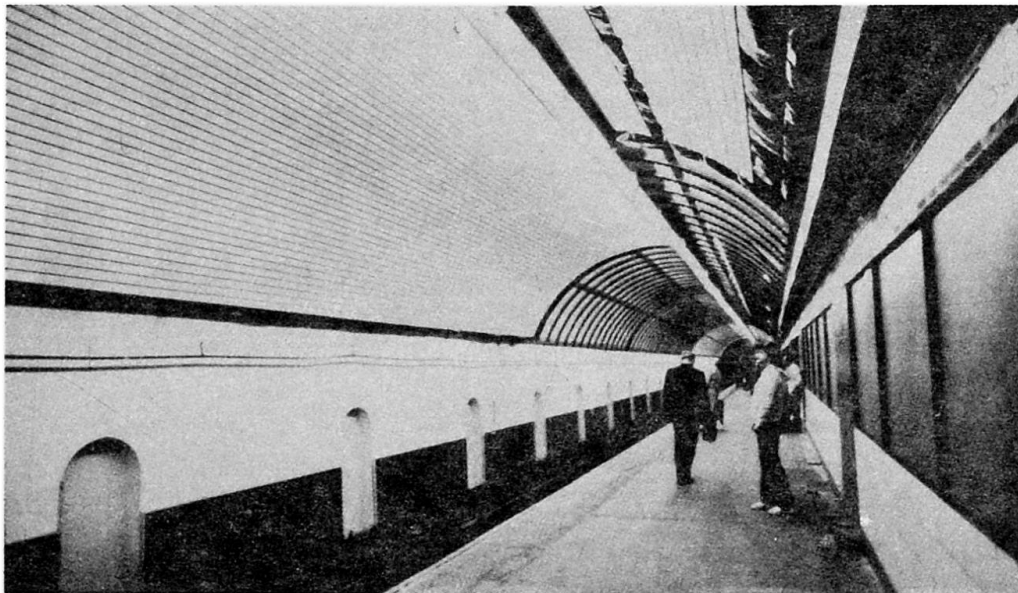
SUBWAY STATION
