Artikel: Dry dock with anchored bottom

Dry Dock with Anchored Bottom

Romeo CIORTAN
Assoc. Prof.
Design Inst. for Transport
Bucharest, Romania

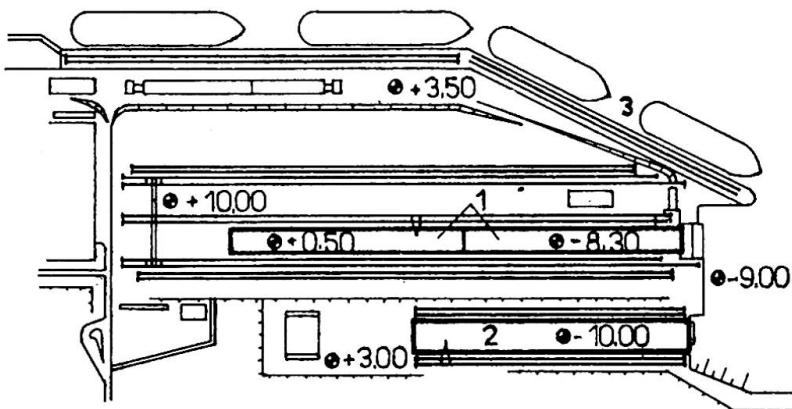
Fig.1 Dry dock in Mangalia shipyard-Romania
1,2-existing dry dock; 3-new repair dry dock

Within Mangalia shipyard located on the Romanian shore of the Black Sea, a dry dock has been built for ship repair up to 250000 dwt (fig.1).

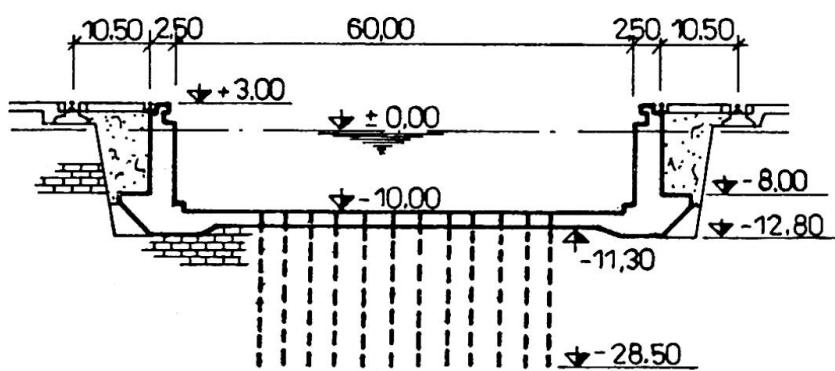
Fig.2 Repair dry dock

In cross section, the dock is made up of an anchored bottom plate 1.80 m thick and of two lock walls 2.75 m thick and 13 m high with a cantilever towards the filling for the balance of the bending moments into the bottom plate (fig.2).

To adopt a classical solution a gravity one would have led to a slab thickness of 7.80 m in order to undertake the water pressure. By excavating the enclosure up to -18.0 m the rock bottom plate would have had a lesser thickness above the half-permeable layer existing the peril to loose its stability under the effect of underpressures. That would have led to considerable increase of inflows into the enclosure with an imprevisible evolution by moving the material from the rock holes. In order to avoid that

The rock between the bottom plate and the anchoring of tie-bars constitutes a ballast in order to undertake the underpressure of water, this, the foundation platform thickness has been reduced to 1.80 m.

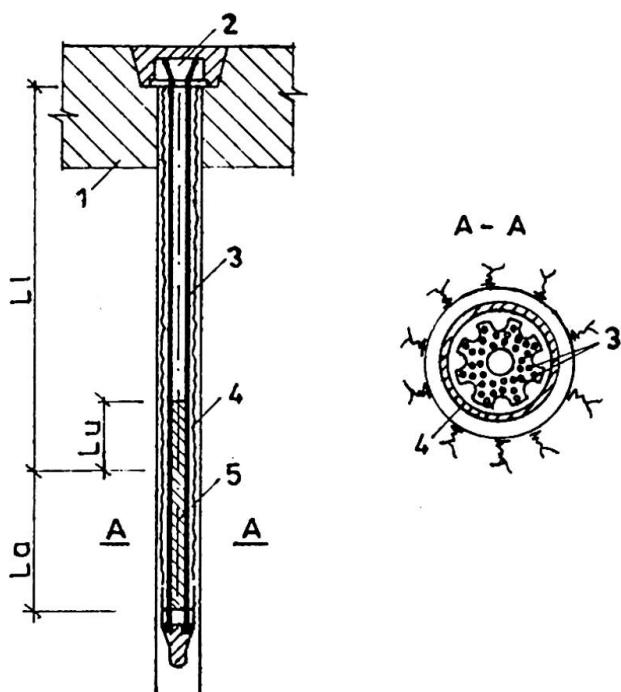
Fig.3 Anchoring cross-bar for the dry dock bottom

1.the dry dock bottom; 2.blocking system; 3. \varnothing 7 mm wires;
4.striated casing; 5.cement mortar ; Lu-prebulb lenght;
La-bulb lenght

The tie-bar is 17.30 m long and comprises an anchoring bulb of 6.0 m the free lenght being of 11.30 m (L1) (fig.3). The anticorrosive protection has been obtained by means of wires into the cement concrete on the bulb area and in a haft fluid solution an the free lenght everything being introduced into a sheath made up of polyetilene \varnothing 110 mm, the wall being 1 mm thick closing the bunch. The space between the rock and the sheath has been filled with mortar and cement.

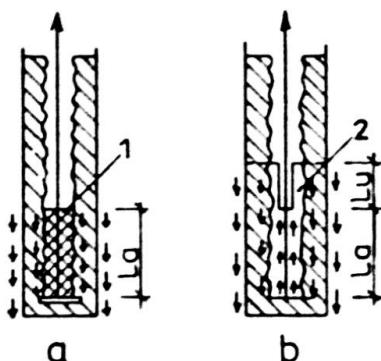
Fig.4. Efficiency of tie-bar with prebulb
 a.tie-bar without prebulb ; b.tie-bar with prebulb
 1.area with cracks ; 2.prebulb with a washer effect

From experiences from similar works the bulb has presented cracks upwards due to the excessive efforts produced by the wire tensioning. In order to eliminate that, the tie-bar has been executed in an original way, using a prebulb 2.80 m length (L_p), upwards of the bulb, having as a characteristic the lack of adherence to the wire. By this constructive measure the prebulb acts like a washer, this contributing to the reduction of the tensioning efforts in the bulb (fig.4).

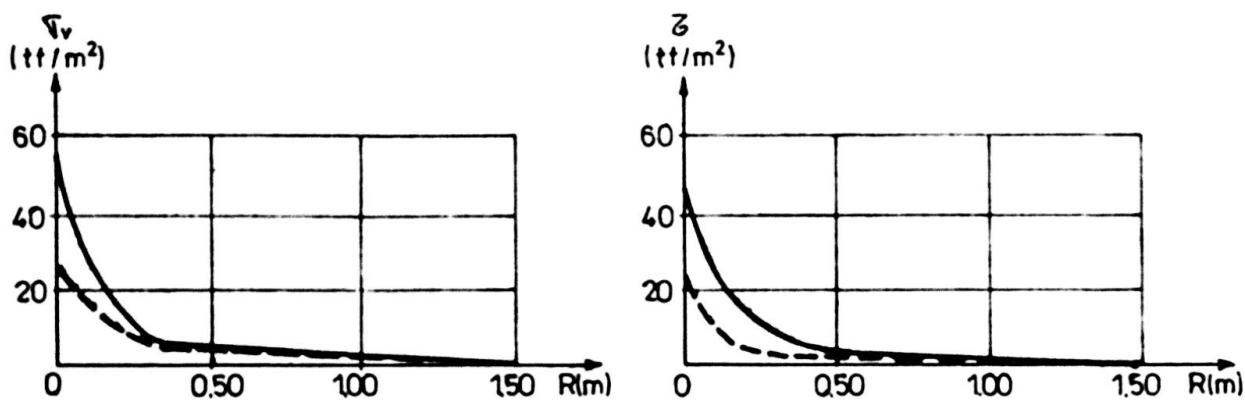
Fig.5 Diagramme of normal and tangential unitary efforts at the level of the contact area between bulb and prebulb
 ----- tie-bar with prebulb
 ——— tie-bar without prebulb

In order to make in evidence the pre-bulb effect, theoretical studies have been made using programme SAP IV, discretising the tie bar into elements with axial rigidity and respectively symmetrically axial calculating the values of efforts in different hypotheses. It has been noticed that in the section immediately downwards to the contact area prebulb-bulb, the maximum tensional vertical effort and the sliding one decreases by about 50% in the variant with pre-bulb (fig.5)

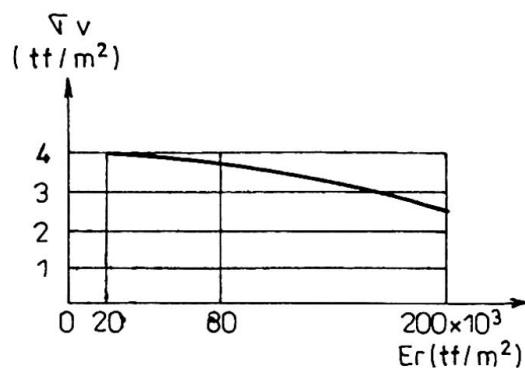
Fig.6-Variation of normal unitary effort V_v at the contact between rock and tie bar, at the upper side of the bulb, according to the size of the elasticity modulus of the rock E_r

In the rock the efforts decrease rapidly that decrease under-taking to a great quota to the loading transmitted to the anchorage (fig.6).

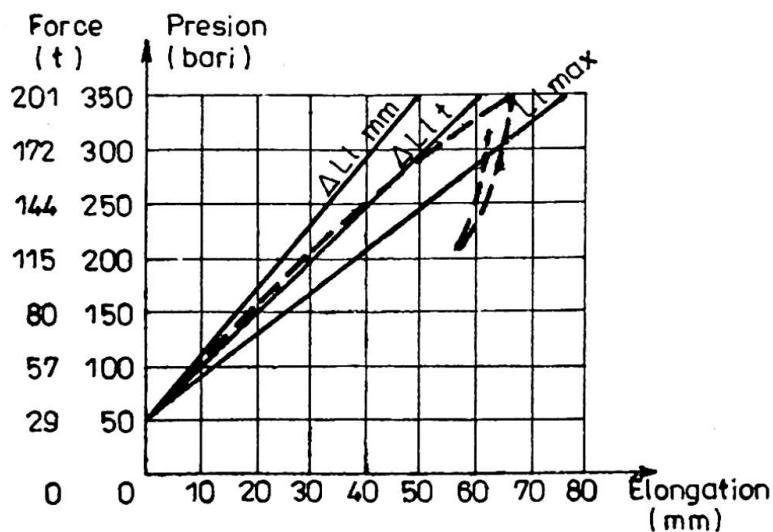
Fig.7 Diagramme of the tie-bar tensioning

The tie-bars were introduced into the holes when the concrete resistance to compression of the bulb reached 250 daN/sq.cm. After reaching a resistance of 280 daN/sq.cm. of the cement mortar of the outer sheath, the tie-bar were pretensioned by means of a hydraulic press of 2,500 KN. Considering the loss of tension into the wires, the blocking force (F_b) of 1840 KN and the operation charge (F_e) of 1450 KN that is $F_b=1.27 F_e$. Tensioning was carried out up to the checking charge (F_v) of 2010 KN ($F_v=1.1 F_b$) which was maintained 10 min and if slipping was greater of 2 mm everything was let clown in steps up to 1150 KN, then tensioning was relaken up to the blocking charge (fig.7)

If slipping surpassed 2 mm the duration of recharging was prolonged with 20 min and if lengthening was stationary, the tie bar was considered as good. If not, pressure was lessened to zero and everything was recharged at a checking charge 10% lesser and was blocked at a charge also 10% lesser. For about 10% of the tie bars the effort checking was made by blocking detachment. At the detachment moment the reading on a manometer was not less than 3% that the blockage value, admitted.

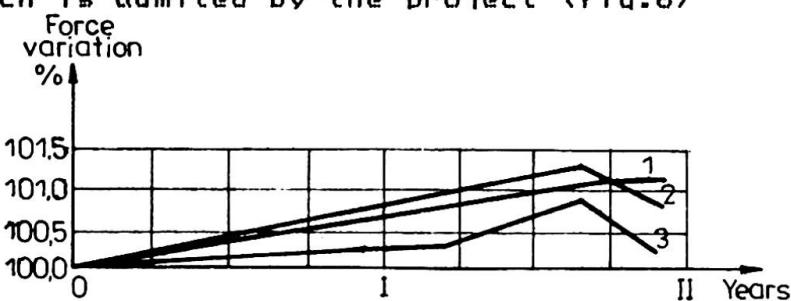
Fig.8 Variation in time of the tie-bar force
1,2,3 -the tie-bars

In order to check in time the efforts inside the tie-bars, some of them were provided with tensiometrical, electroacoustical doses, making periodical measurements.

In the first 5 years, the initial effort decreased by 1-1.5% which is admitted by the project (fig.8)
