**Artikel:** Load and destruction test of 160-Ft. girder designed for first prestressed concrete bridge in U.S.A.  
**Autor:** Fornerod, M.  
**DOI:** <https://doi.org/10.5169/seals-10582>

## **Load and Destruction Test of 160-Ft. Girder Designed for First Prestressed Concrete Bridge in U.S.A.**

M. FORNEROD, Chief Engineer, Preload Enterprises, Inc., New York, N. Y.

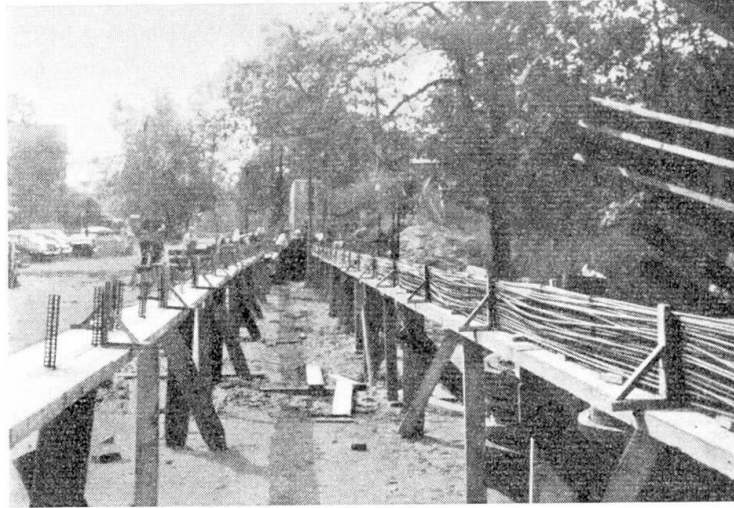
Fig. 5. Cable Assembly and Comb Spacers

Simultaneously with the pouring of the girders the assembly of the longitudinal prestressing cables was accomplished on special assembly benches with special "comb spacers" (Fig. 5). These cables consist of 24 to 64 parallel 0.276" diameter high carbon steel wires. They were inserted in the longitudinal holes in the girders by a special jacking arrangement.
