Artikel: Impact resistance on prestressed concrete masts
Autor: Abeles, P.W.
DOI: <https://doi.org/10.5169/seals-15750>

Impact Resistance on Prestressed Concrete Masts¹⁾

P. W. ABELES, London

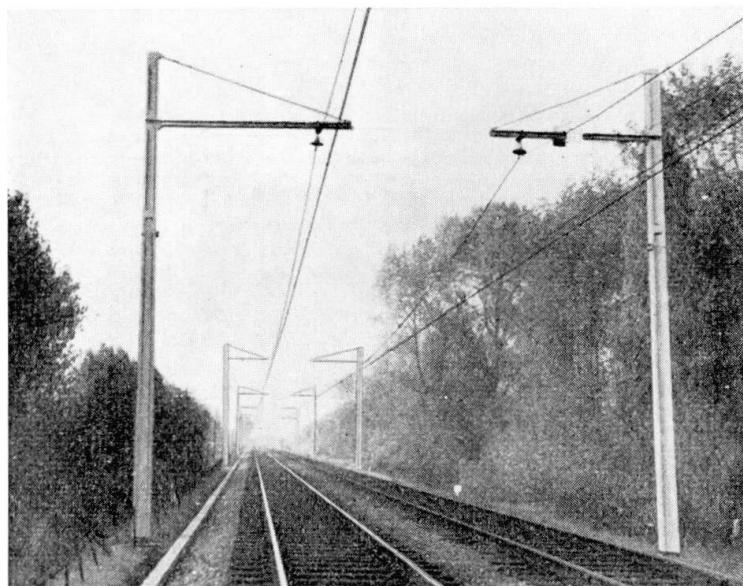
Fig. 1. Prestressed Concrete Cantilever Masts near Southend (England).

From figs. 1—3 it is seen that the prestressed concrete masts differed but little in size from the steel masts. This was achieved by making full use of the tensile resistance of the concrete under working conditions, which is particularly advantageous if loading in opposite directions occurs. Freedom from

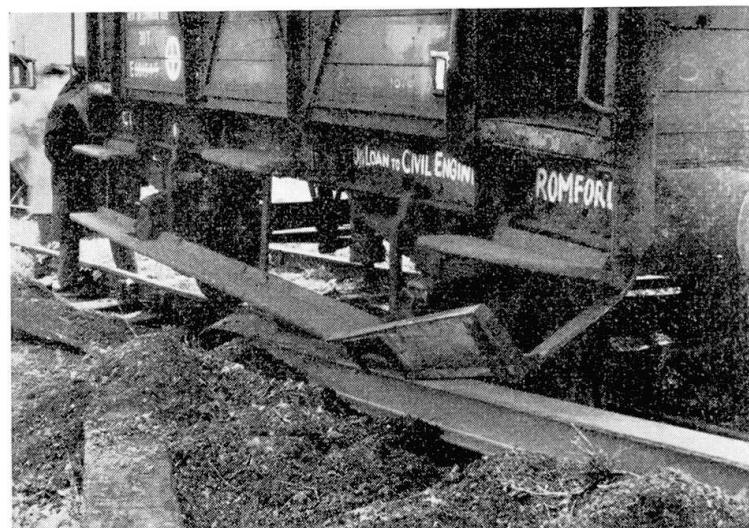
Fig. 4. Romford Impact Tests. Steel Mast After Direct Impact.

The impact was applied by means of a brake van of 20 tons weight which was projected into the mast with a speed of approximately 10 miles per hour. For each individual test the track was slewed so that either the entire mast or only part of a flange was hit. The tests have proved, as was to be expected, that in the event of a direct hit both types of mast become unserviceable. The steel mast was entirely bent down (fig. 4), although it had been expected by those favouring steel that it would only be bent slightly and would still be able to carry the high voltage wires in the air; the prestressed concrete
